REHABILITATION AND CONSTRUCTION OPTIONS FOR CONCRETE BRIDGES — ENSURING LONG SERVICE LIFE

Gerardo G. Clemeña, Ph.D., MSc.
Virginia Transportation Research Council*
Charlottesville, Virginia

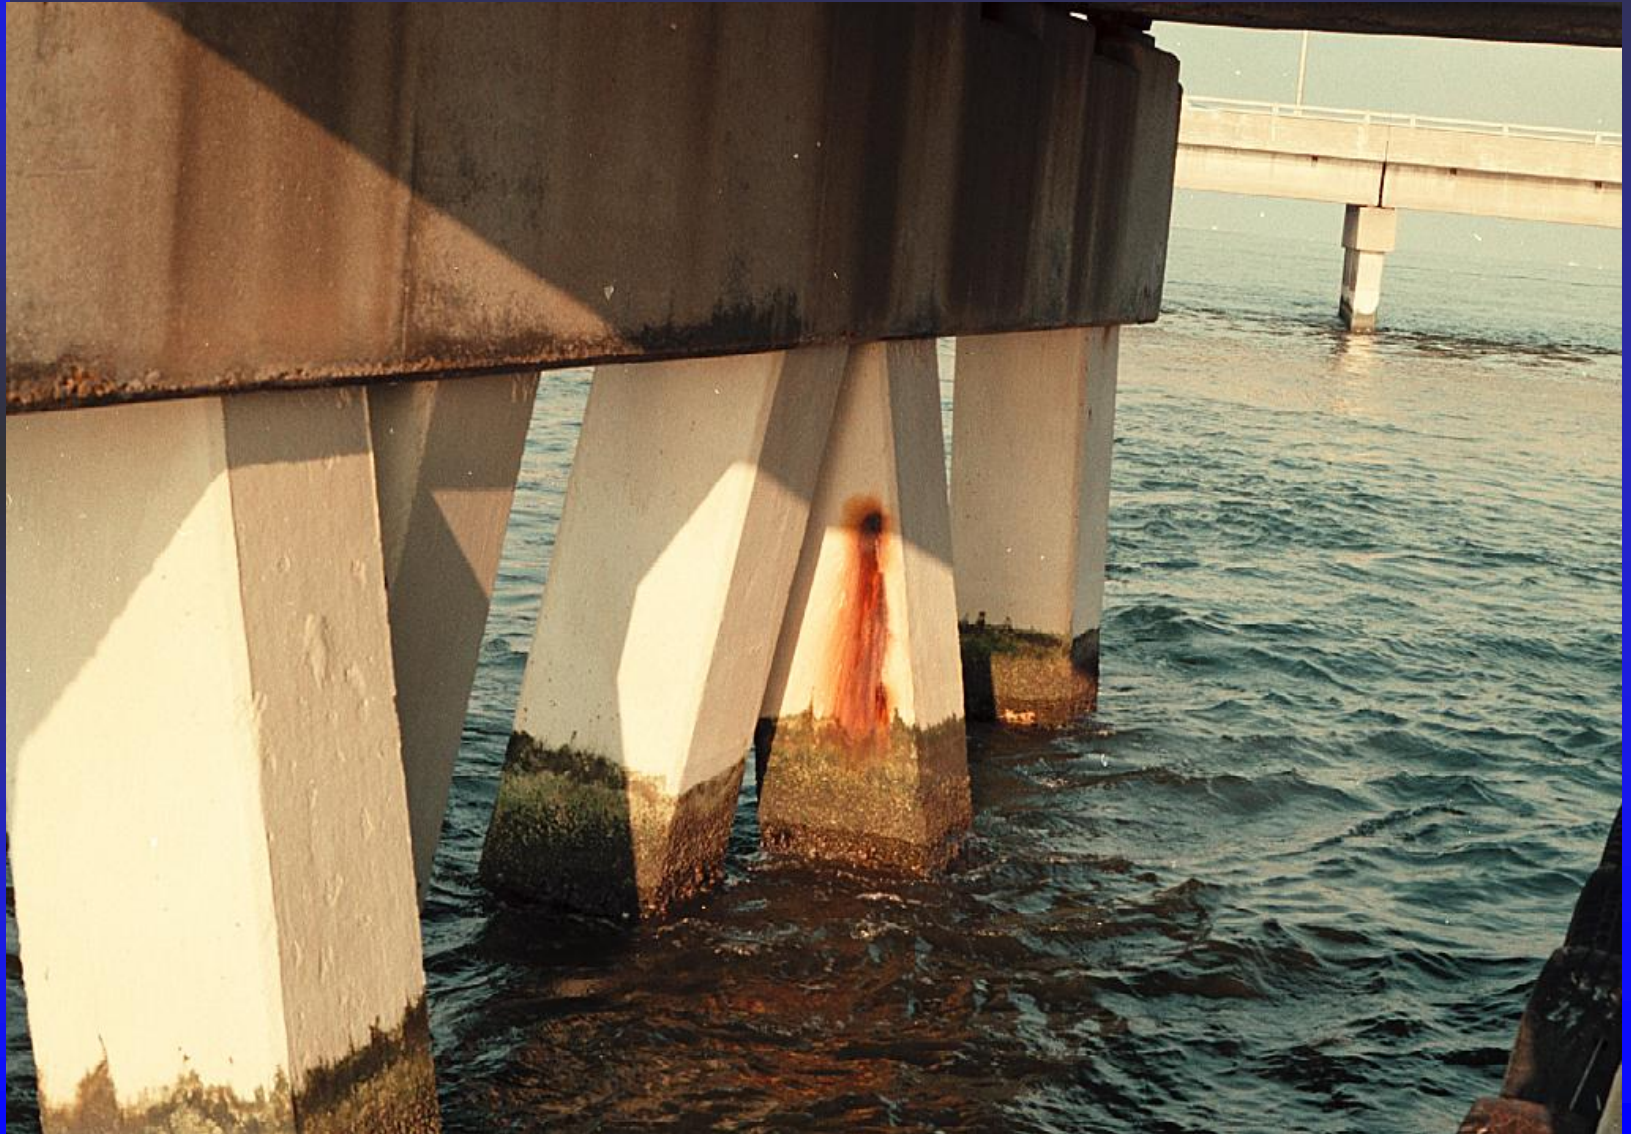
Corrosion Problem on Prestressed Concrete Piles in Virginia Coastal Areas

- **Prestressed Concrete:**
 - Still isolated to concrete piles in coastal areas.

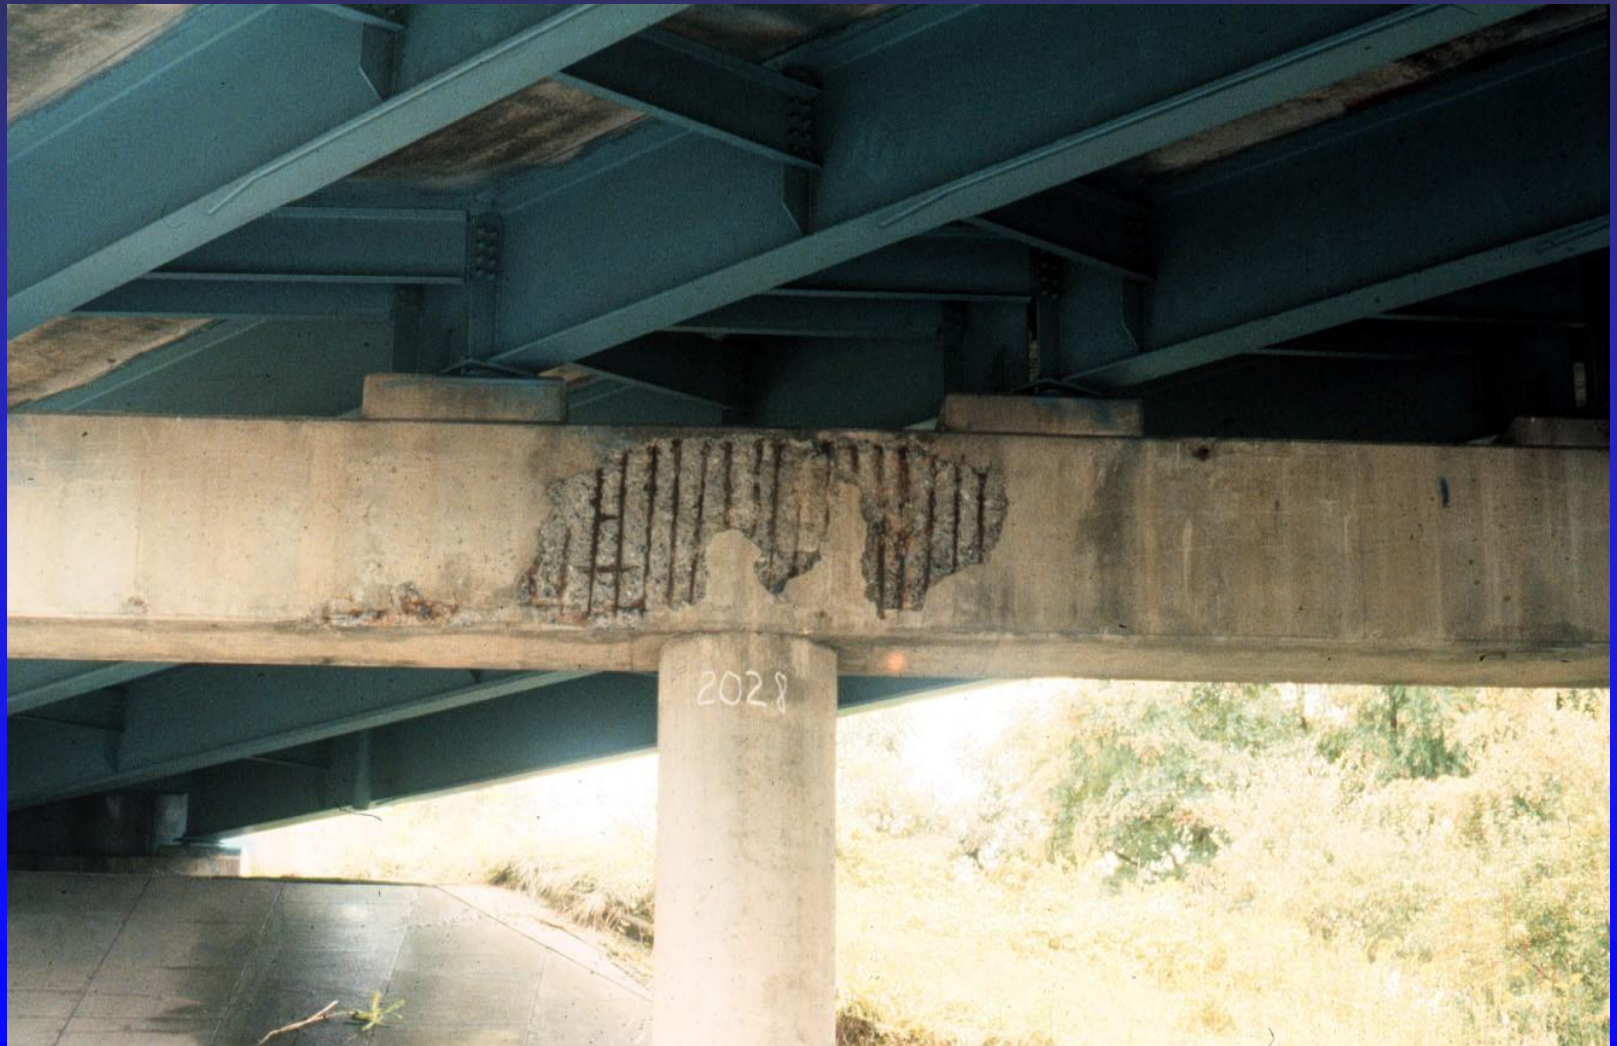
Corrosion Problem on Inland Concrete Piers in Virginia

- **Conventional Reinforced Concrete:**
 - Decks – extensive in older decks built with bare steel bars.
 - Piers – same.

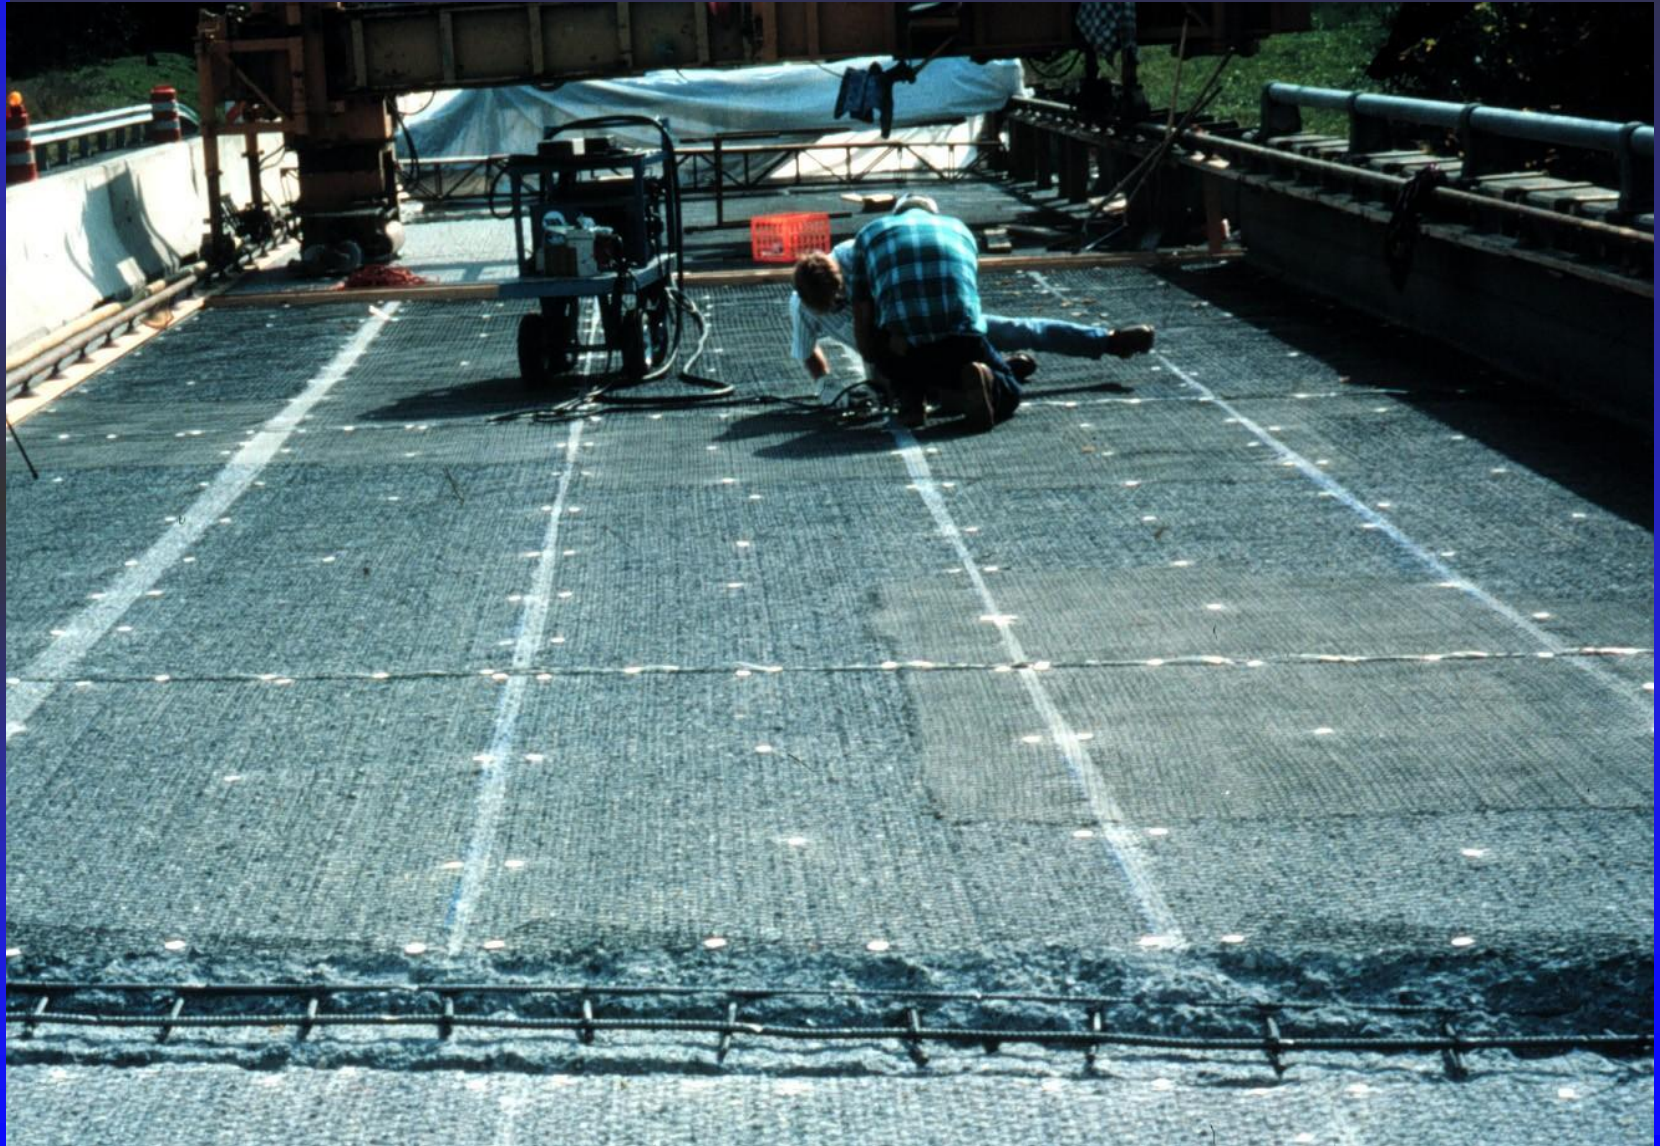
IC-CP of Concrete Decks (Using Ti Mesh as Anodes)

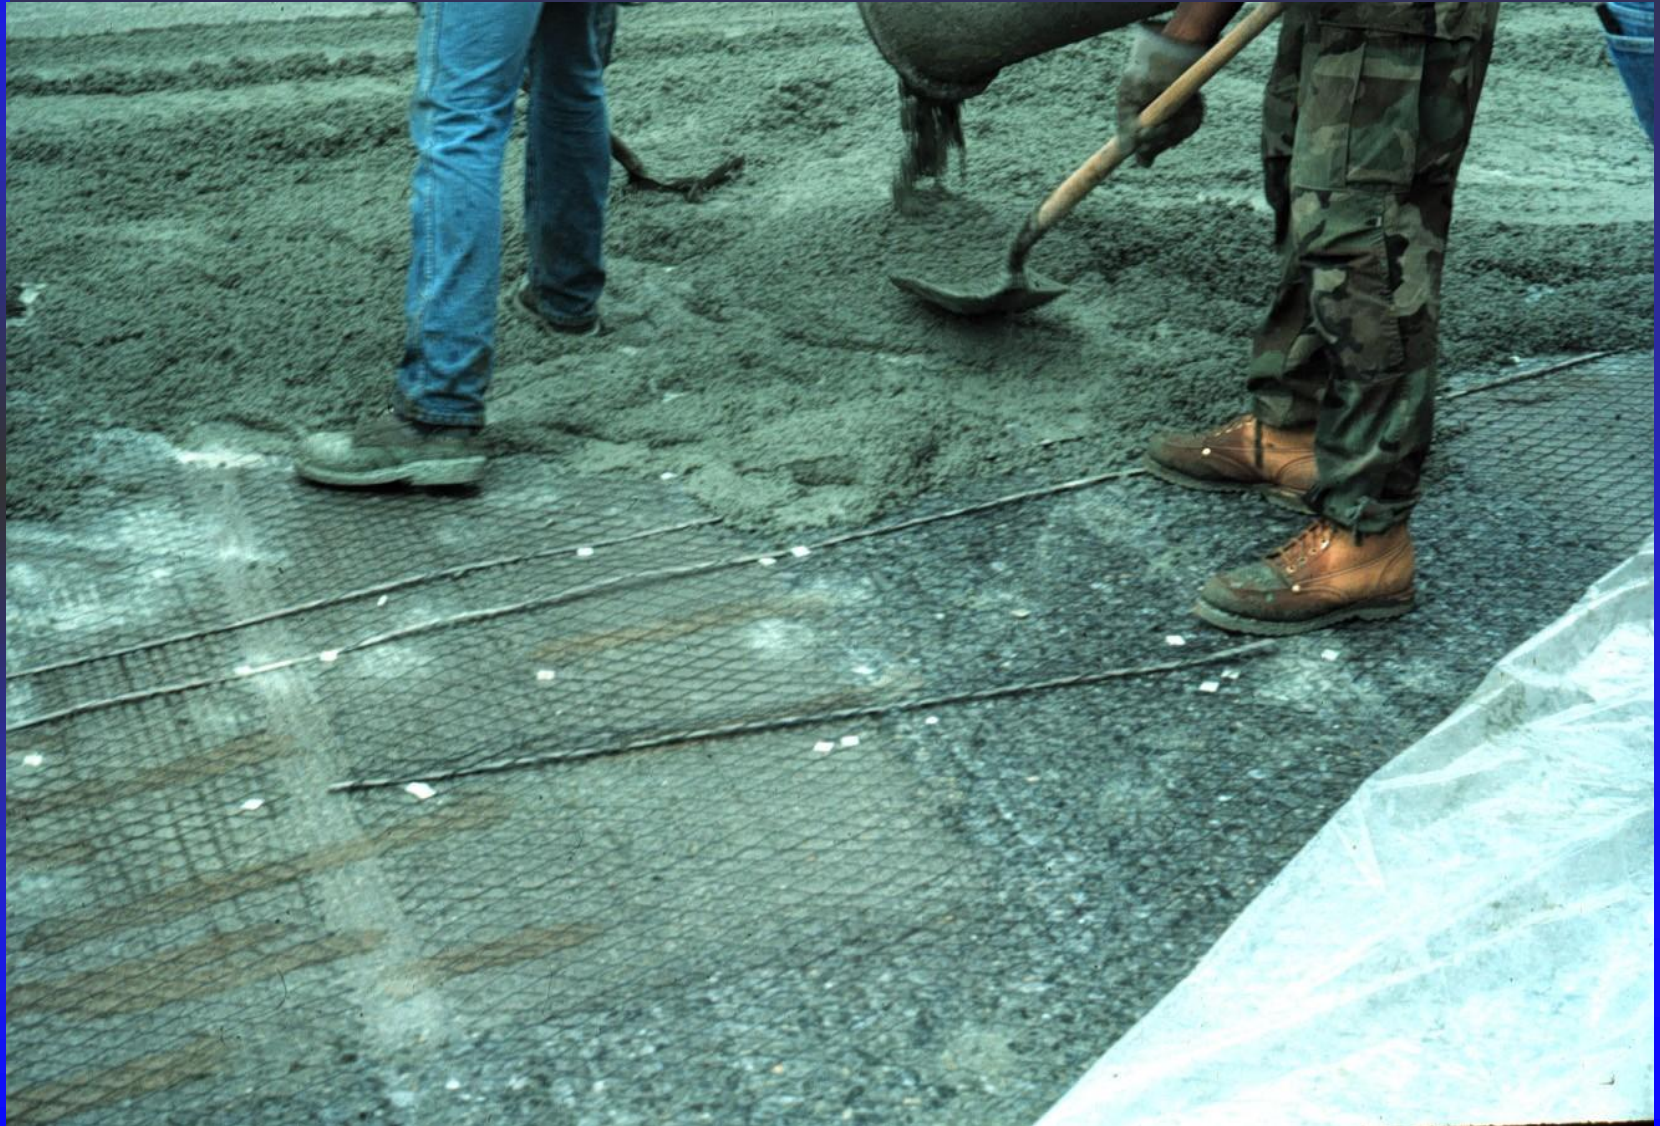
Overlaying of the Ti-Mesh Anode with Fresh Concrete

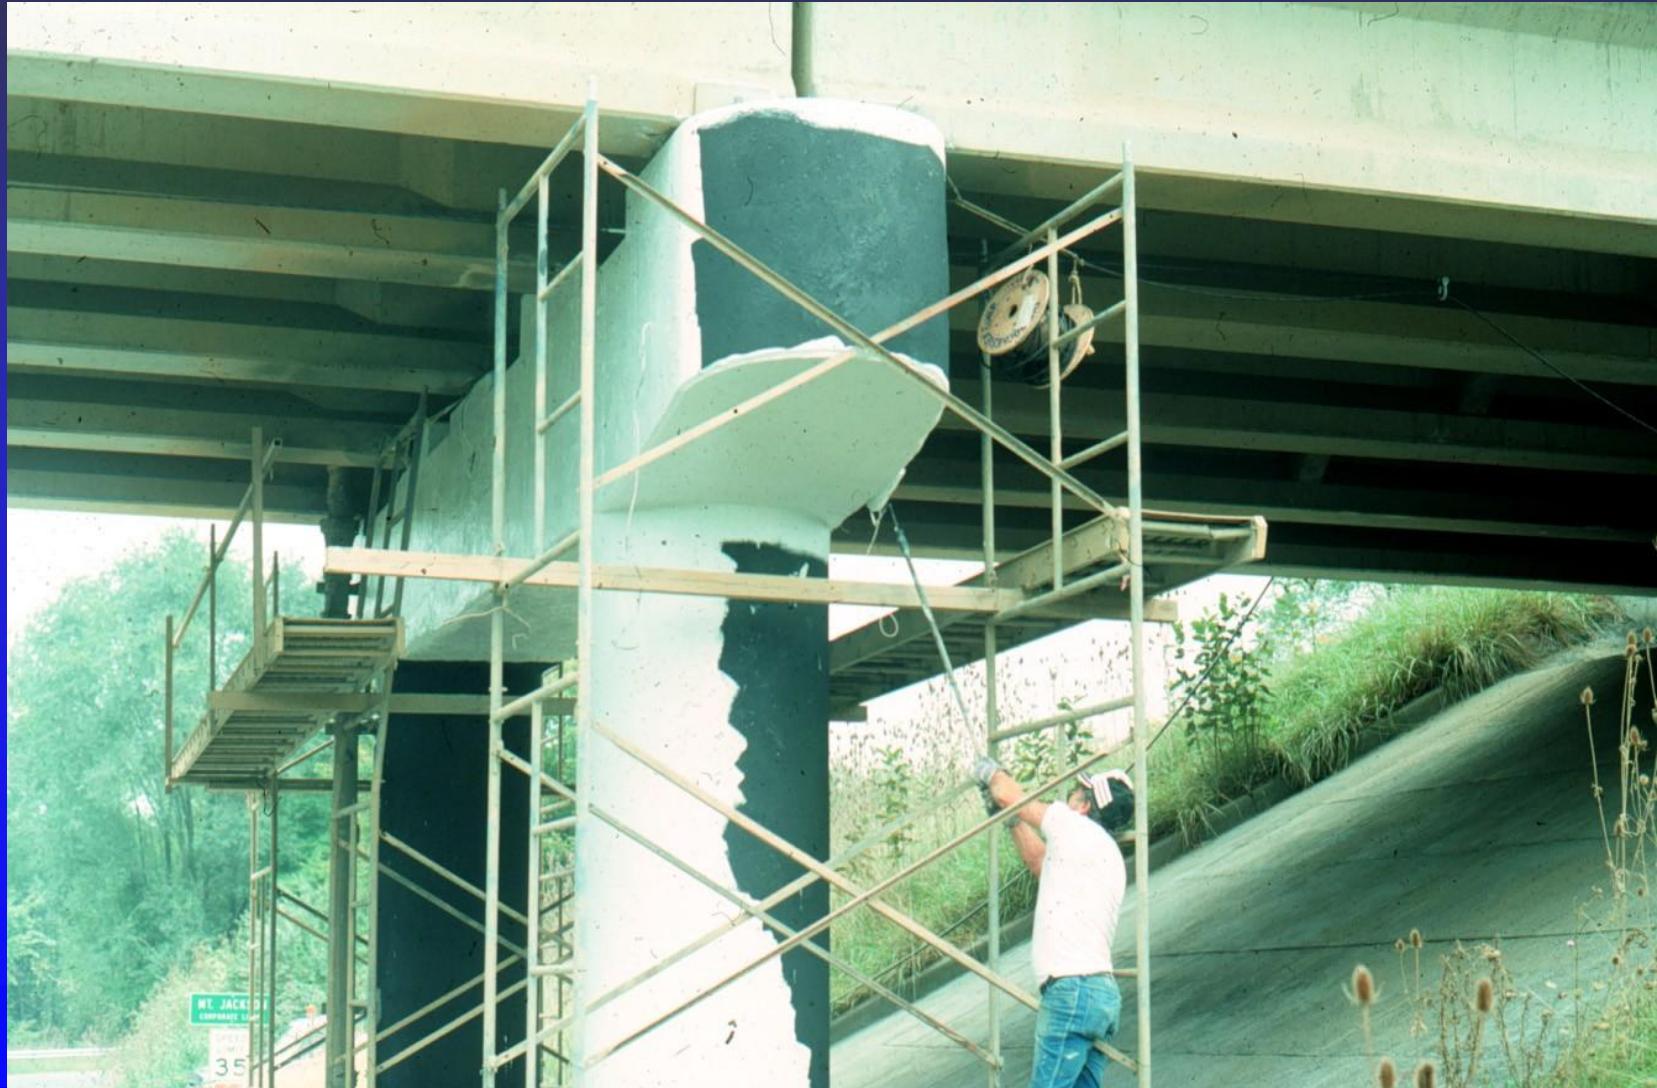
IC-CP of Inland Concrete Piers (Using Conductive Coatings as Anode)

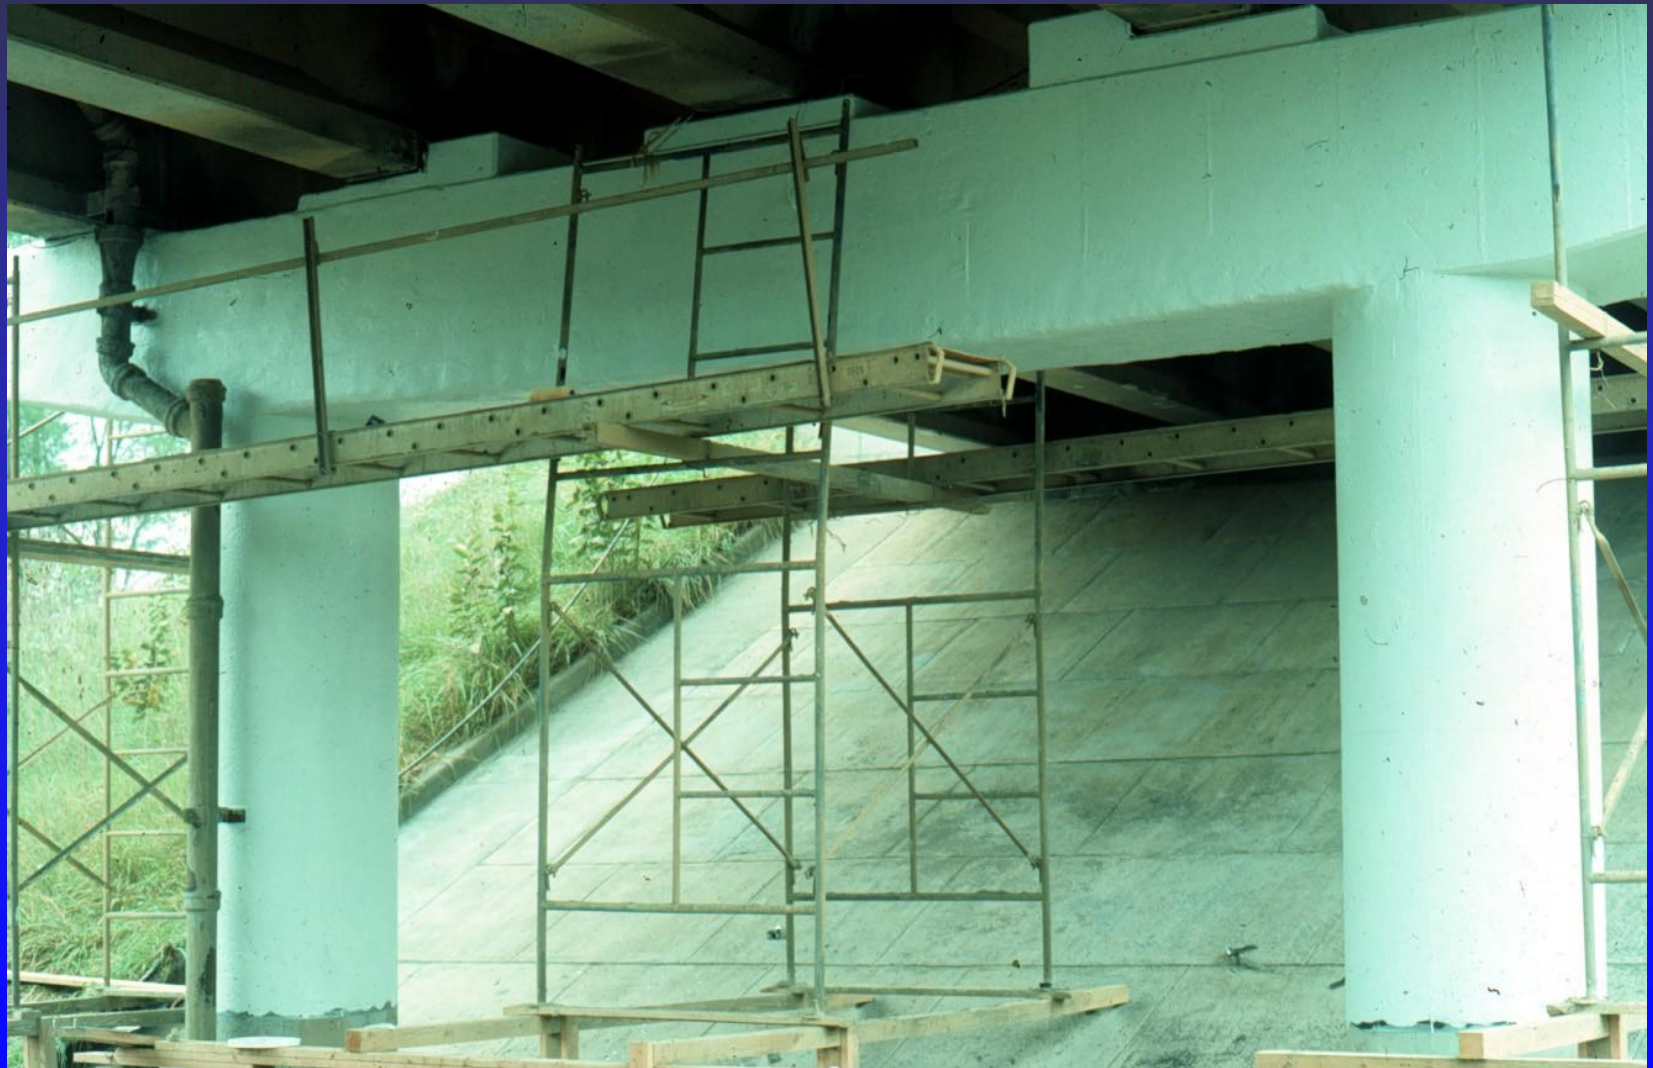
A Completed Conductive-Coating Anode System

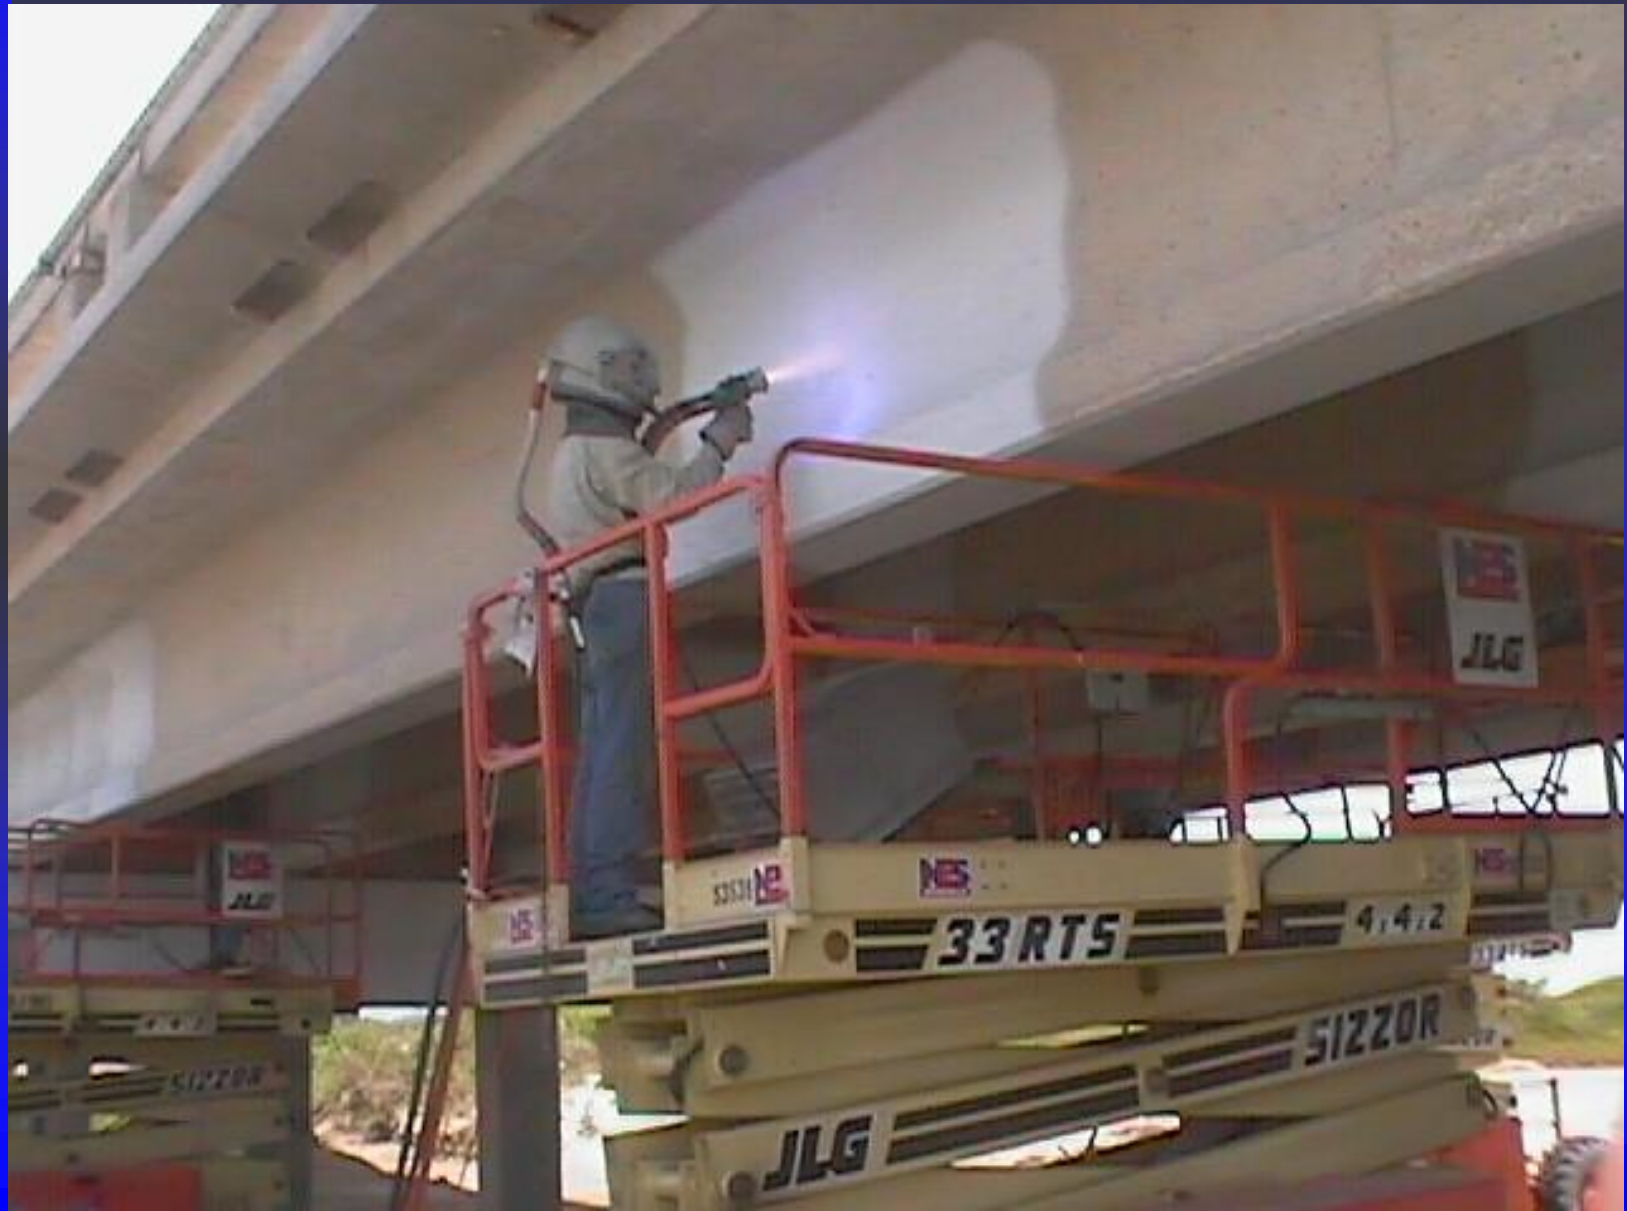
G-CP of PS Beams (Using Arc-Spraying of Al-Zn-In Anode)

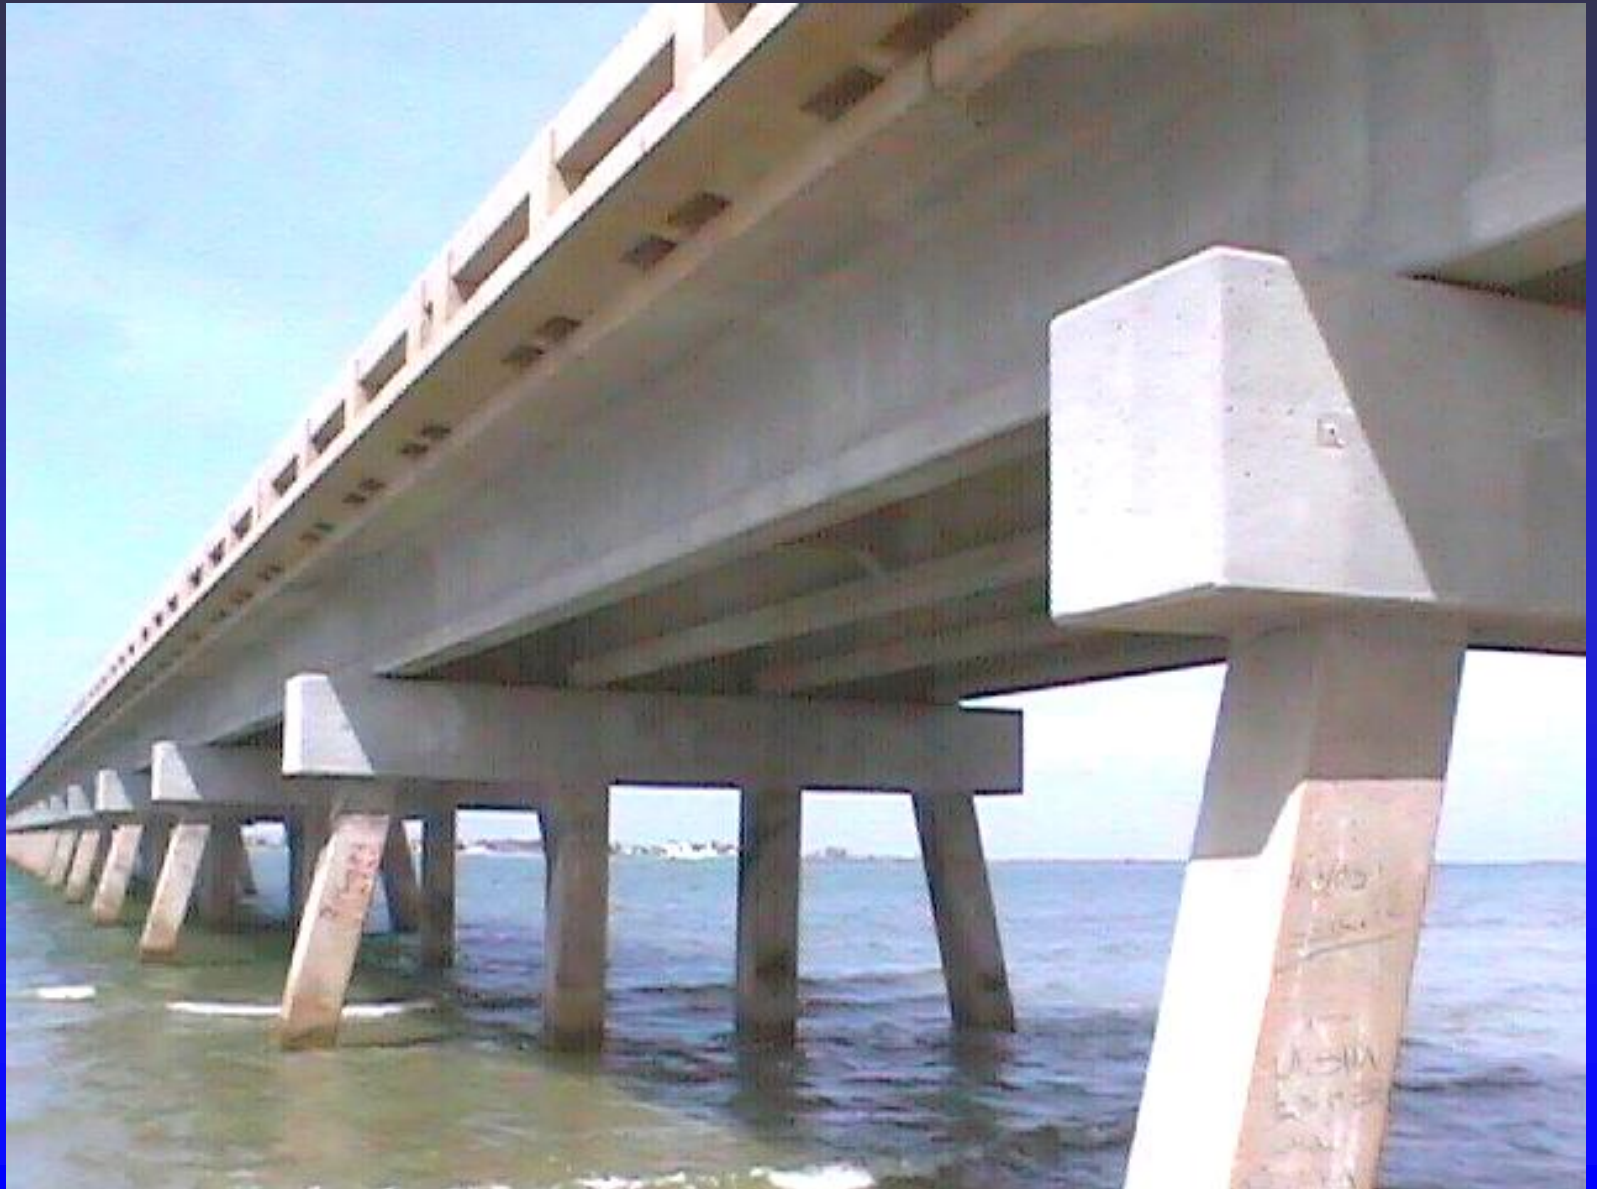
A Completed Al-Zn-In CP System

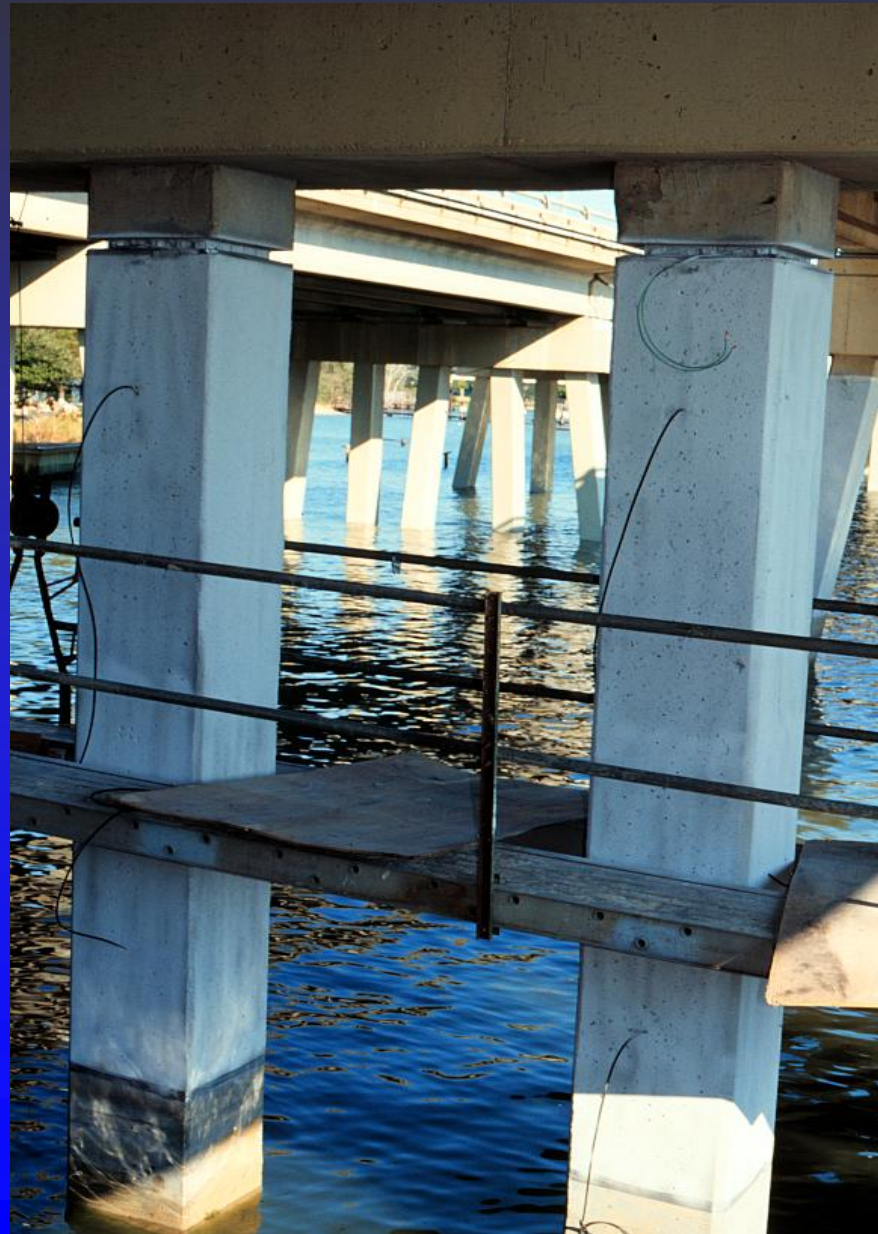
A Al-Zn-In Installation on PS Piles

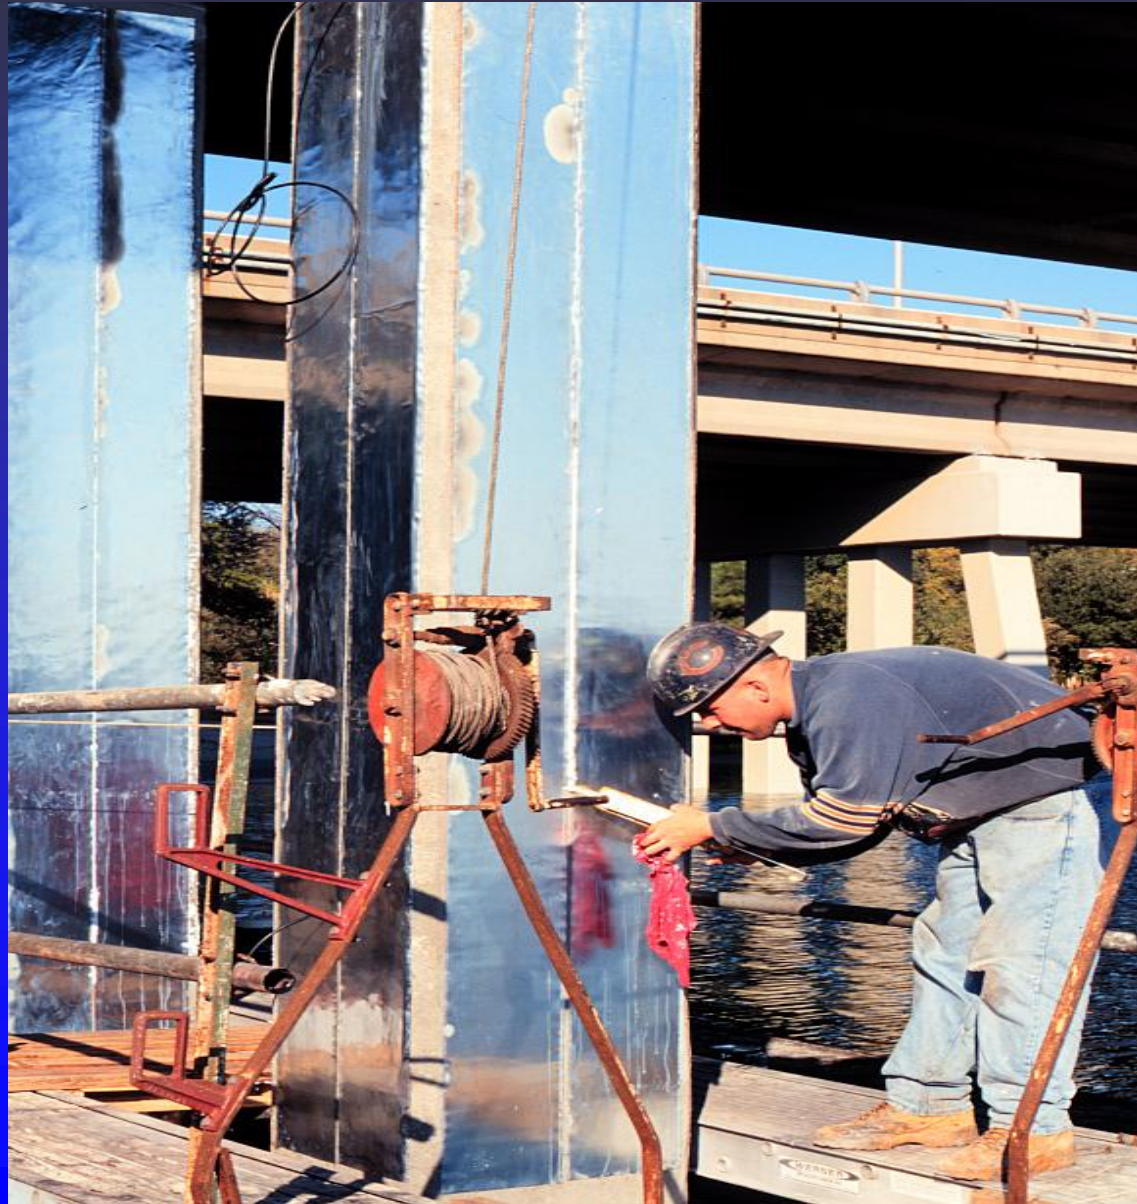
Installation of Zn / Hydrogel Anode on PS Piles

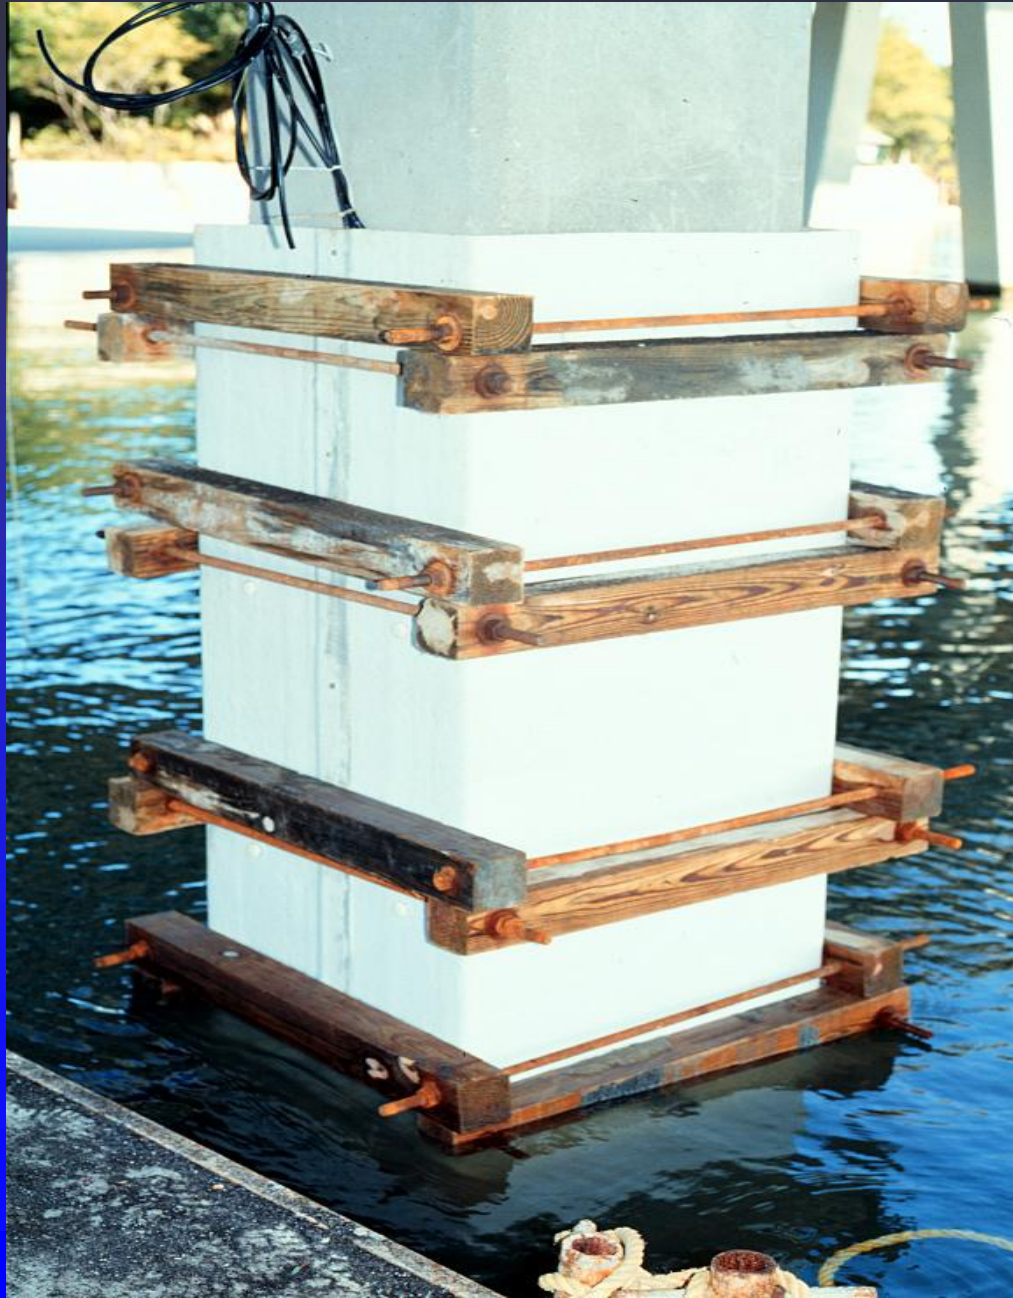
A Zn Mesh / Grout Jacket Anode

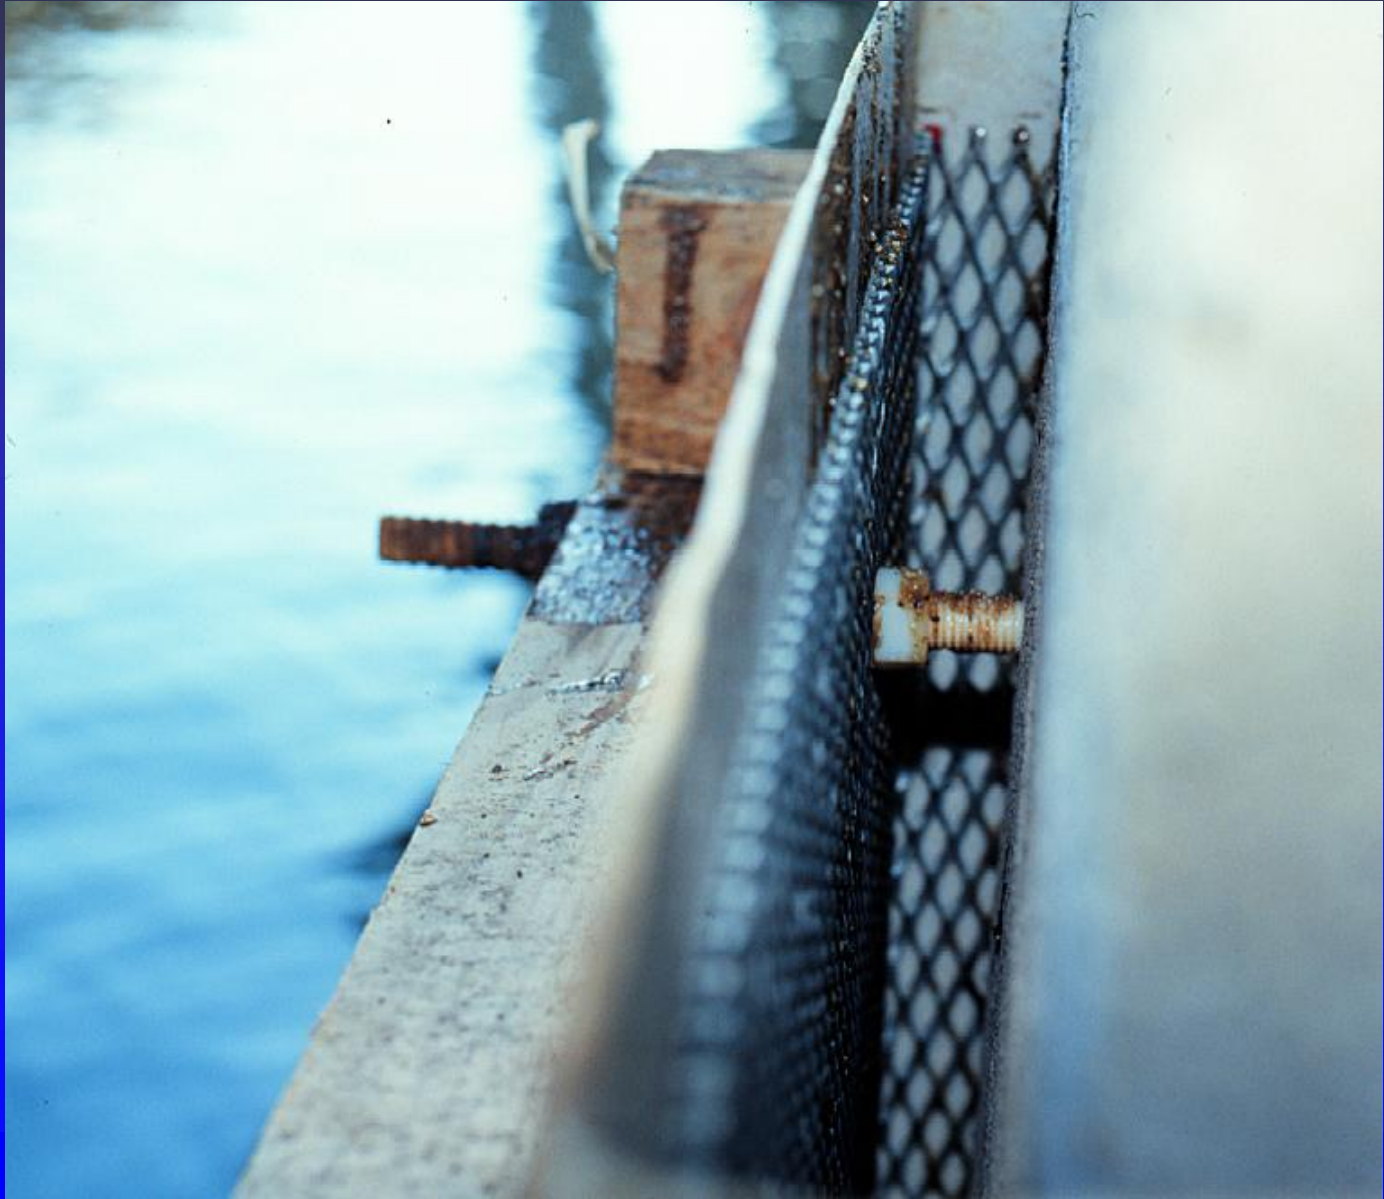
A Close-Up of the FRP Jacket and Zn Mesh

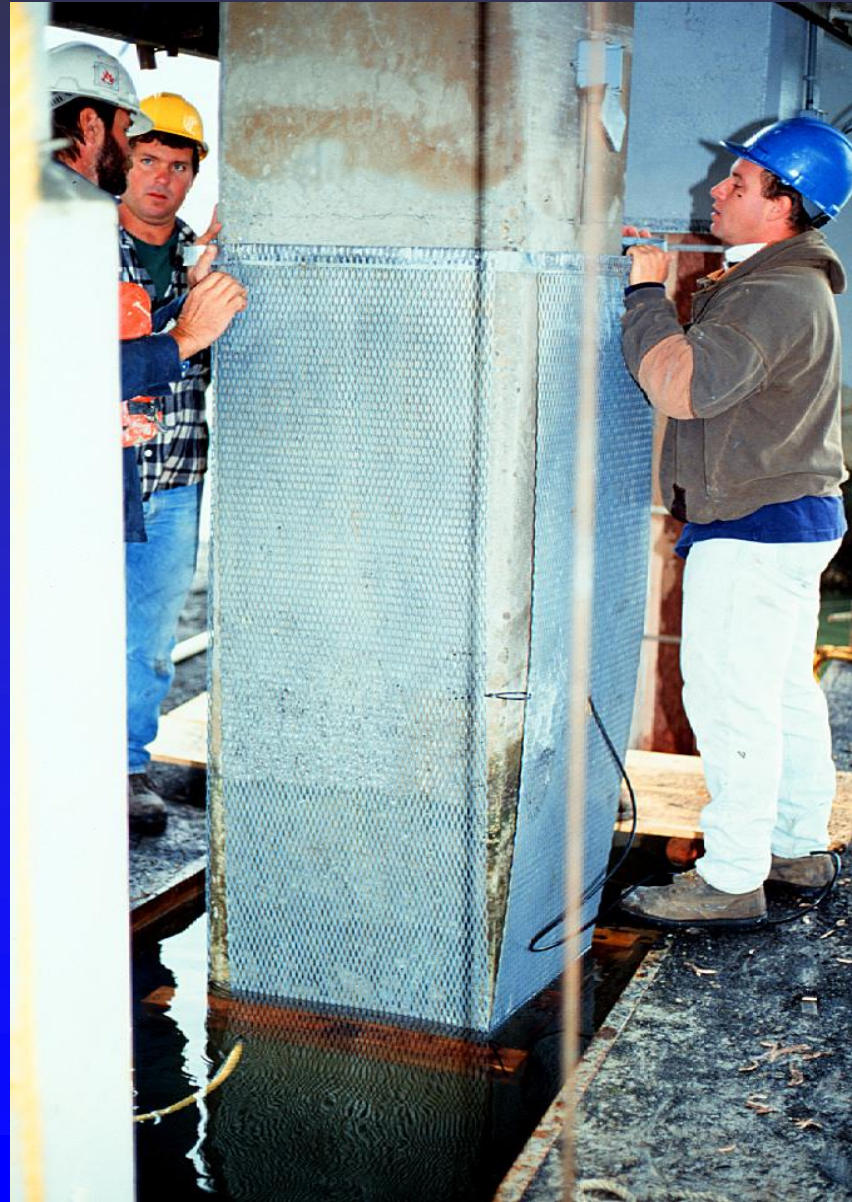
Zn Mesh / Compression Panel Anode

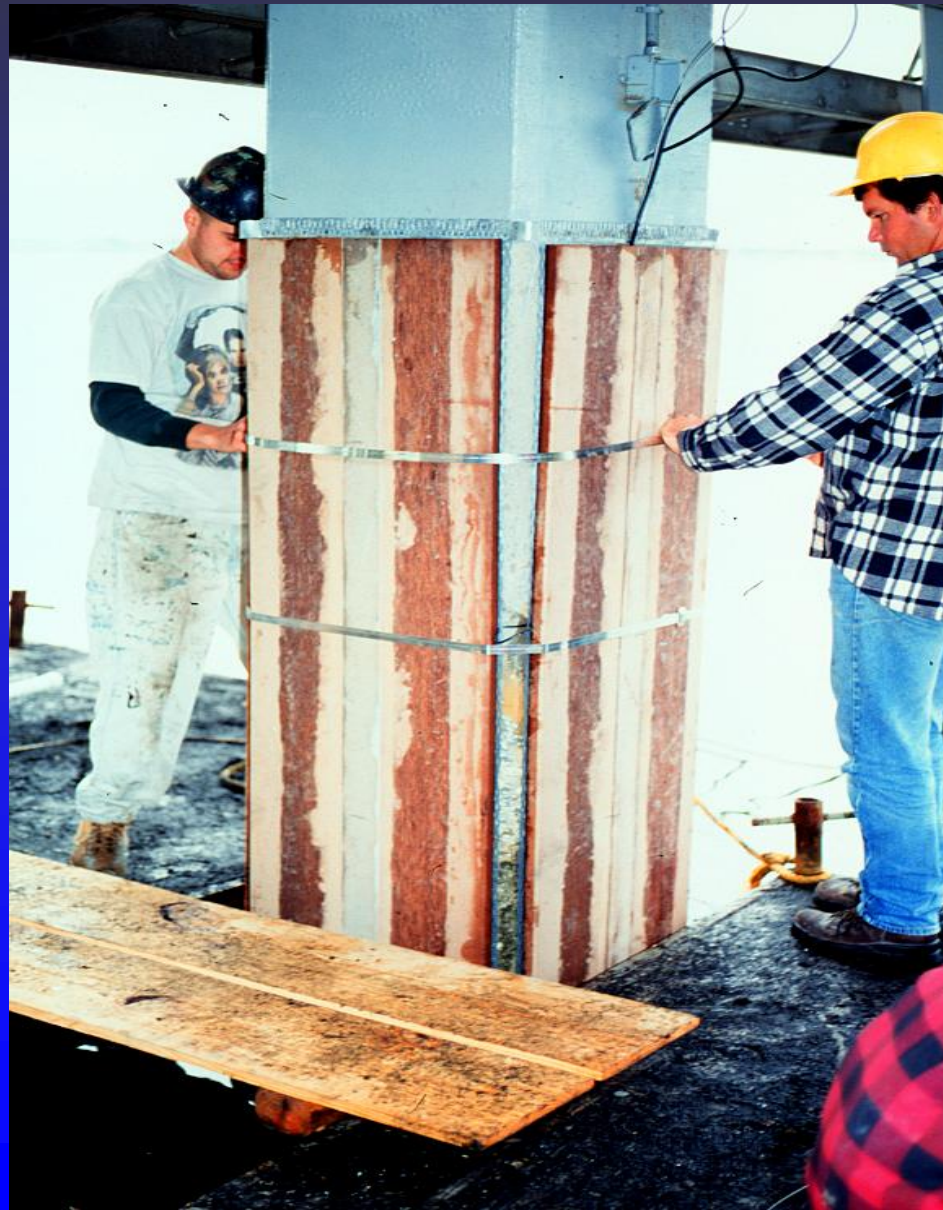
An Almost Completed Zn / Compression Panel Anode
