REHABILITATION AND CONSTRUCTION OPTIONS FOR CONCRETE BRIDGES — ENSURING LONG SERVICE LIFE

Gerardo G. Clemeña, Ph.D., MSc.
Virginia Transportation Research Council*
Charlottesville, Virginia

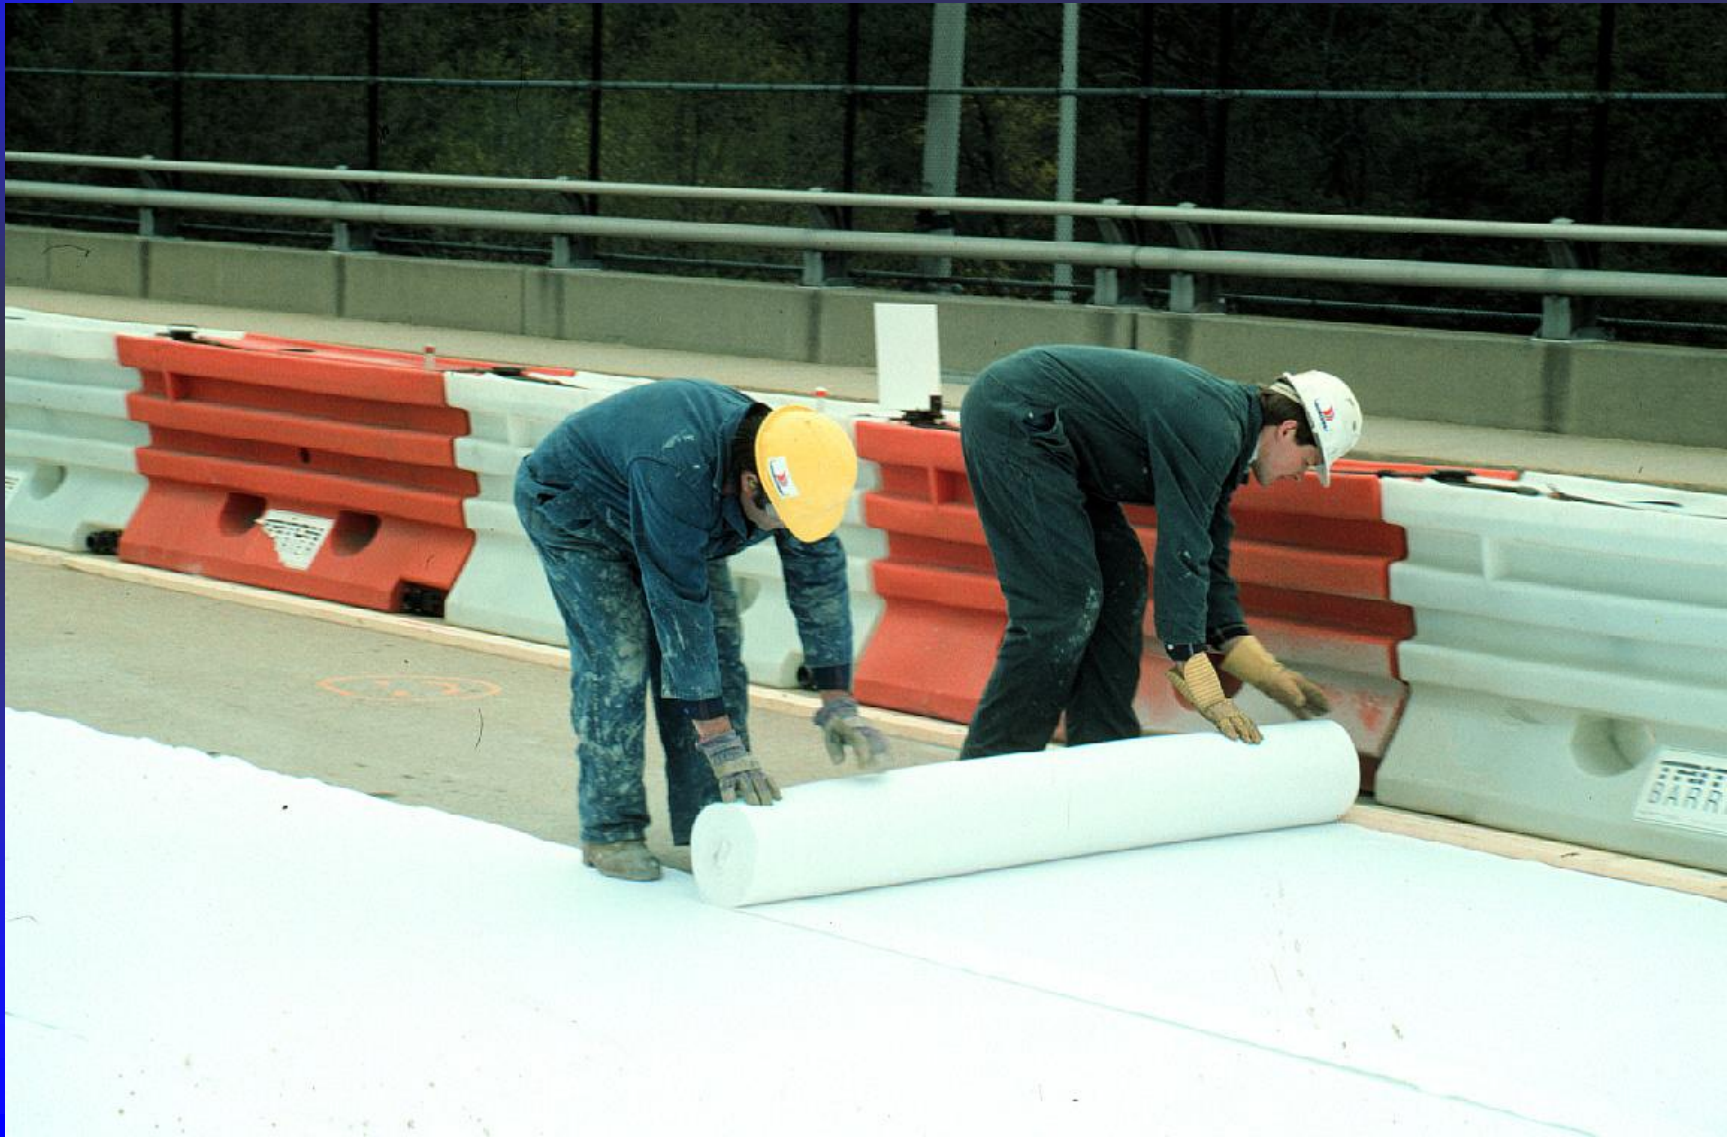
Installation of a ECE System on Decks

Laying of Felts over the Concrete

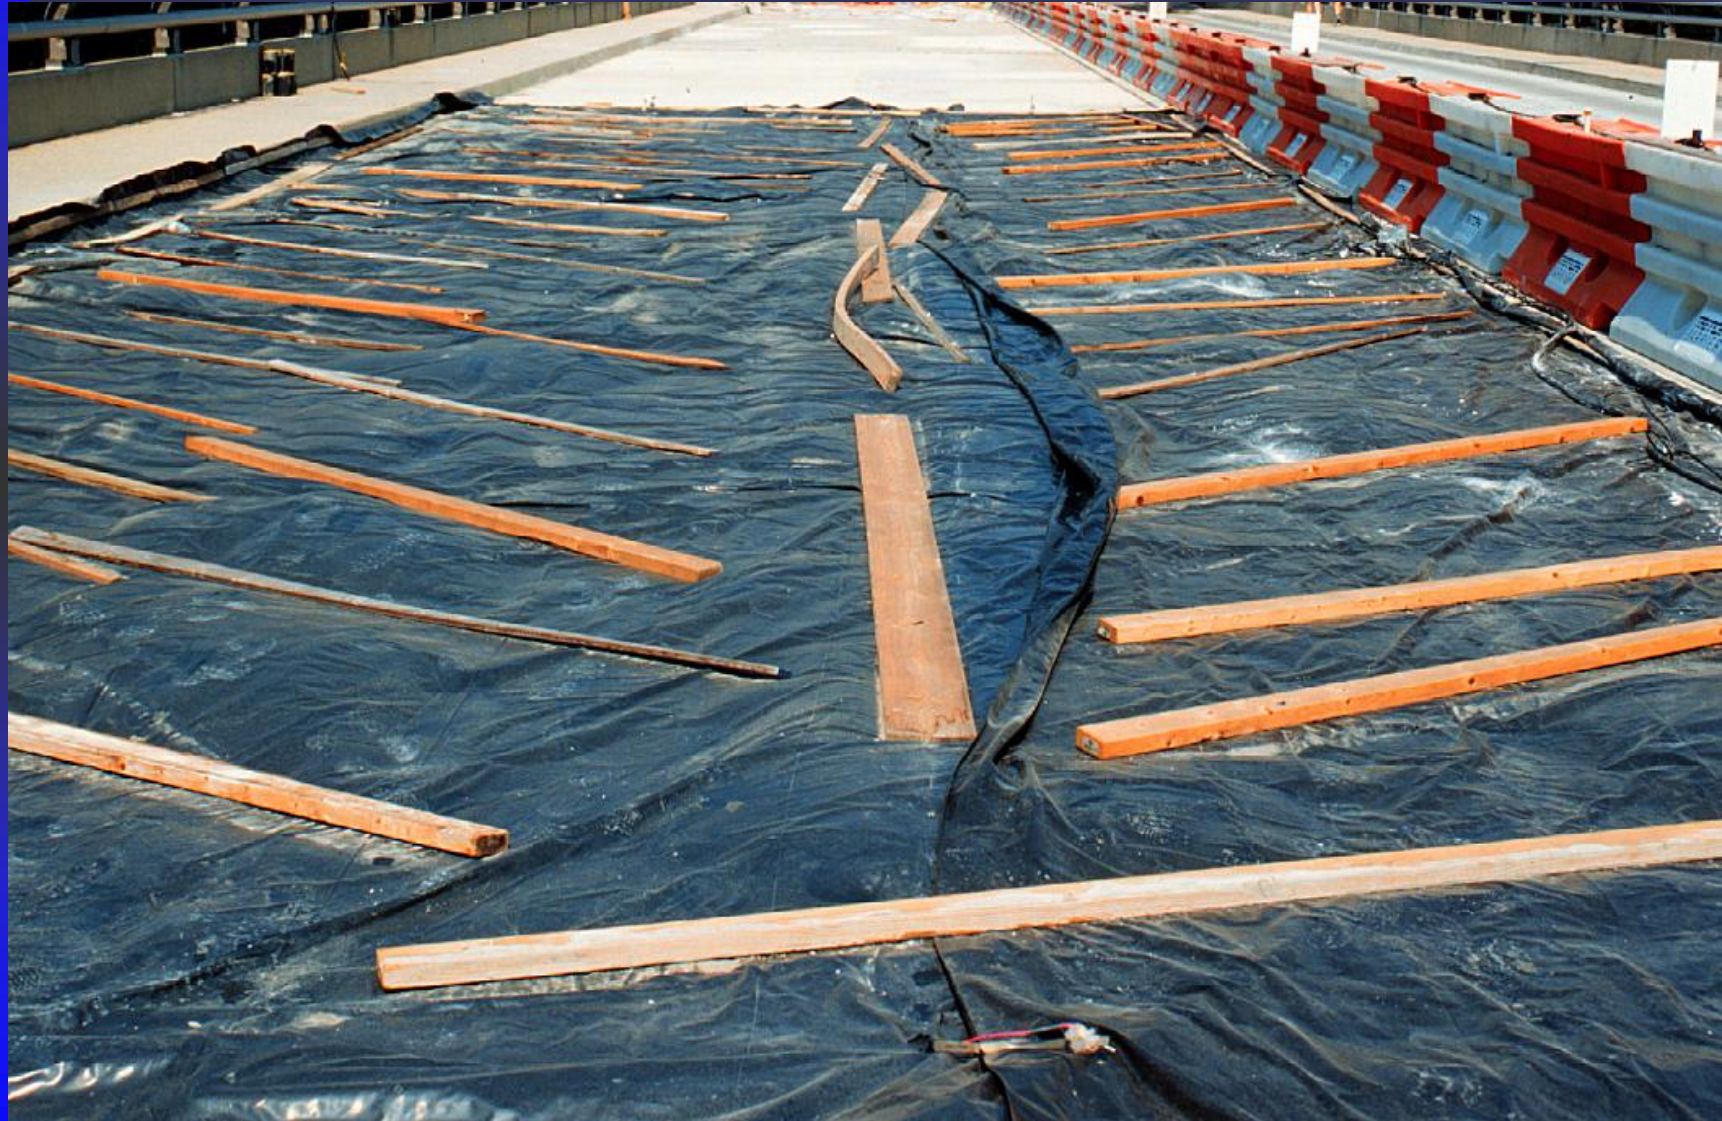
Part of a Completed ECE System for Concrete Decks

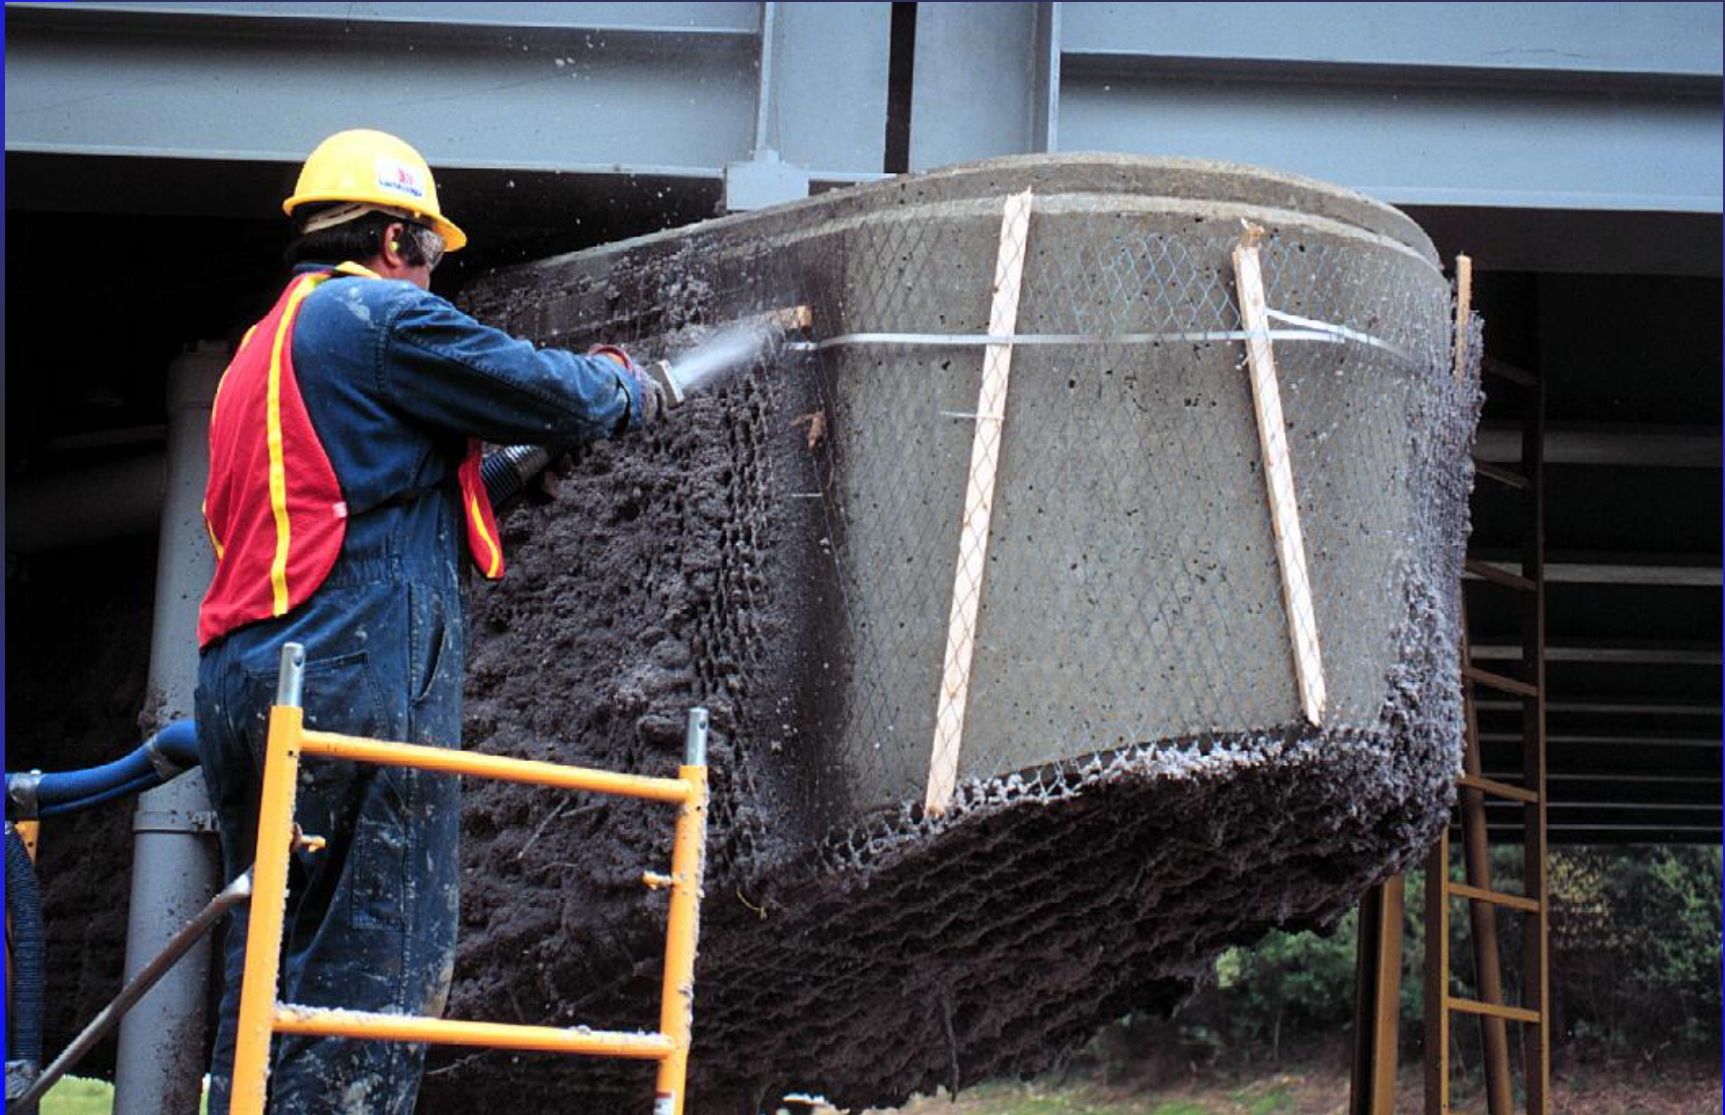
Installation of a ECE System on Piers Spraying of Wet Fibers on Piers

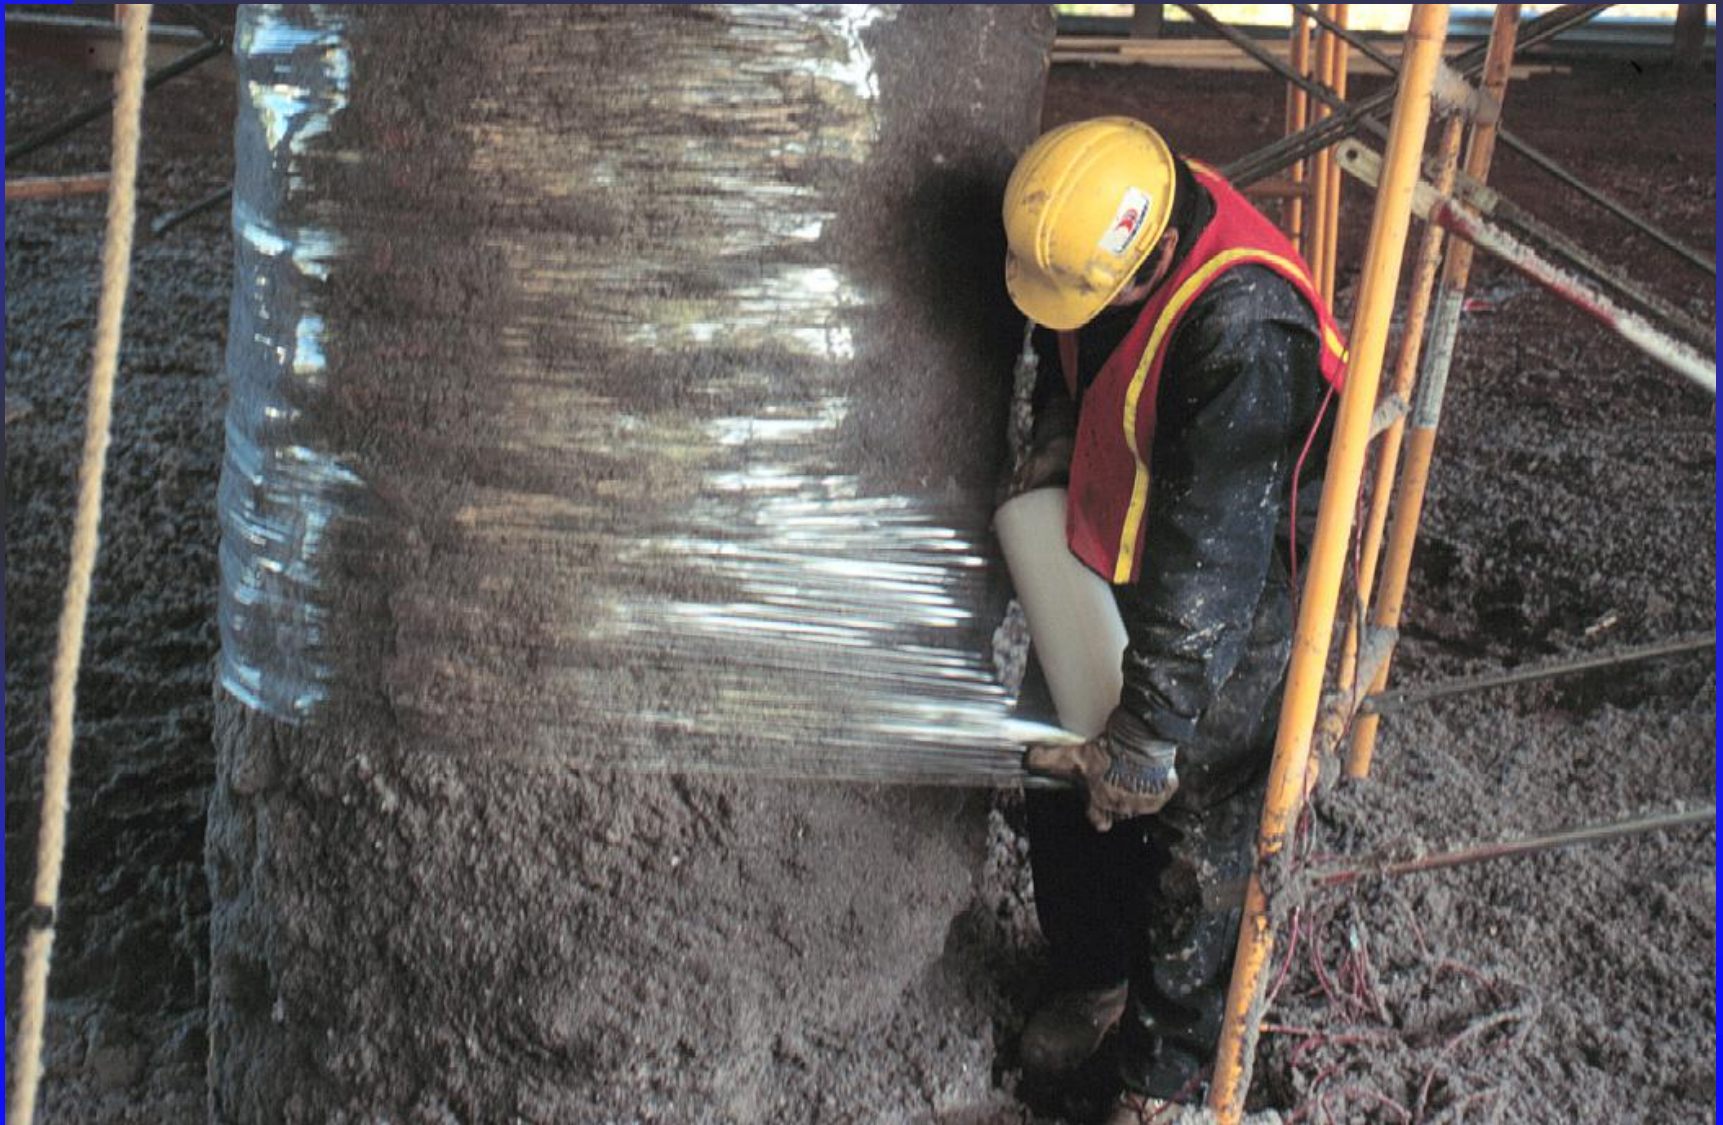
Wrapping of Piers with Plastics

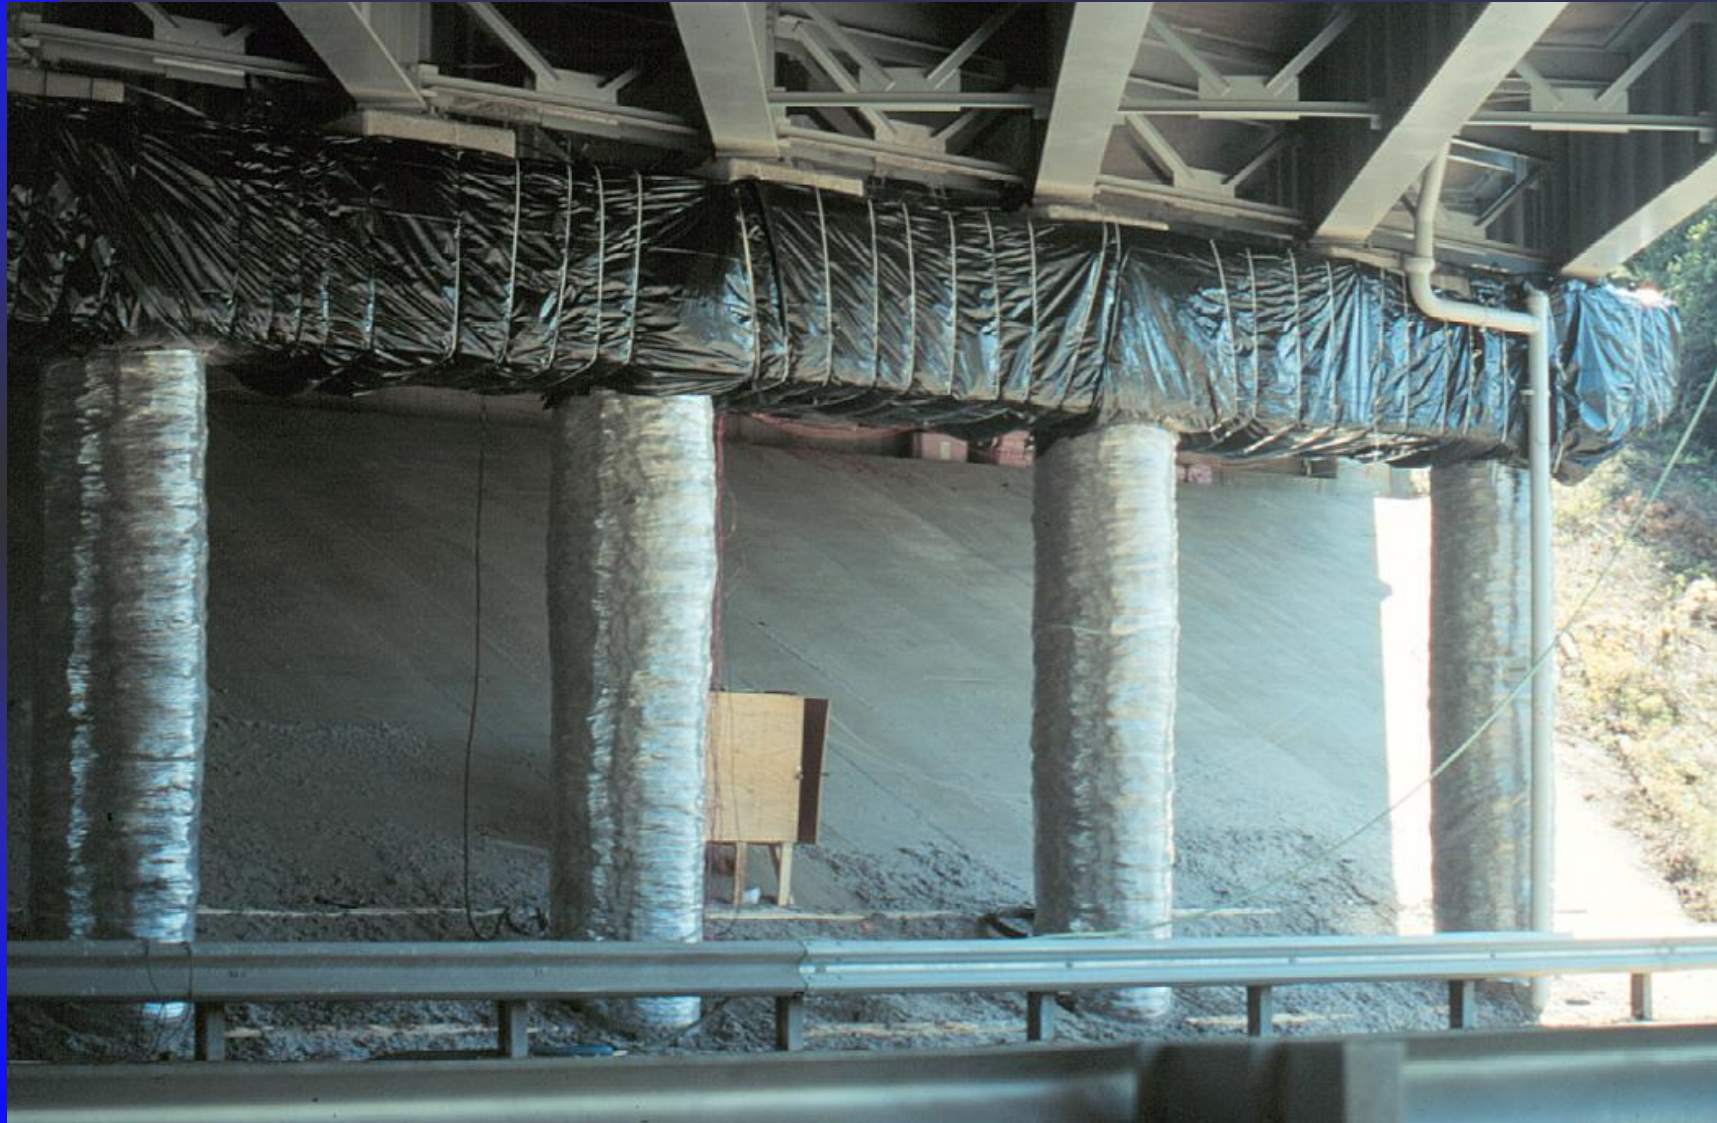
A Completed EC Treatment System

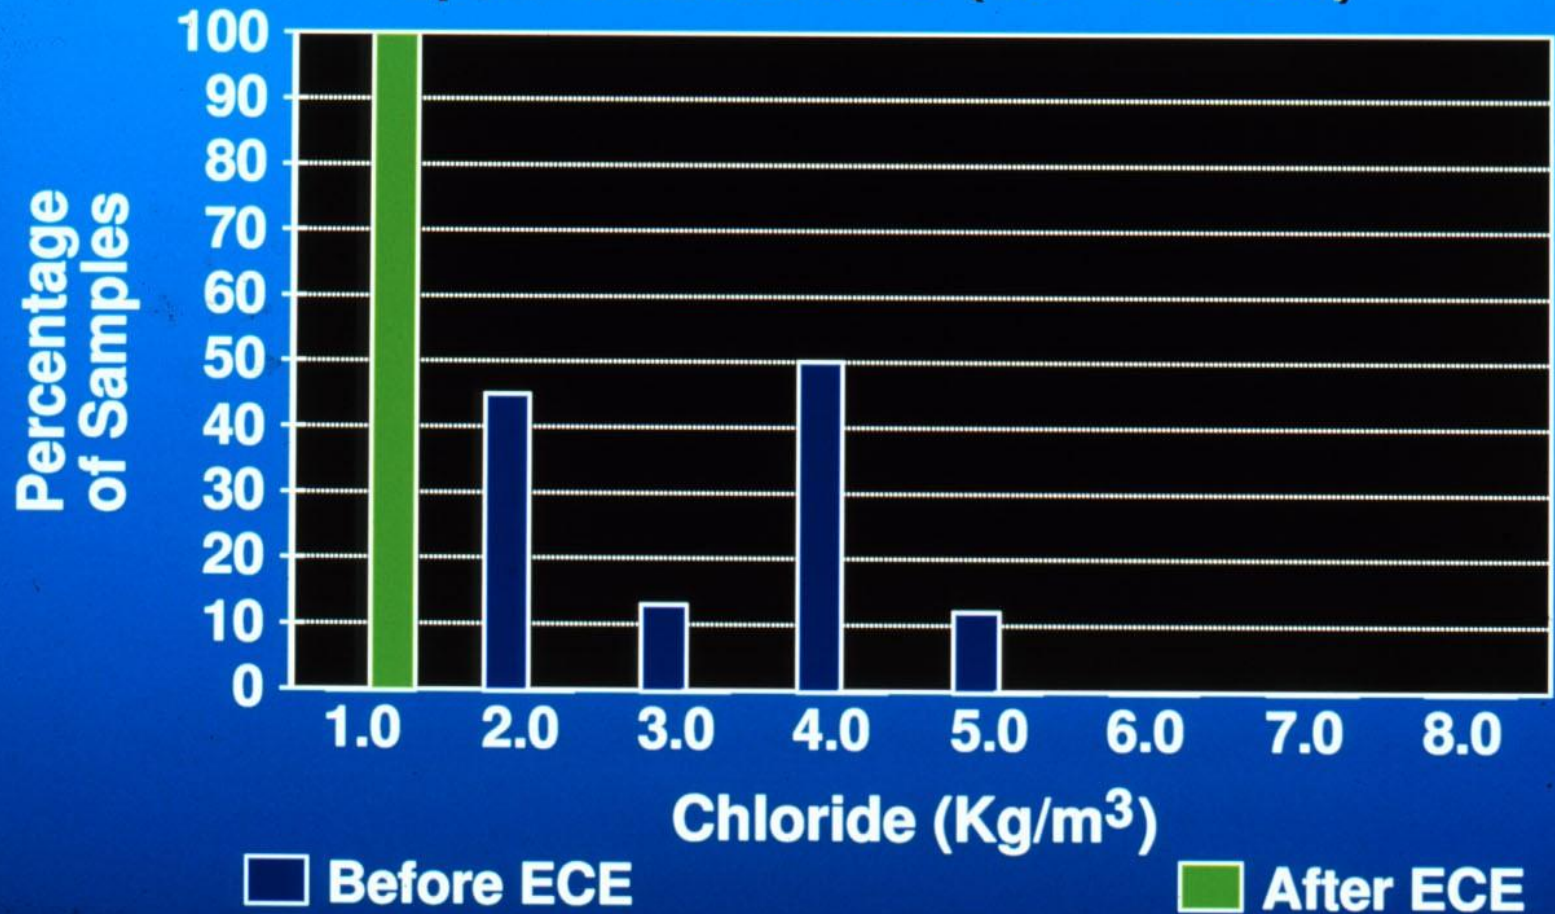
Span 4 South Half (1.9 - 3.2 cm)

DISTRIBUTION OF CHLORIDE CONCENTRATIONS

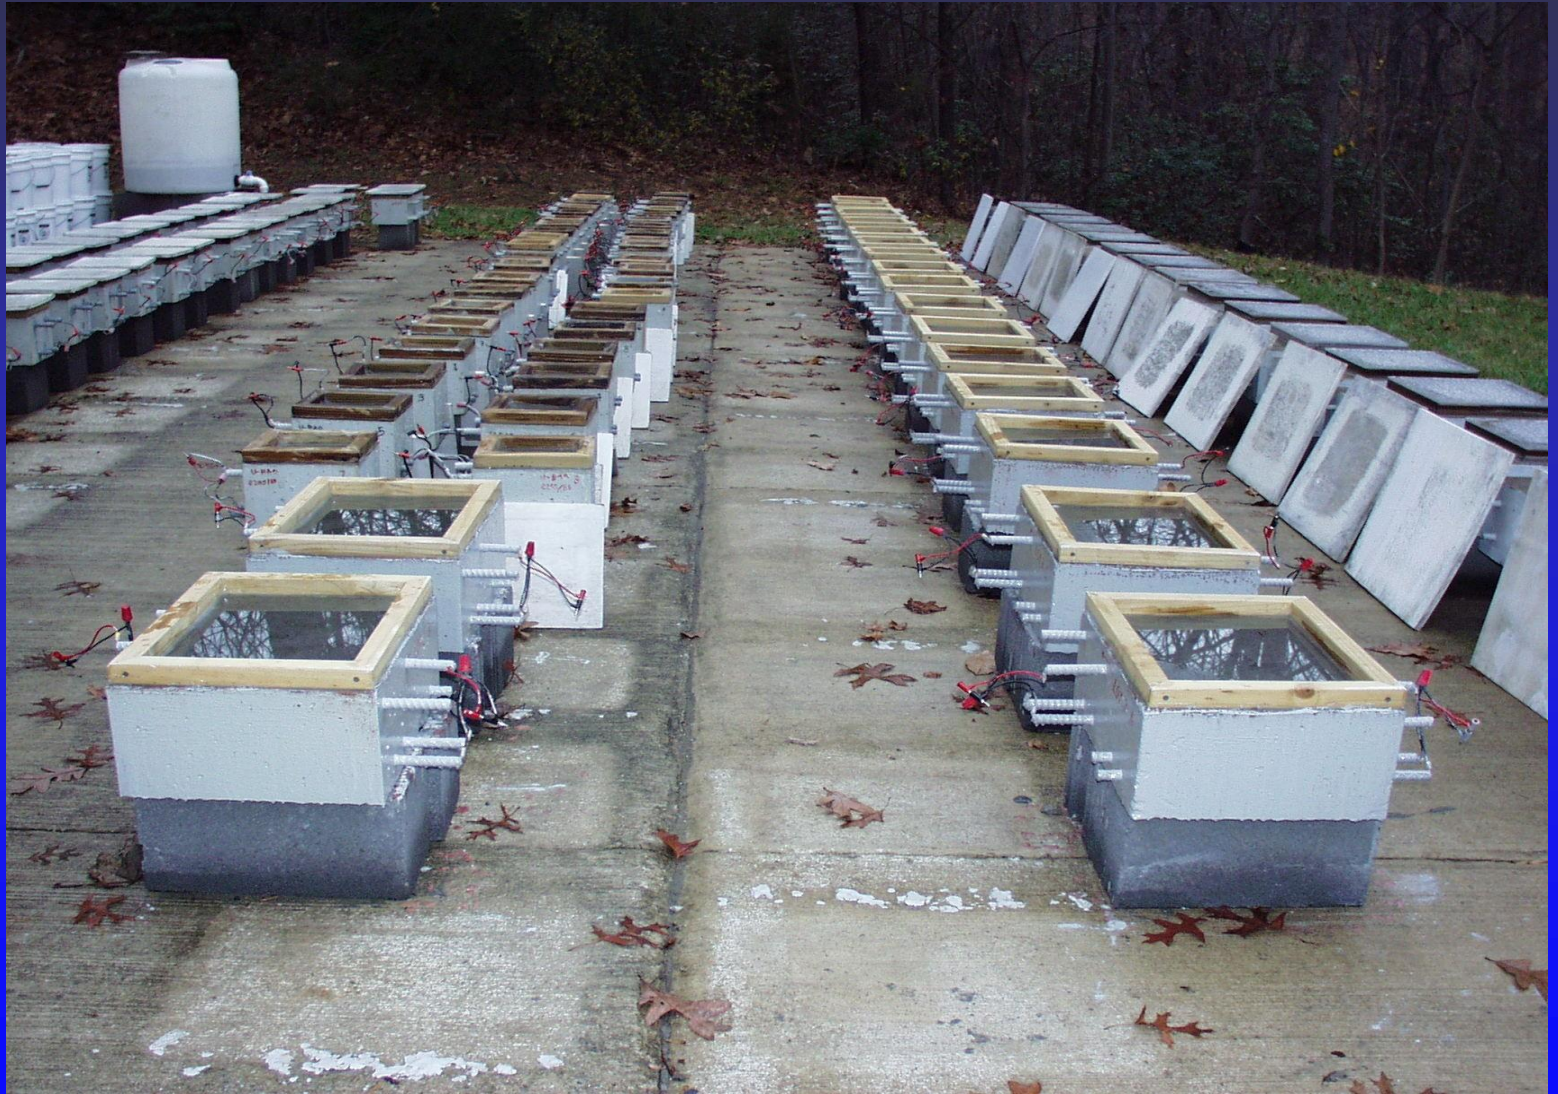
Exposure of the Concrete Blocks

1. Embed the bars in concrete blocks.
2. Weekly exposure the blocks to a NaCl solution.
3. Monitor the corrosion status of each bar to pinpoint its time-to-corrosion (T_c)
4. Estimate the chloride concentration in the concrete at each T_c .

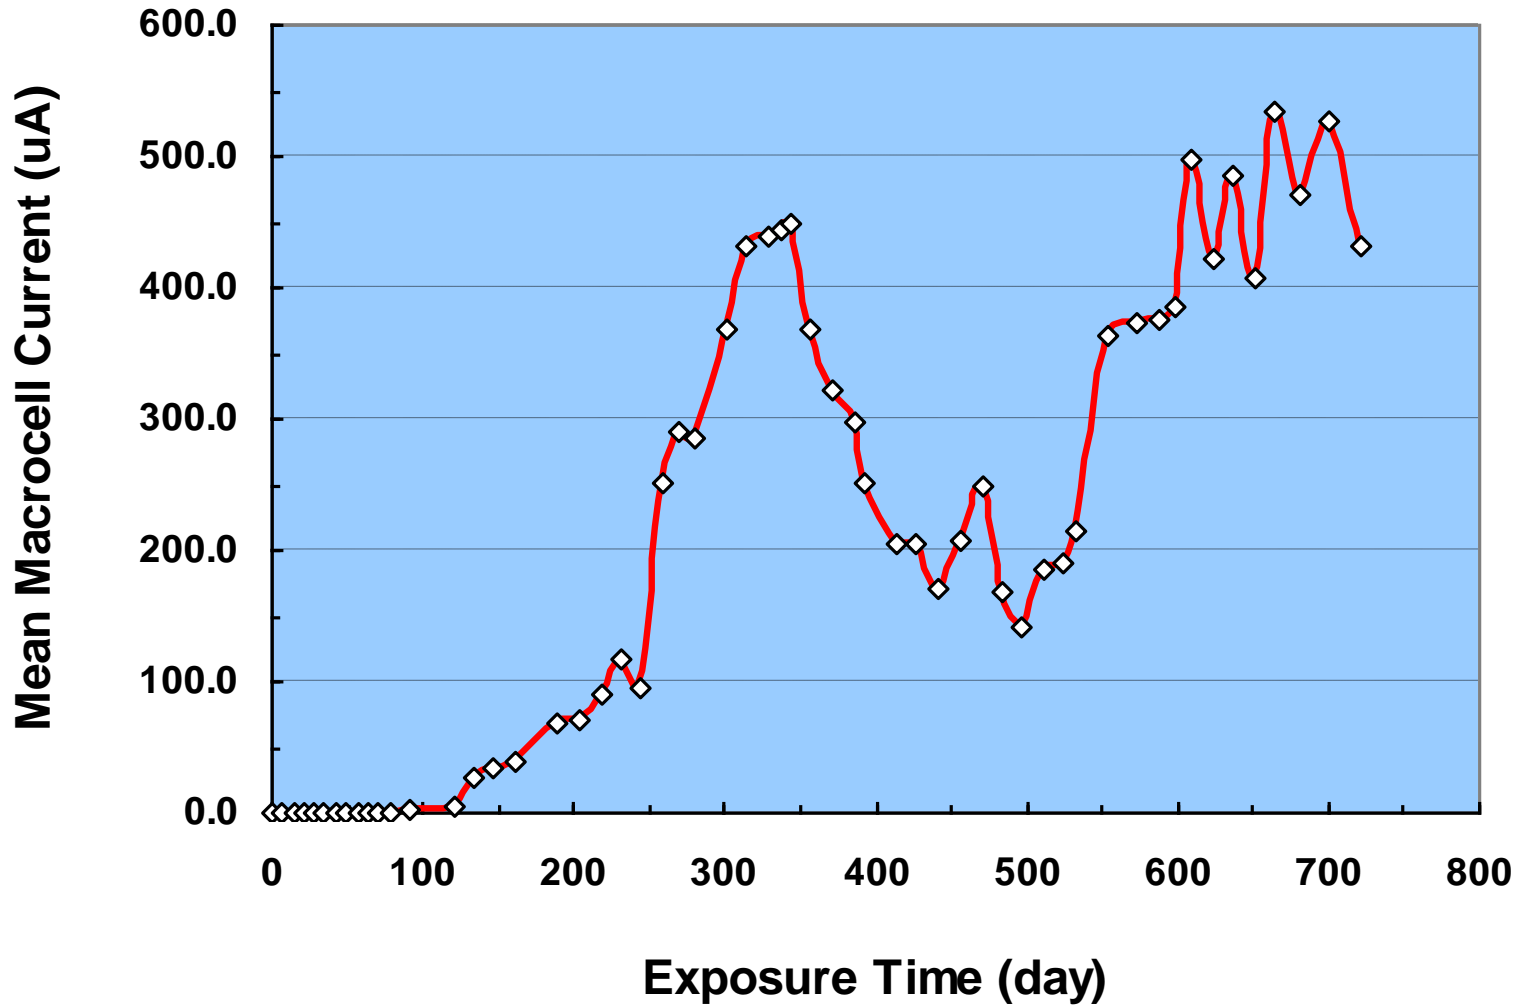
Carbon Steel Bars (ASTM A615)

Time-to-Corrosion = 92 ± 3 days

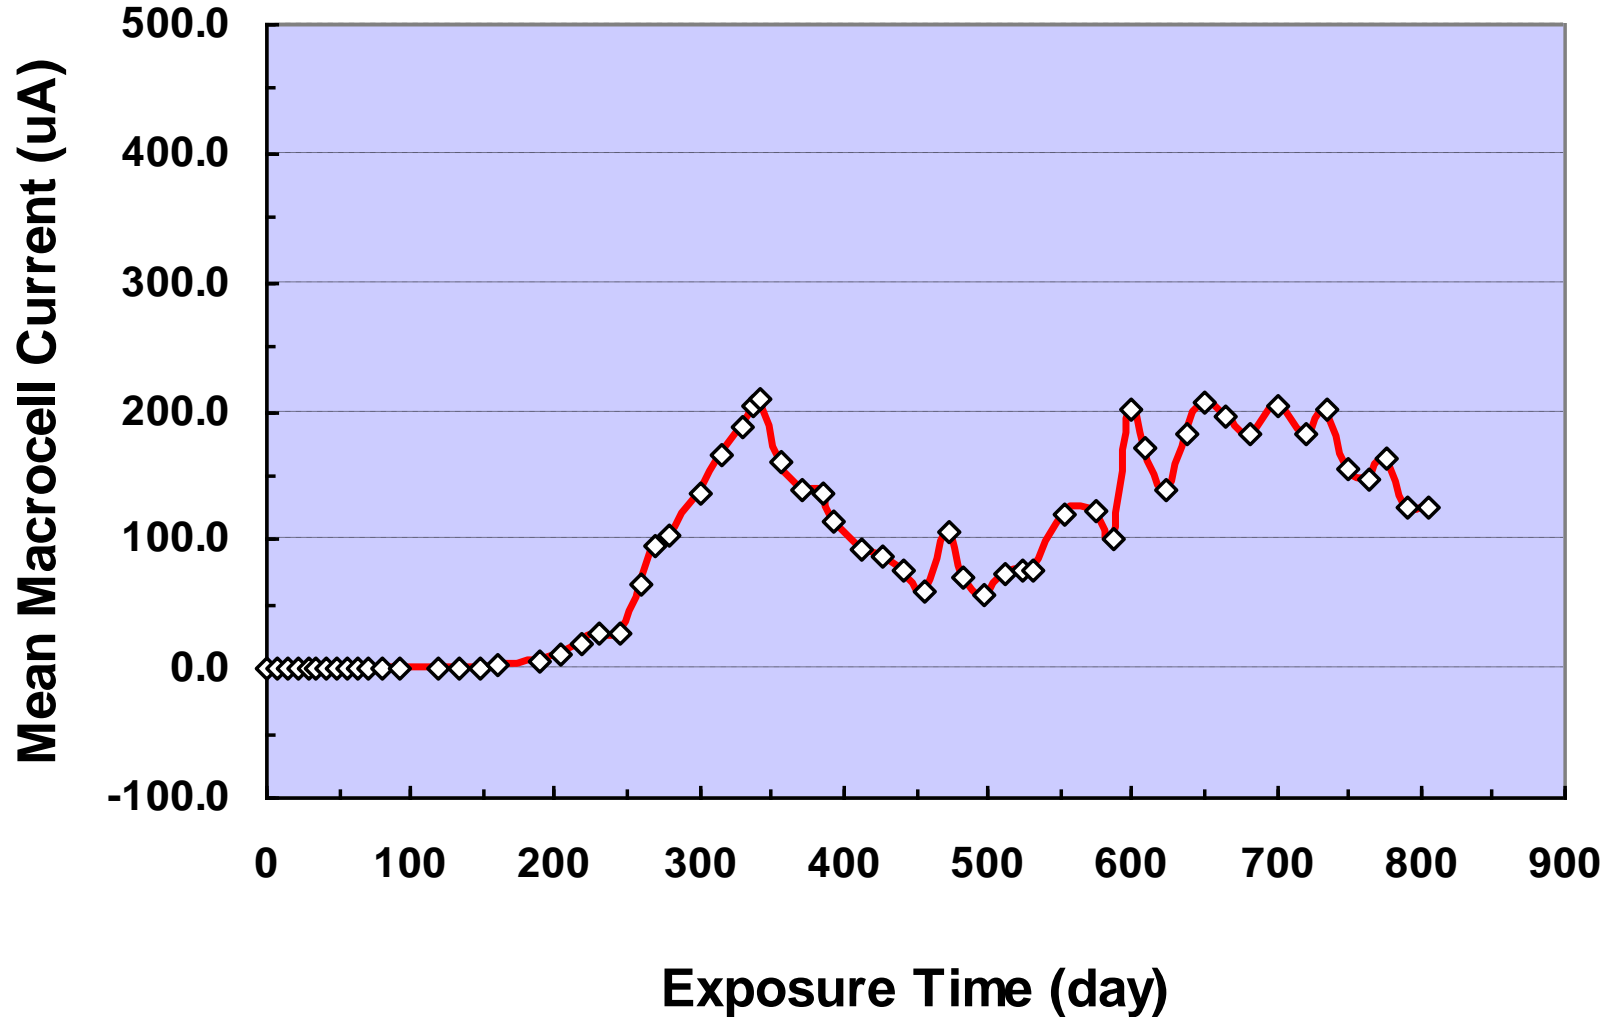
Unpickled 2101 LDX

Time-to-Corrosion = 147 ± 3 days

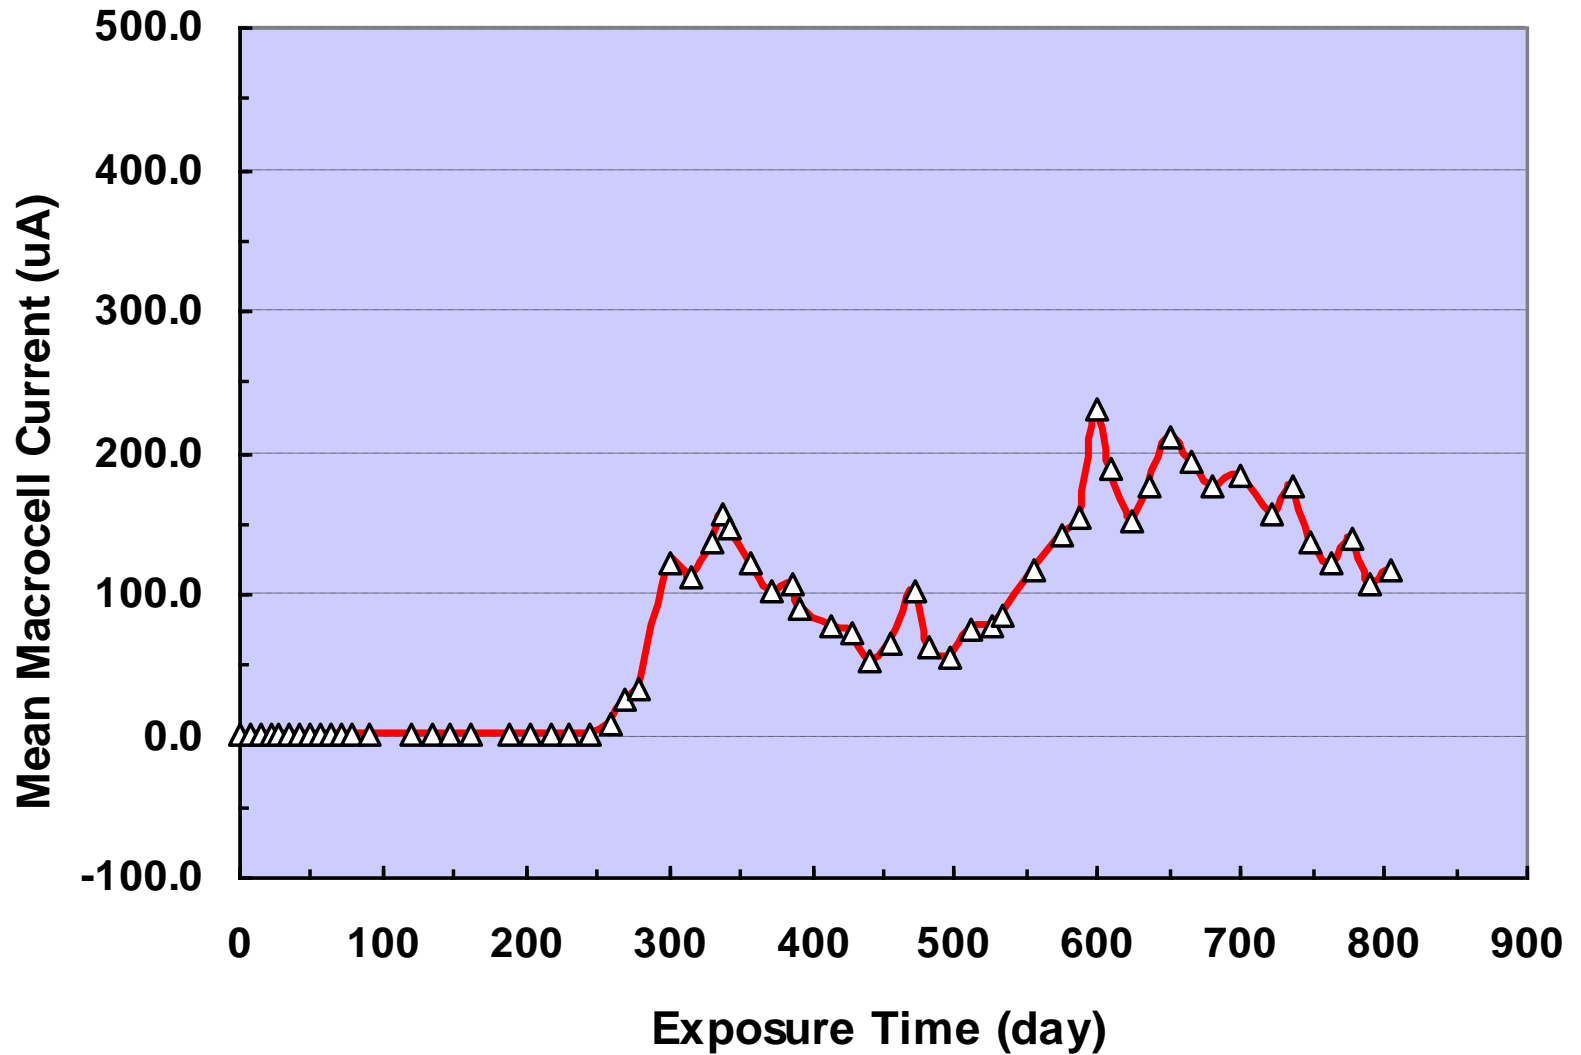
MMFX-2 Microcomposite Steel

Time-to-Corrosion = 245 ± 3 days

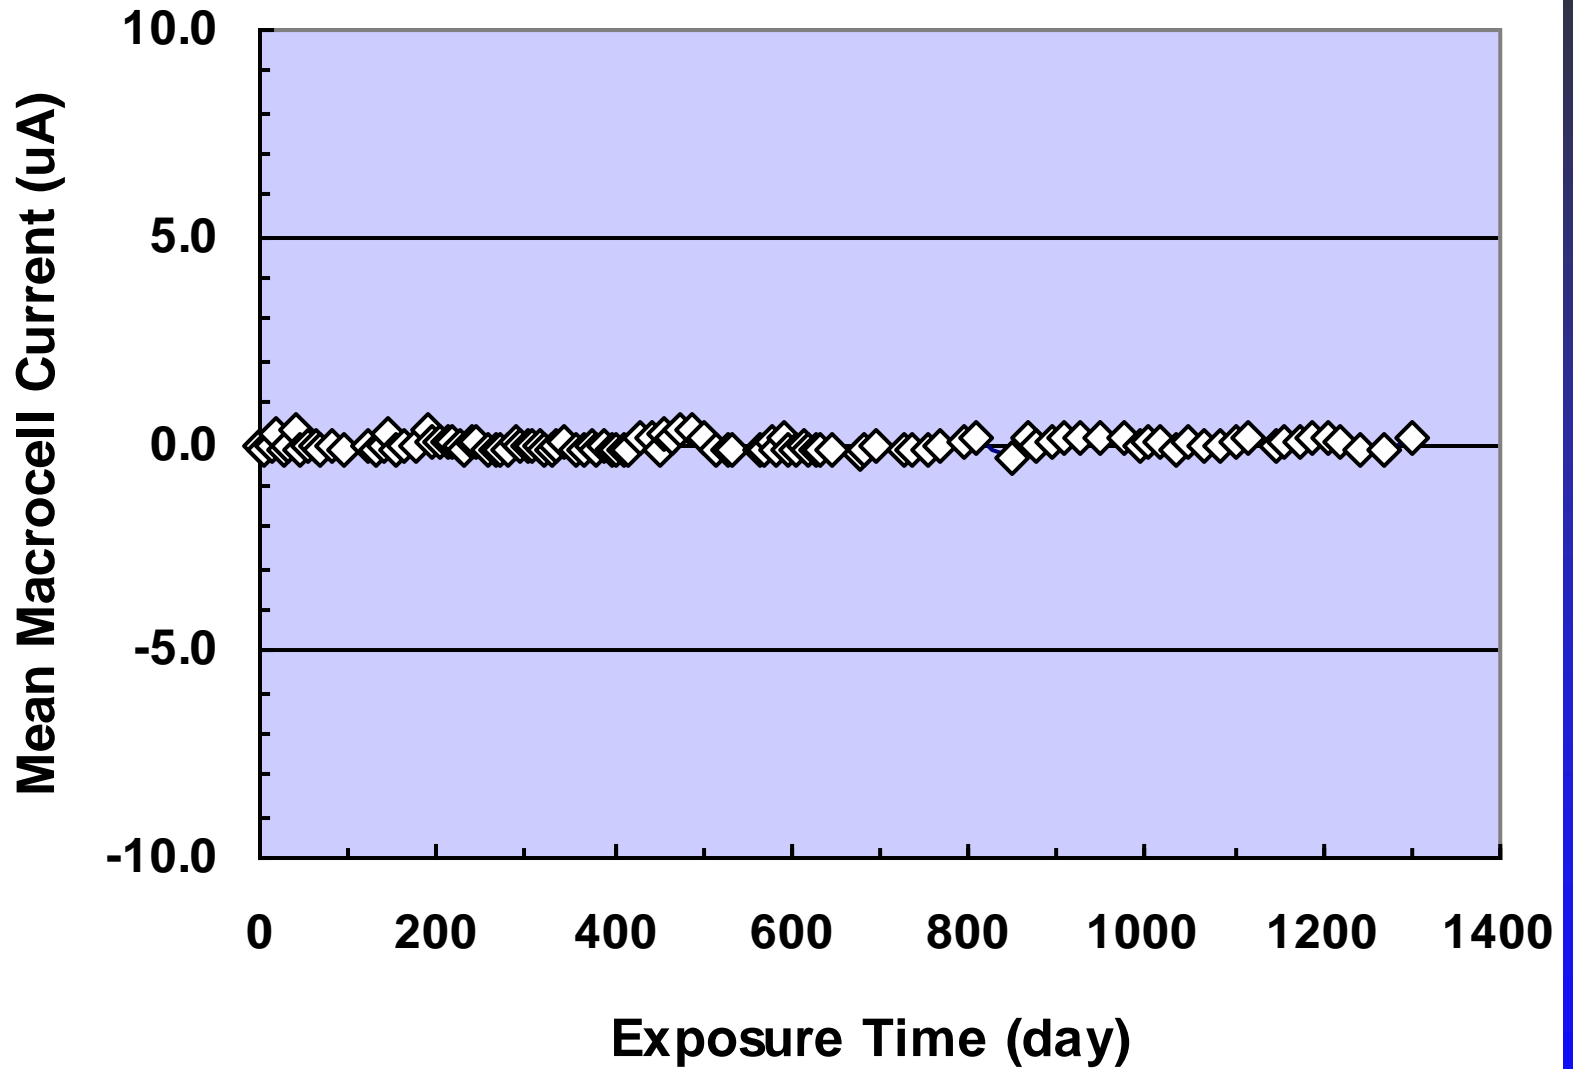
R304 Stainless Steel

Time-to-Corrosion > 1,200 days

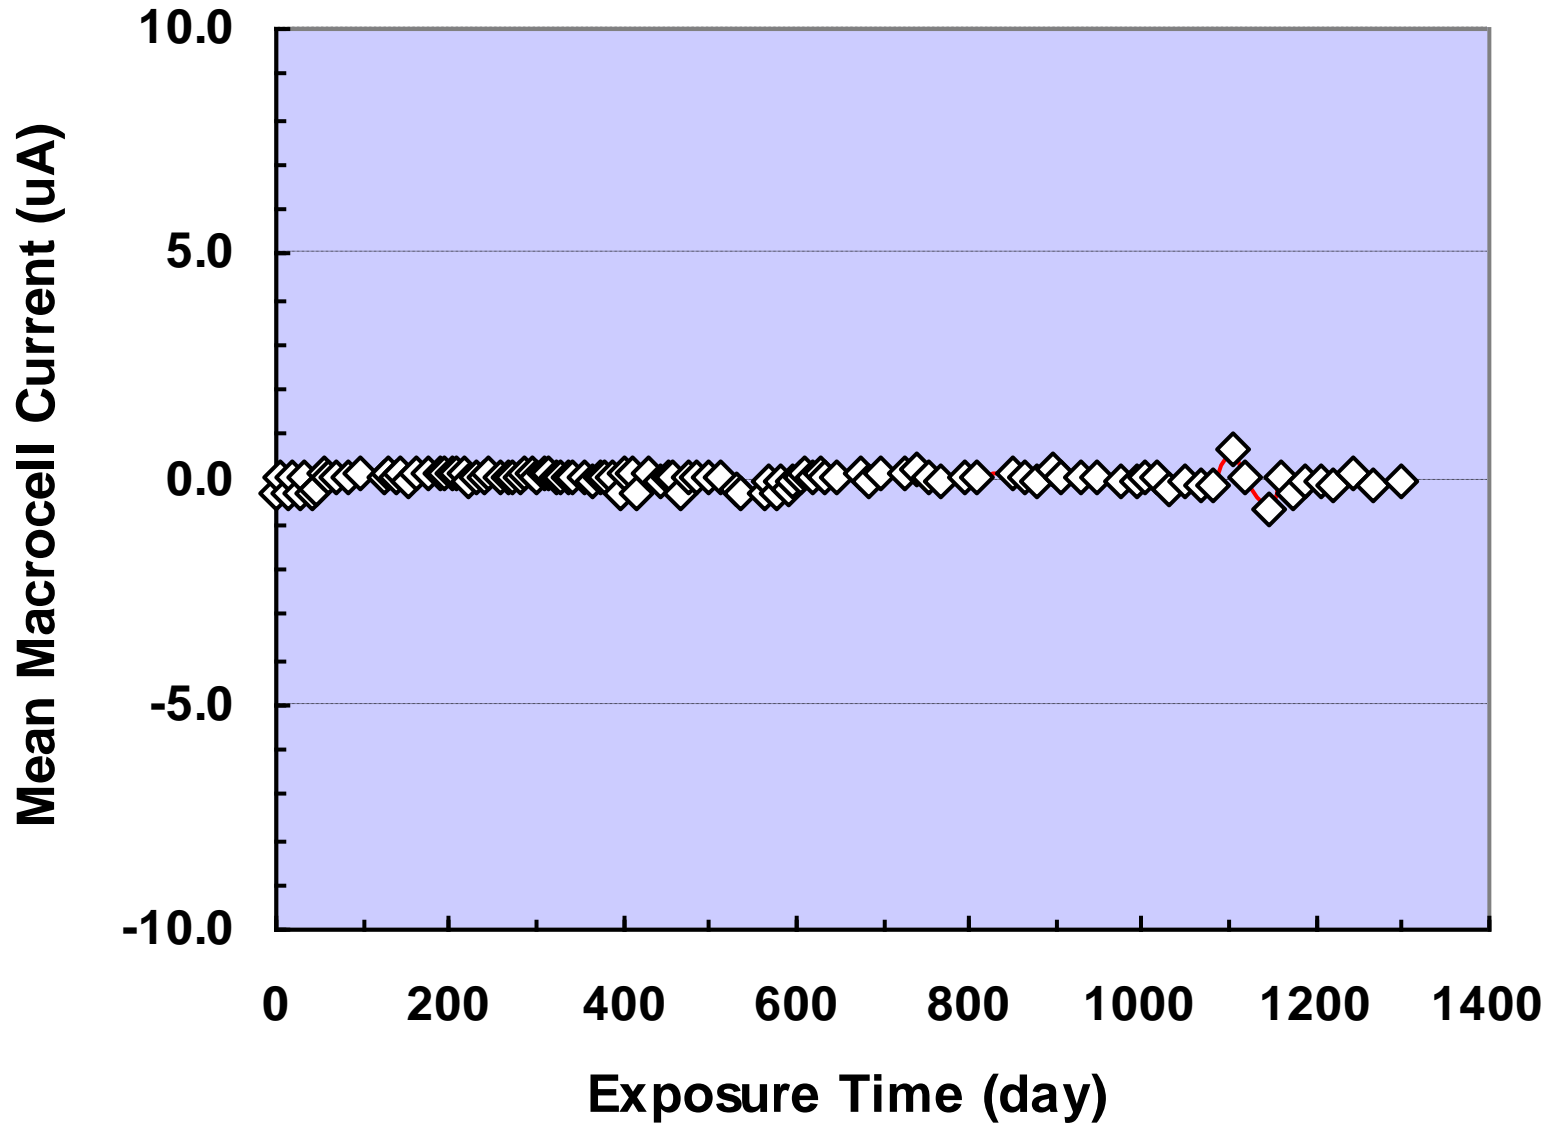
316L-Clad Carbon Steel

Time-to-Corrosion > 1,200 days

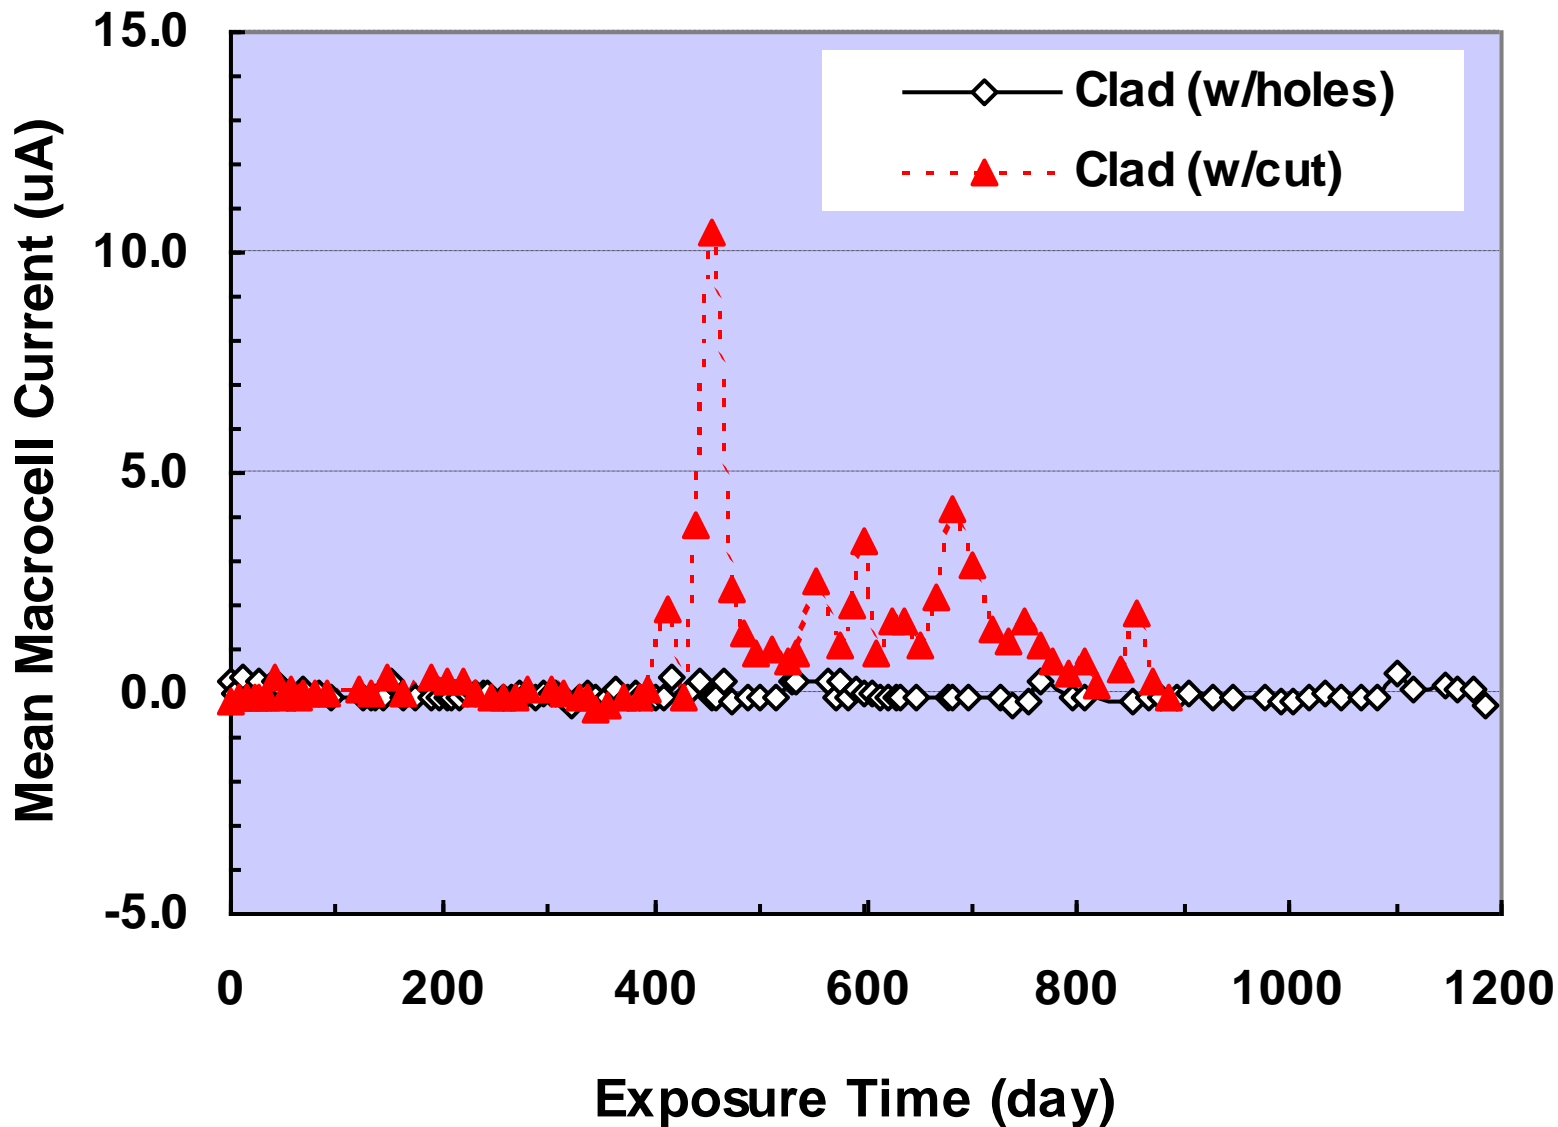
$T_{\text{clad w/ holes}} > 1,200 \text{ days}$

$T_{\text{clad w/ cut}} = 392 \pm 3 \text{ days}$
