REHABILITATION AND CONSTRUCTION OPTIONS FOR CONCRETE BRIDGES — ENSURING LONG SERVICE LIFE

Gerardo G. Clemeña, Ph.D., MSc.
Virginia Transportation Research Council*
Charlottesville, Virginia

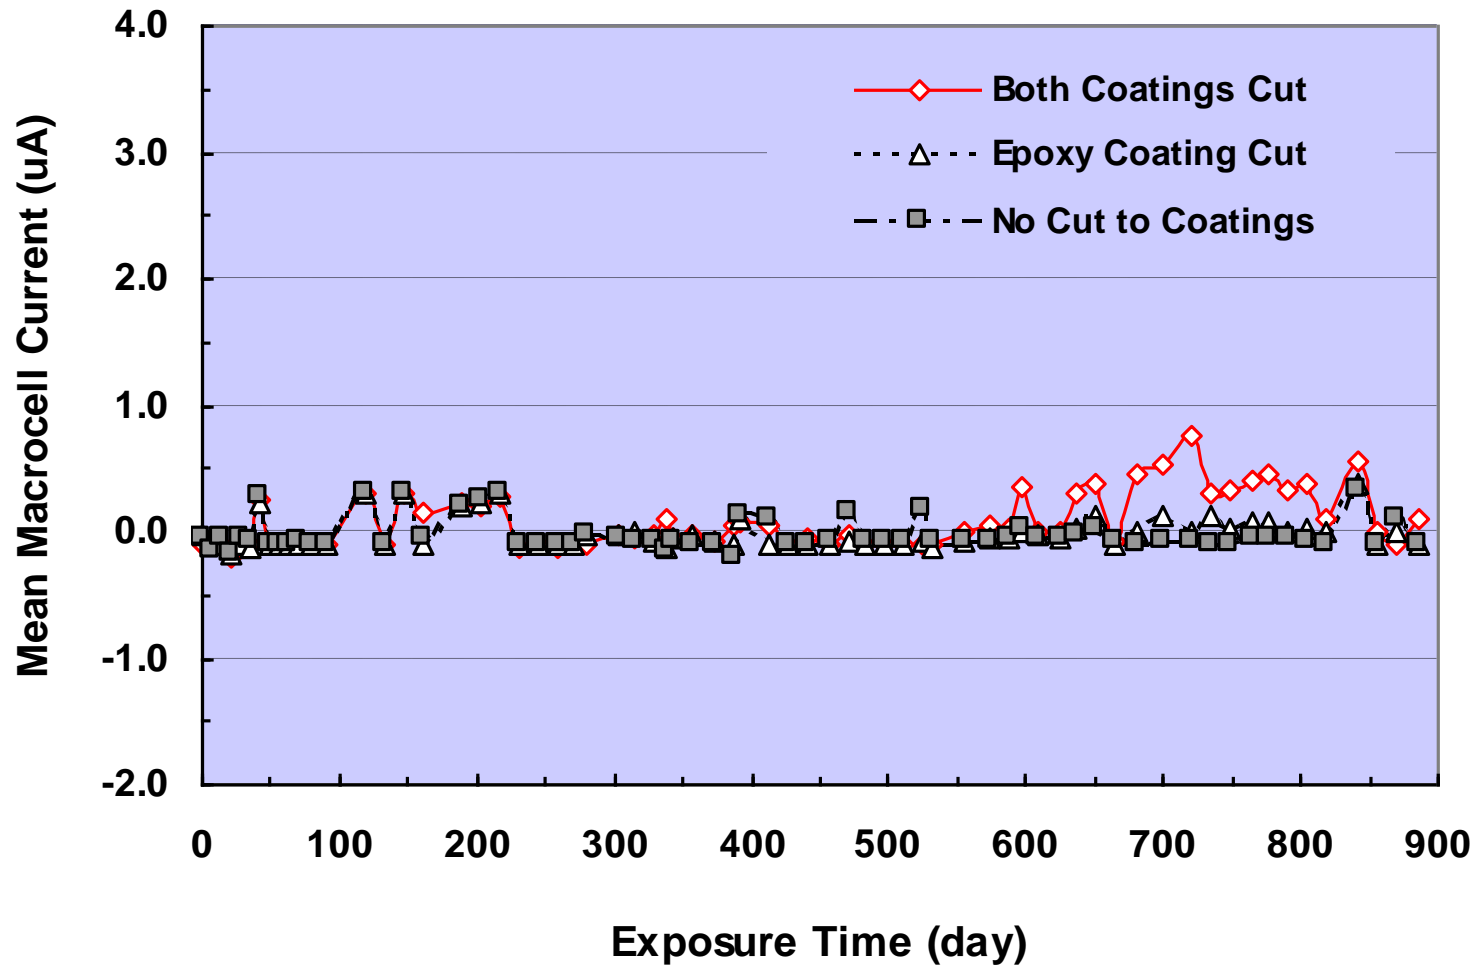
Zinc-Epoxy Coated Bars

$T_{\text{both coatings cut}} = 532 \pm 3 \text{ days}$

$T_{\text{epoxy cut}} = 637$

$T_{\text{no cut}} > 820$

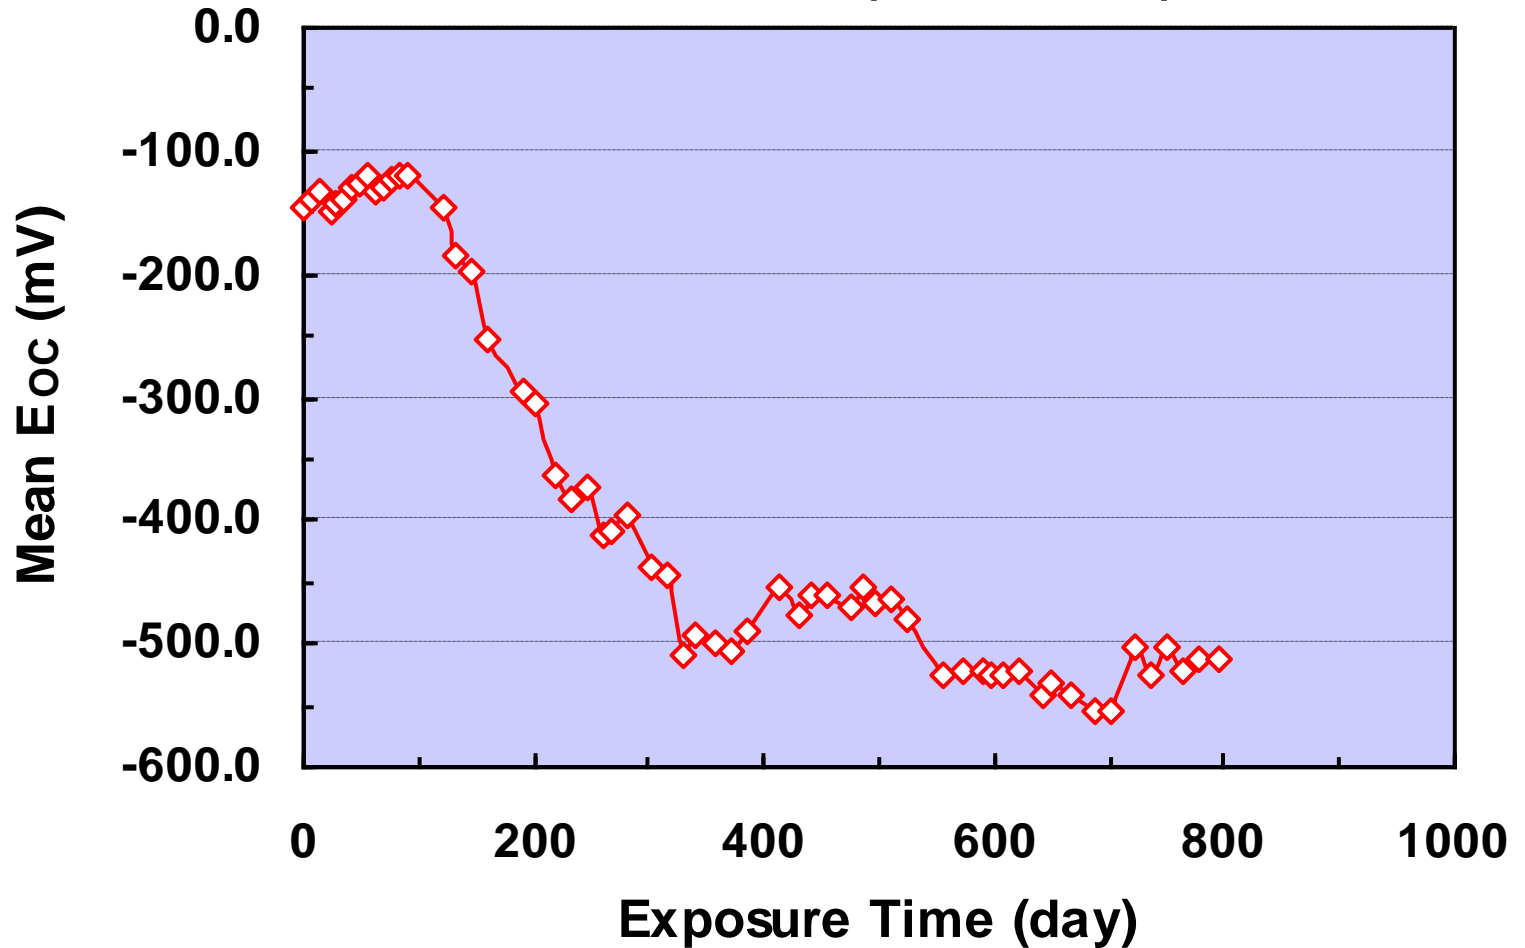
Carbon Steel Bars (ASTM A615)

Time-to-Corrosion = 92 ± 3 days

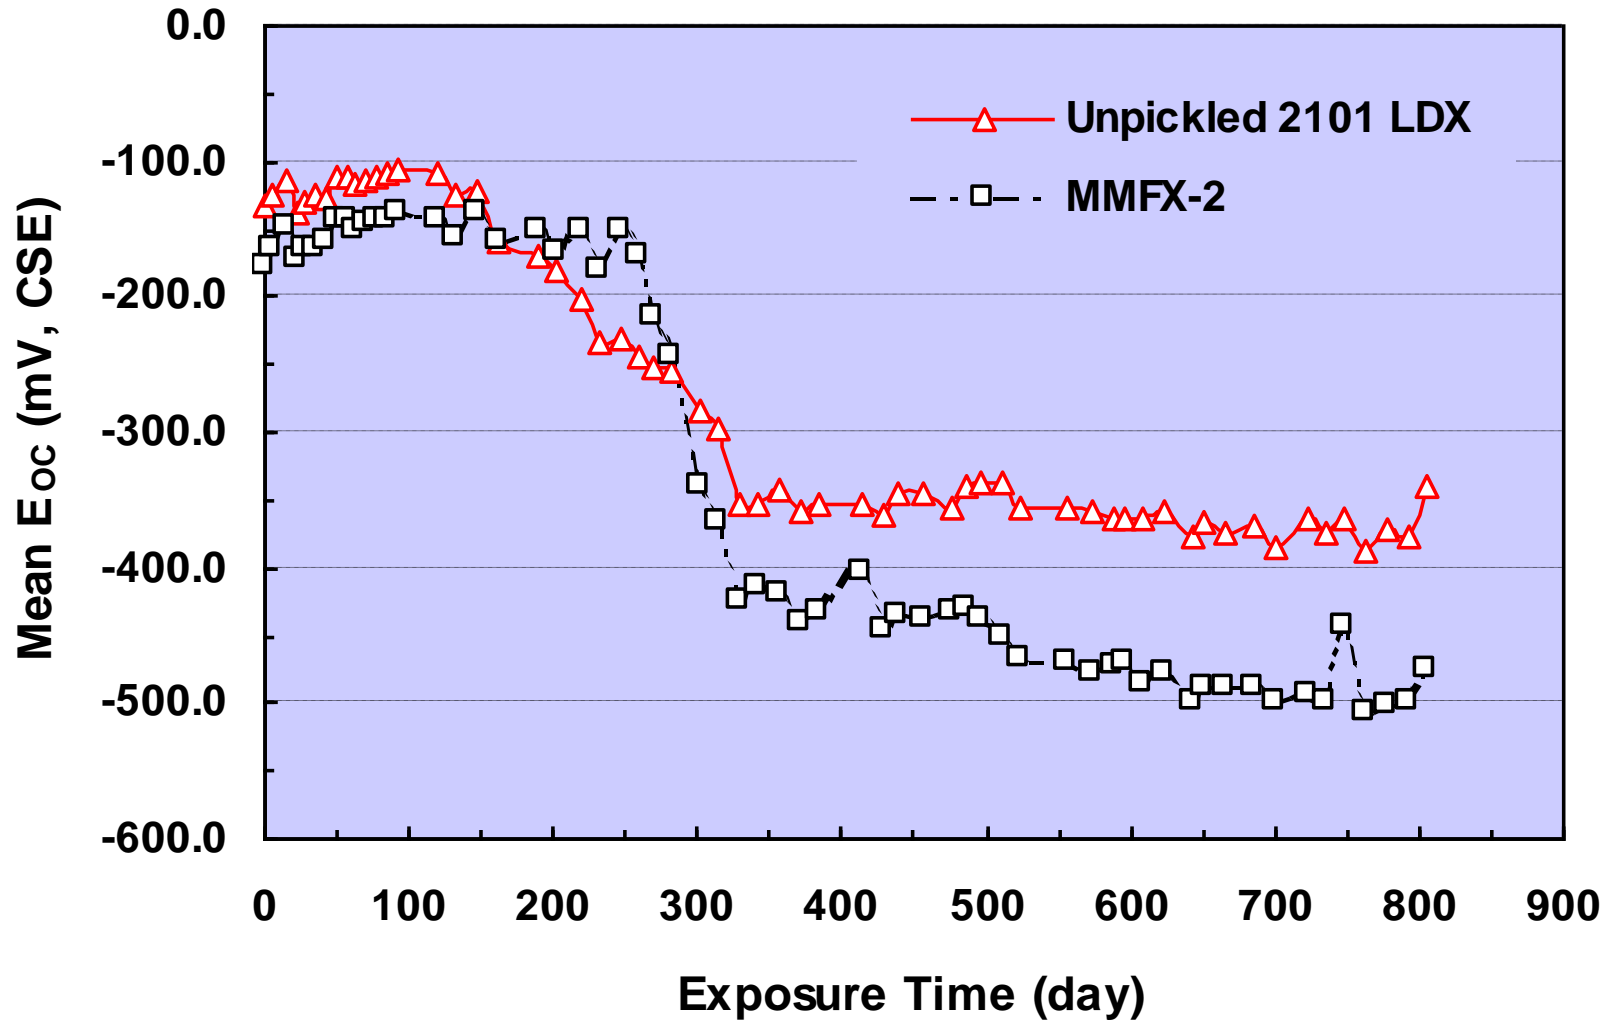
$T_{2101 \text{ LDX}} = 147 \pm 3 \text{ days}$
 $T_{\text{MMFX-2}} = 245$

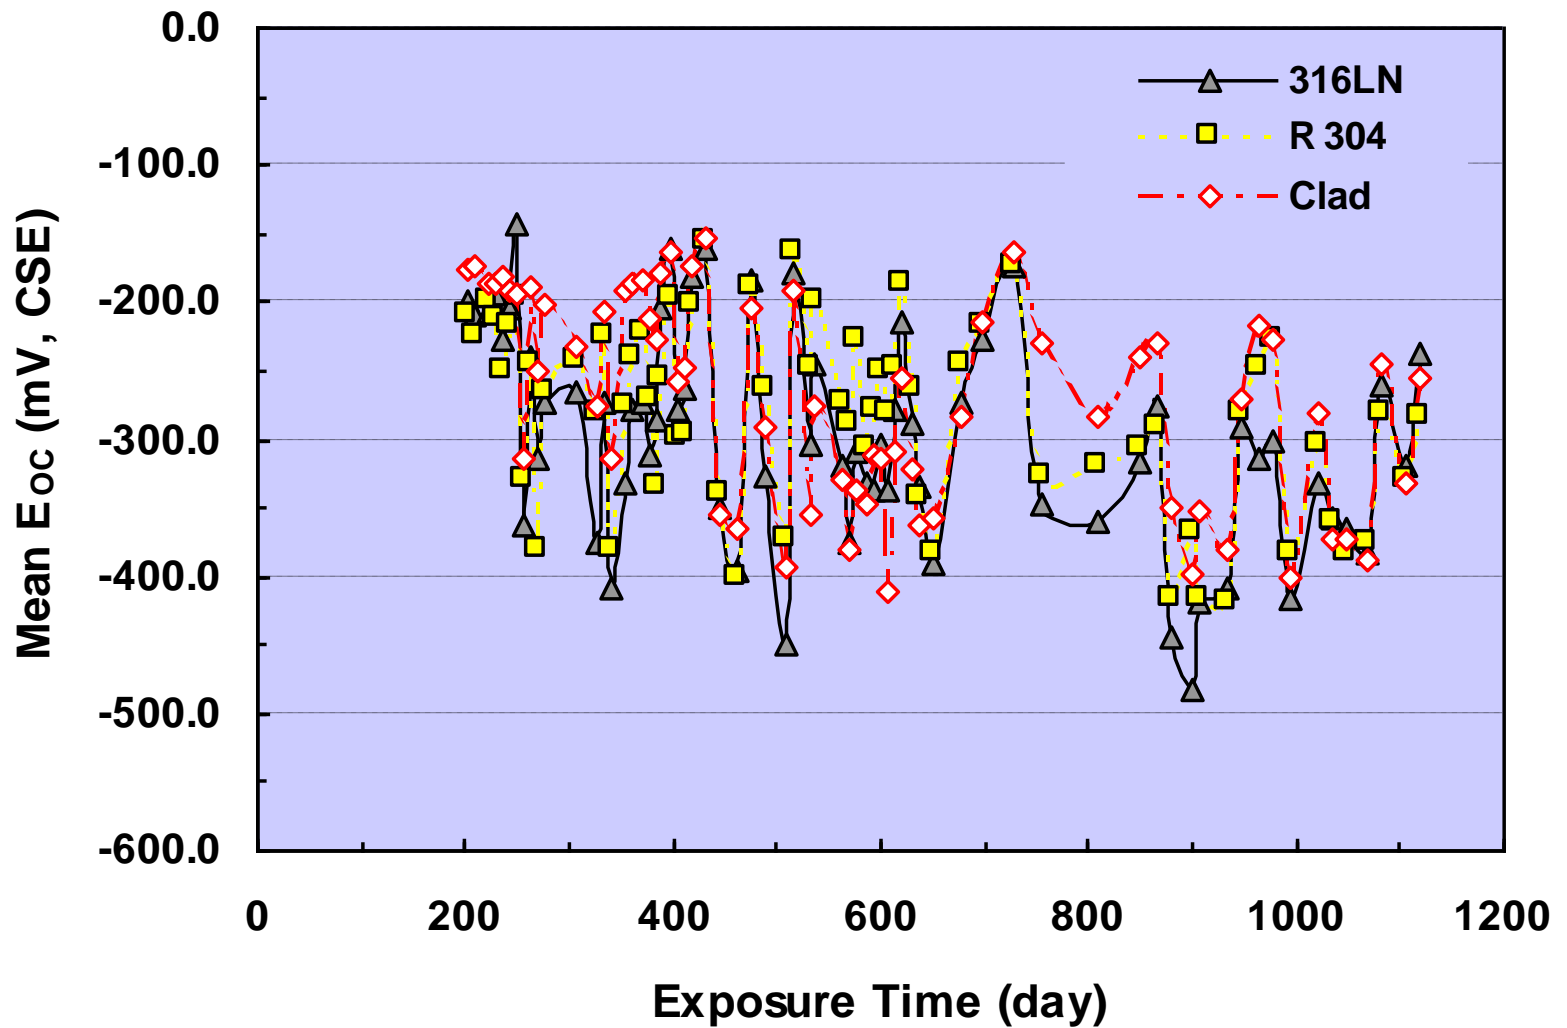
$T_{R\ 304} \approx T_{Clad} \approx T_{316LN} > 1,200$ days

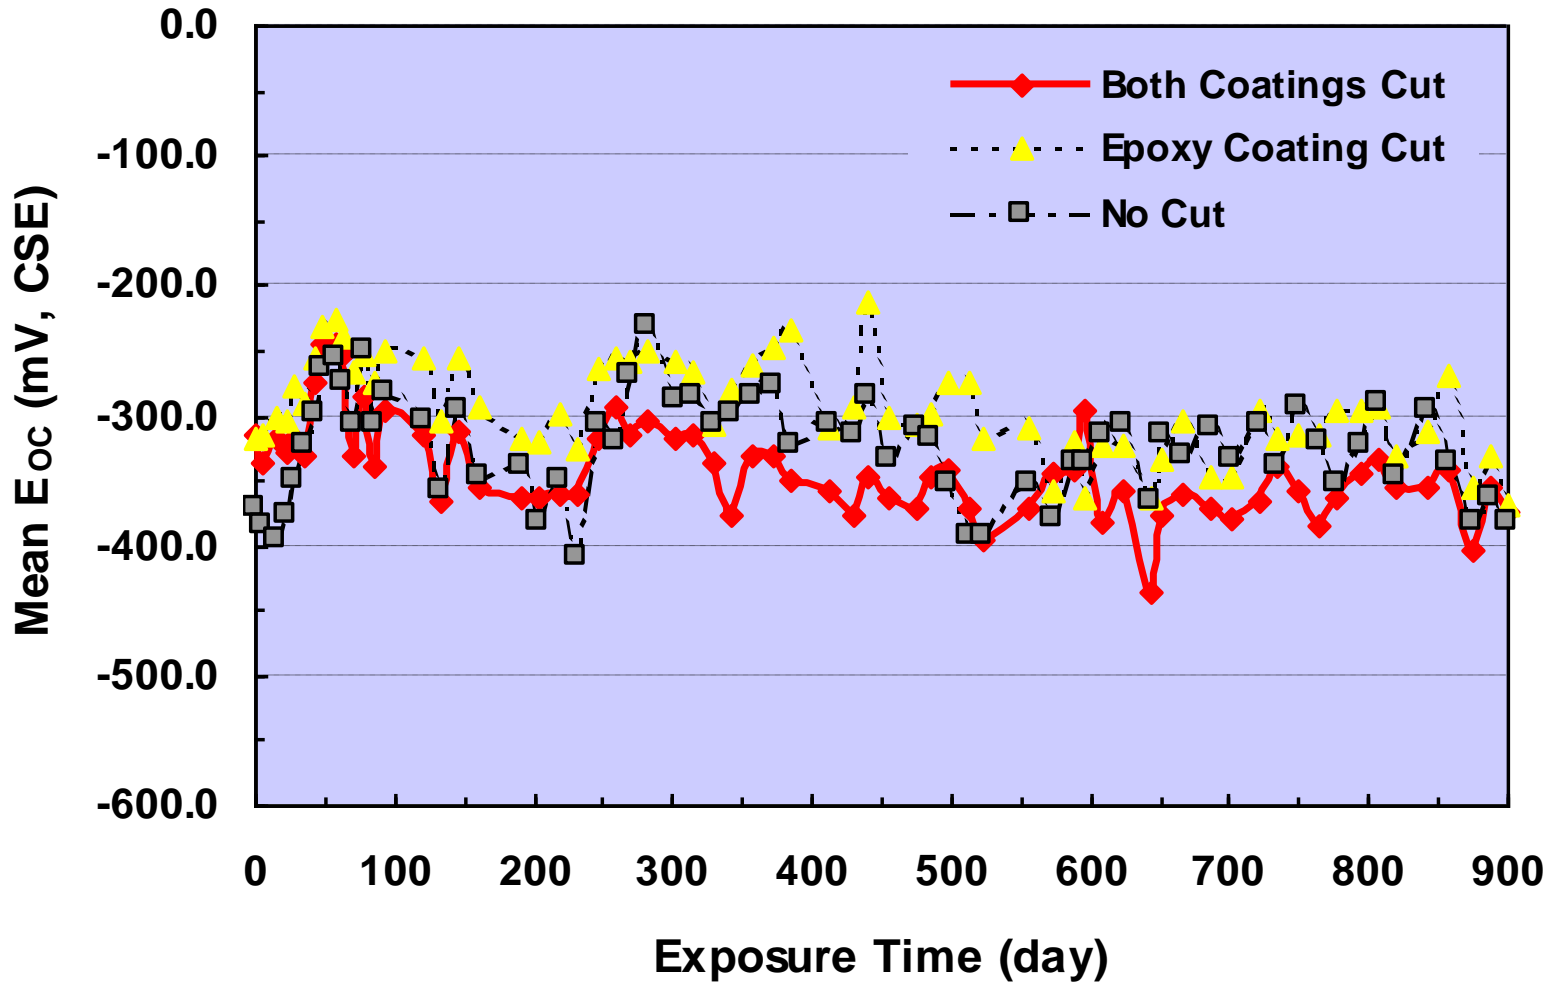
Galvanized-Epoxy Coated Bars

The times-to-corrosion of this type of bars with a composite coating system is difficult to pinpoint from their potentials.

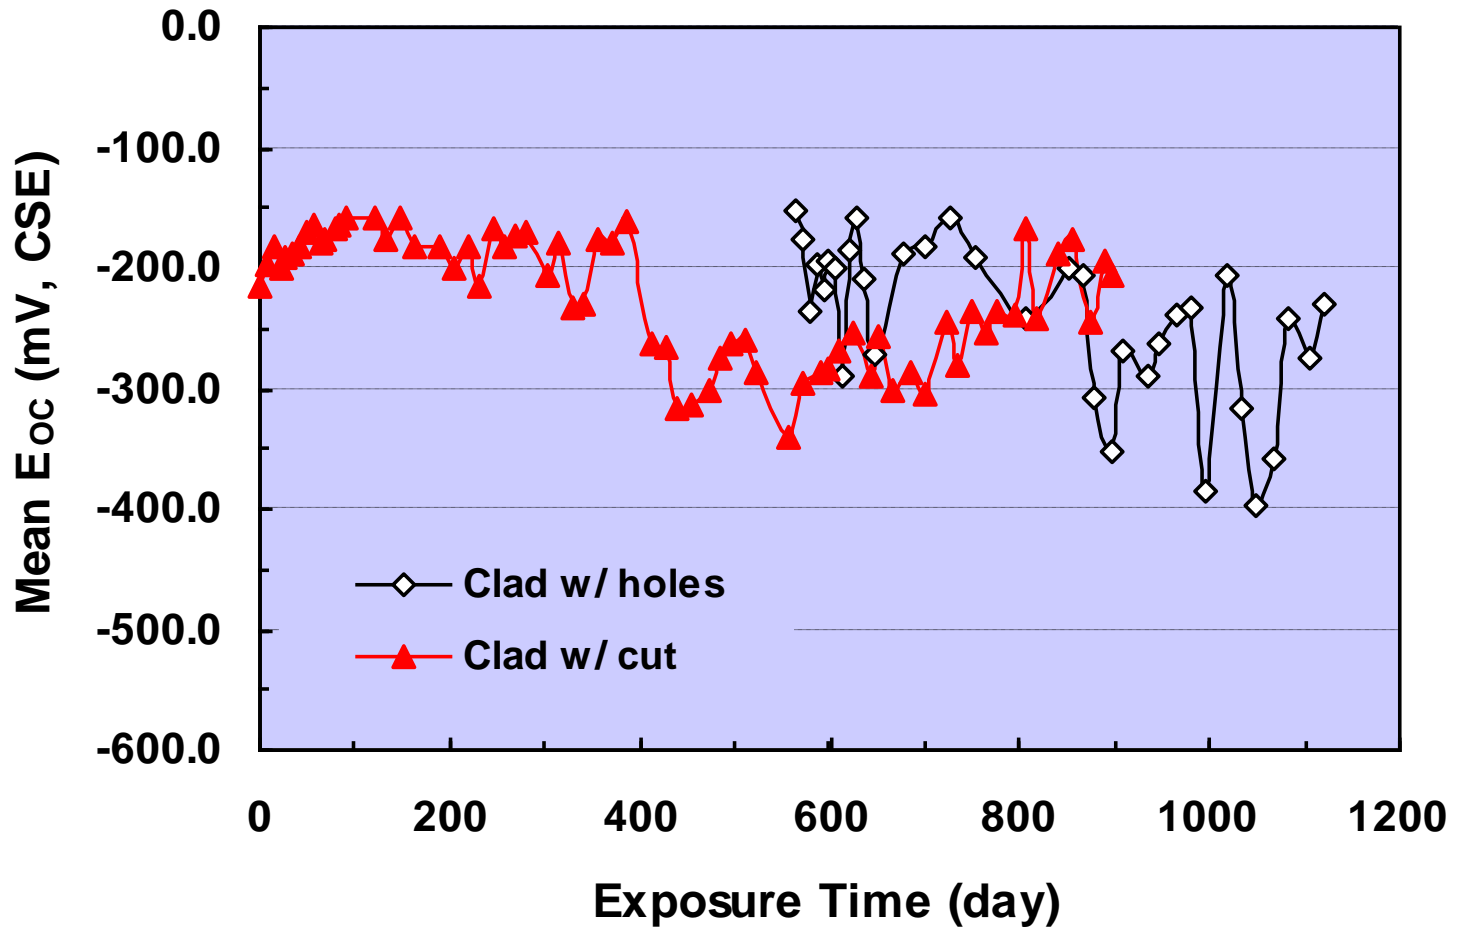
Clad Bars With Intentional Defects

The clad bars with cut in cladding became unstable after 392 days, then regained stability at 820 days.

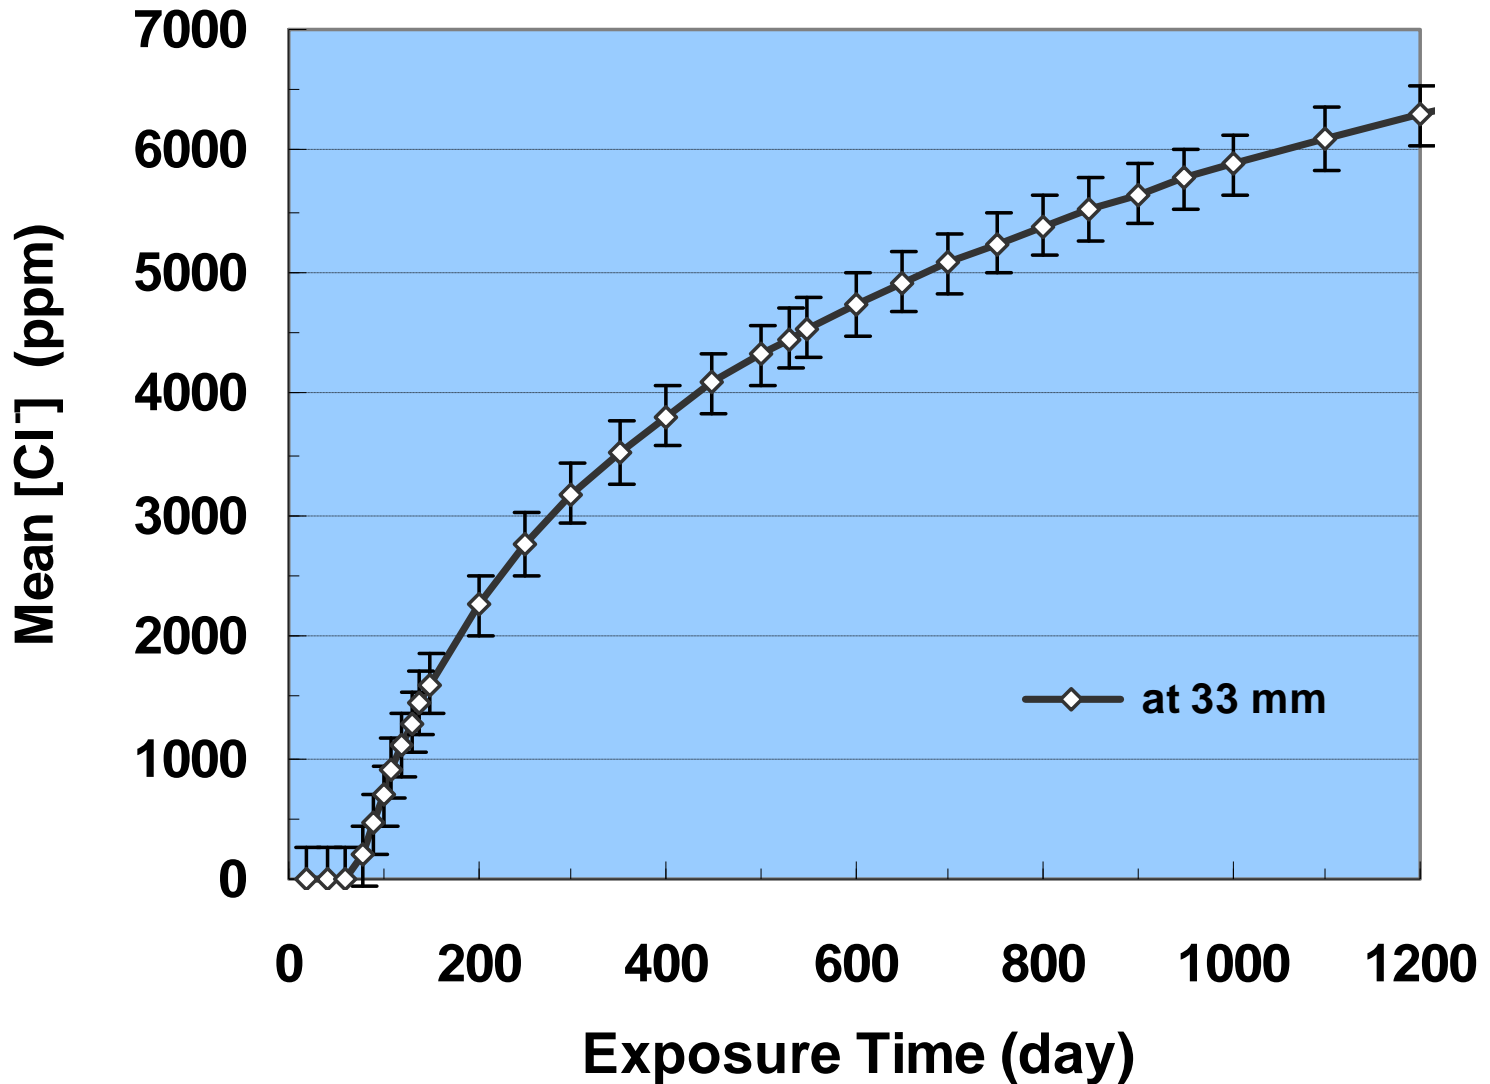
**[Cl⁻] vs. Depth (in Concrete)
vs. Exposure Time**

The best-fit curve relating $[Cl^-]$, at depth of top bars, to exposure time.

Bar	[CL⁻]_{corr}, (ppm)	Ratio
Carbon Steel	430 - 580	1.0
Unpickled 2101 LDX	1,520 - 1,610	2.6 - 3.7
Unpickled MMFX-2	2,690 - 2,740	4.6 - 6.4
316L-Clad (w/cut)	3,750 - 3,790	6.5 - 8.8
Zn/EC (both coatings cut)	4,450 - 4,470	7.7 - 10.4
Zn/EC (epoxy coating cut)	4,860 - 4,880	8.4 - 11.3
Zn/EC (no defect)	> 5,380*	> 9.3 - 12.5*
316L-Clad (w/holes)	> 6,300*	> 10.9 - 14.7*
316L-Clad	> 6,300*	> 10.9 - 14.7*
R 340	> 6,300*	> 10.9 - 14.7*
316LN	> 6,300*	> 10.9 - 14.7*

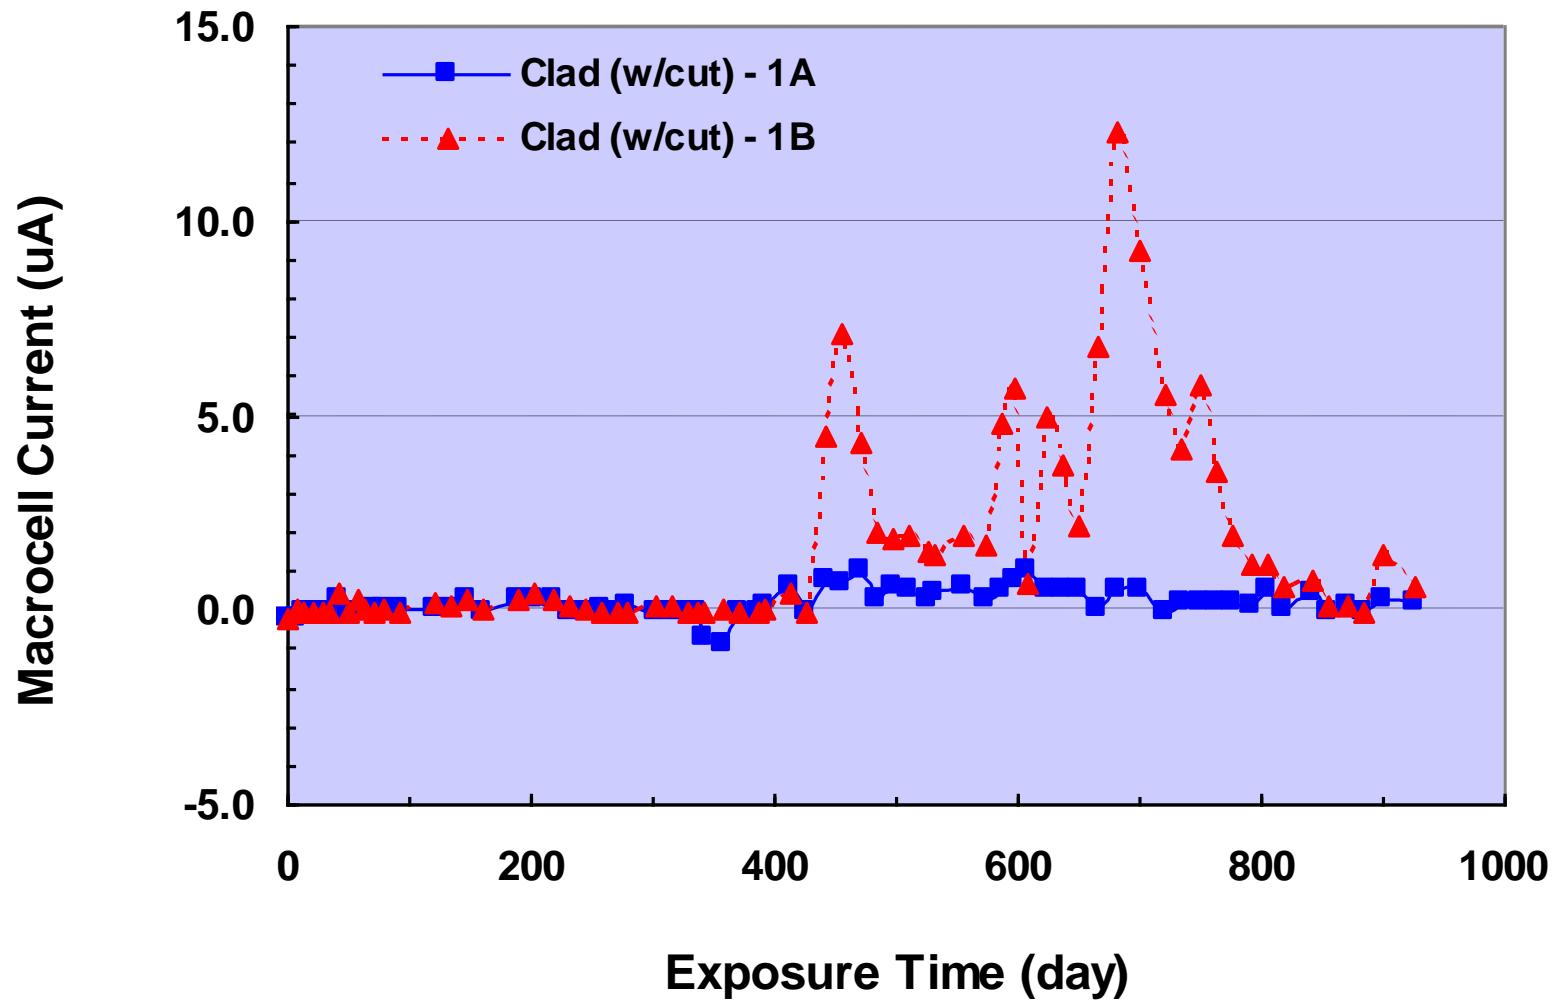
The differences in the macrocell currents of Clad Bars 1A and 1B explained the difference in the conditions of these two bars, as revealed in the autopsy.

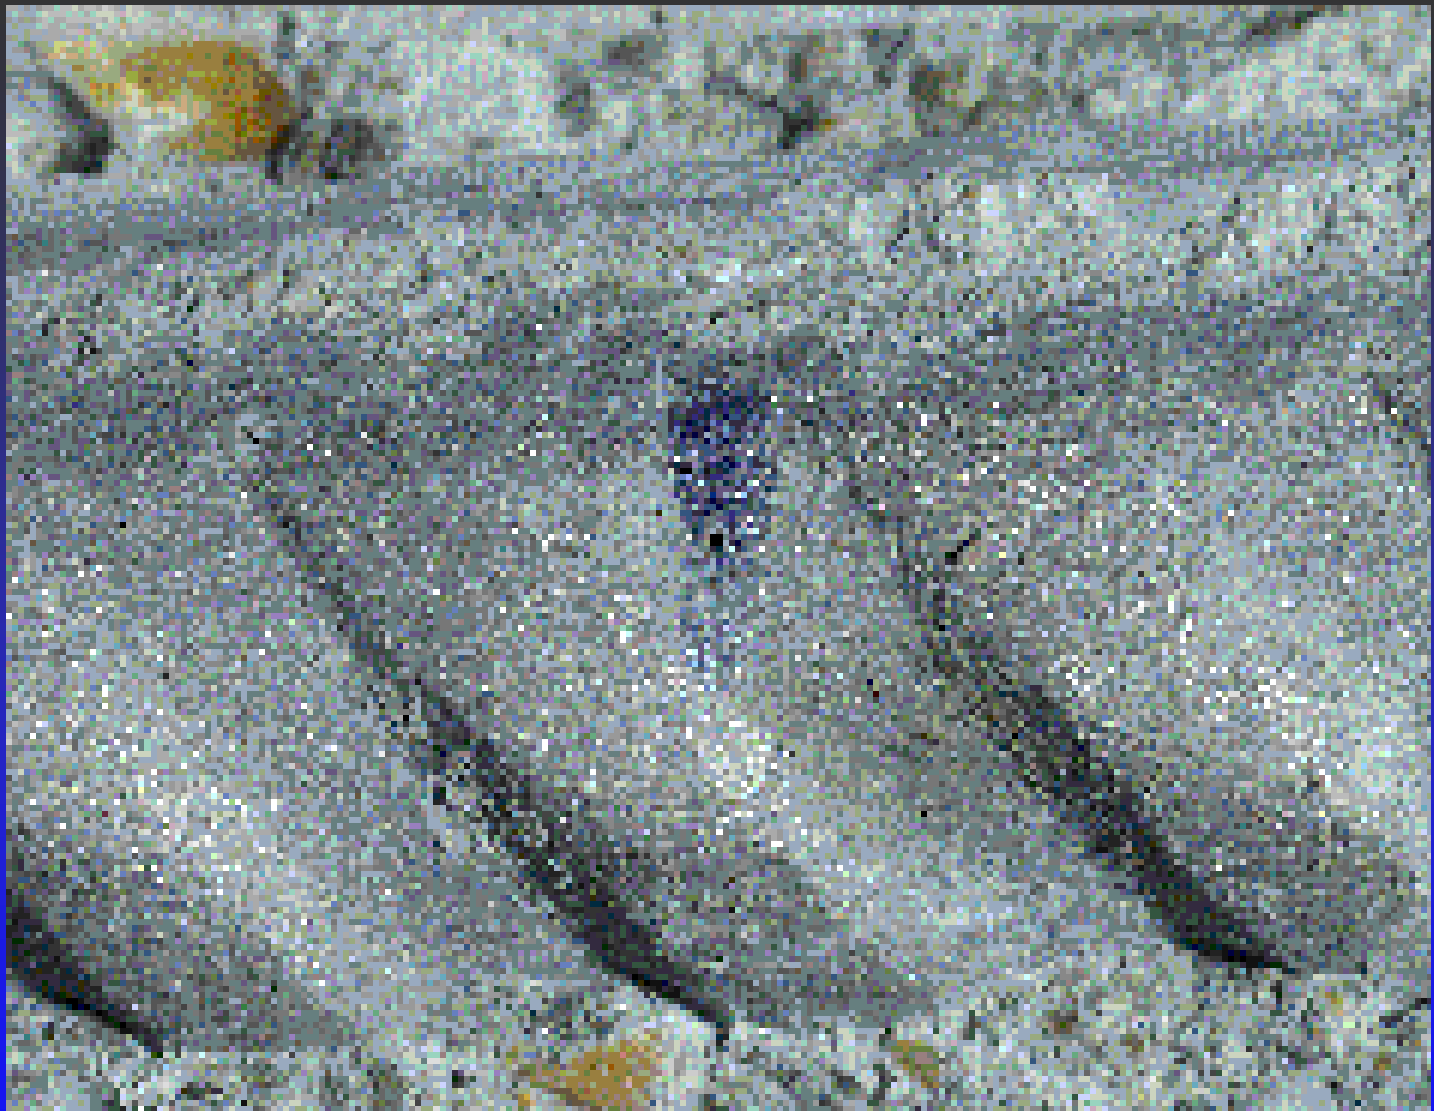
A Clad Bar with One of the Holes (shaded area) Through the Cladding. (Notice There is No Sign of Corrosion.)

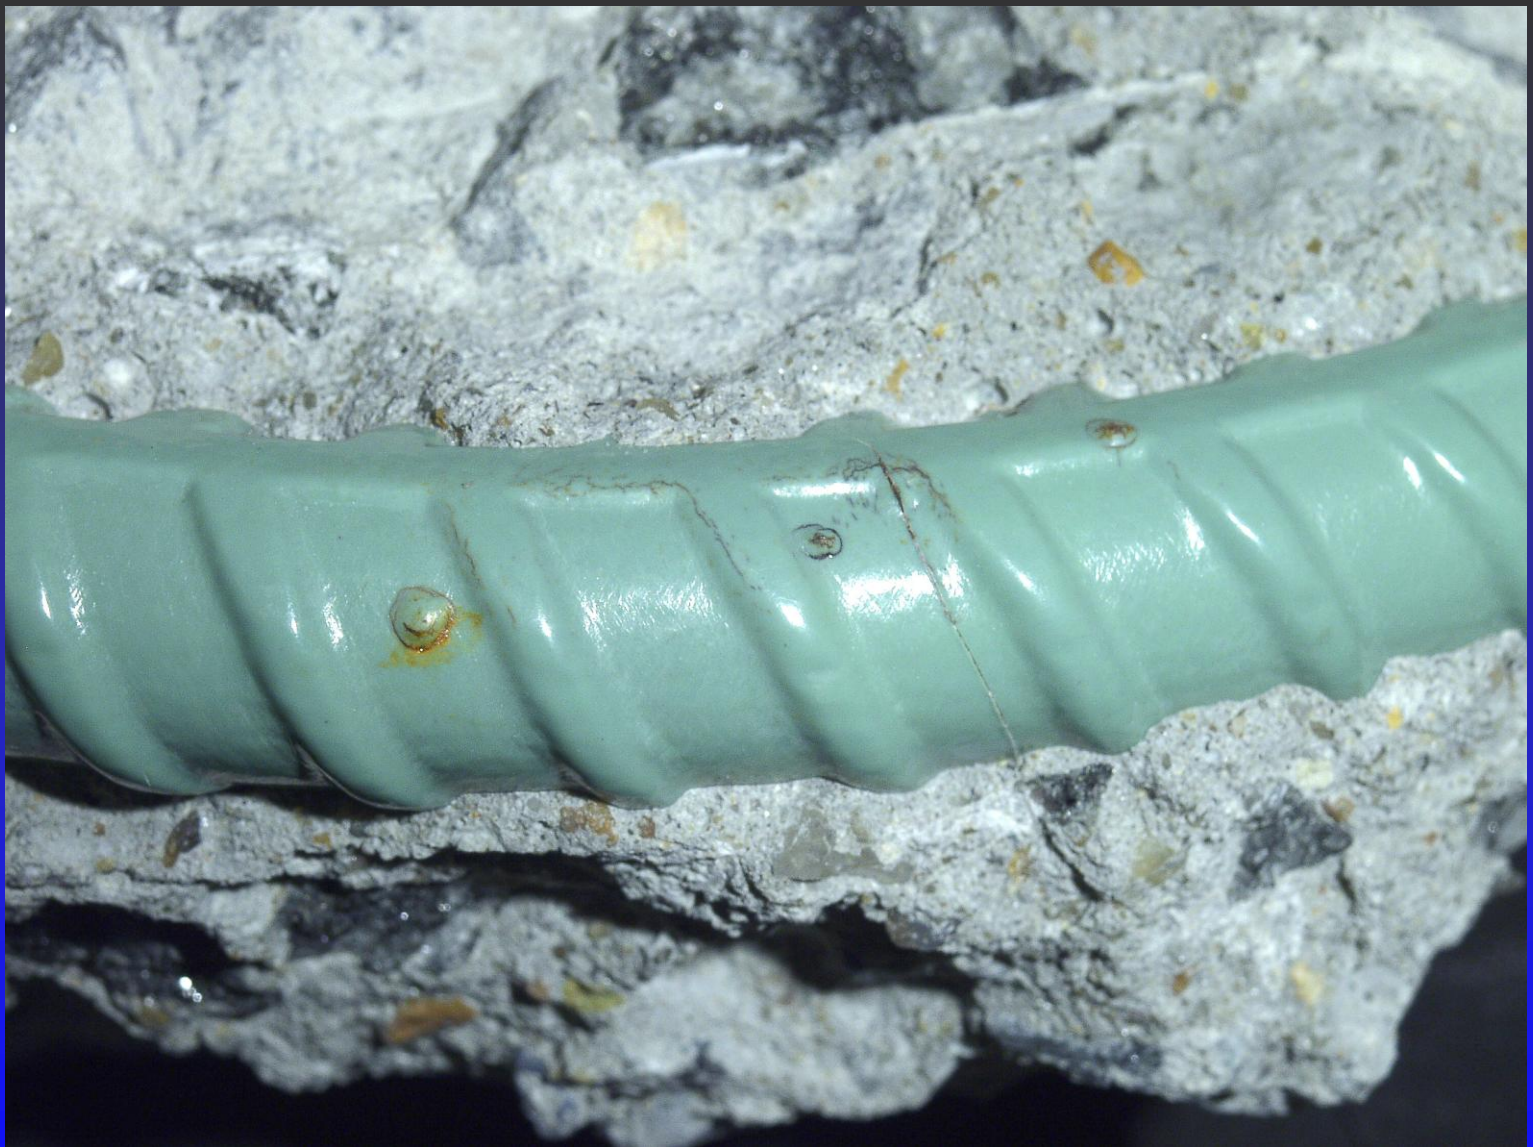
A Zn-Epoxy Coated Bar (1B) with a Cut Through Both Coatings. (Notice a corroded area under the coatings, at the top end of the cut.)

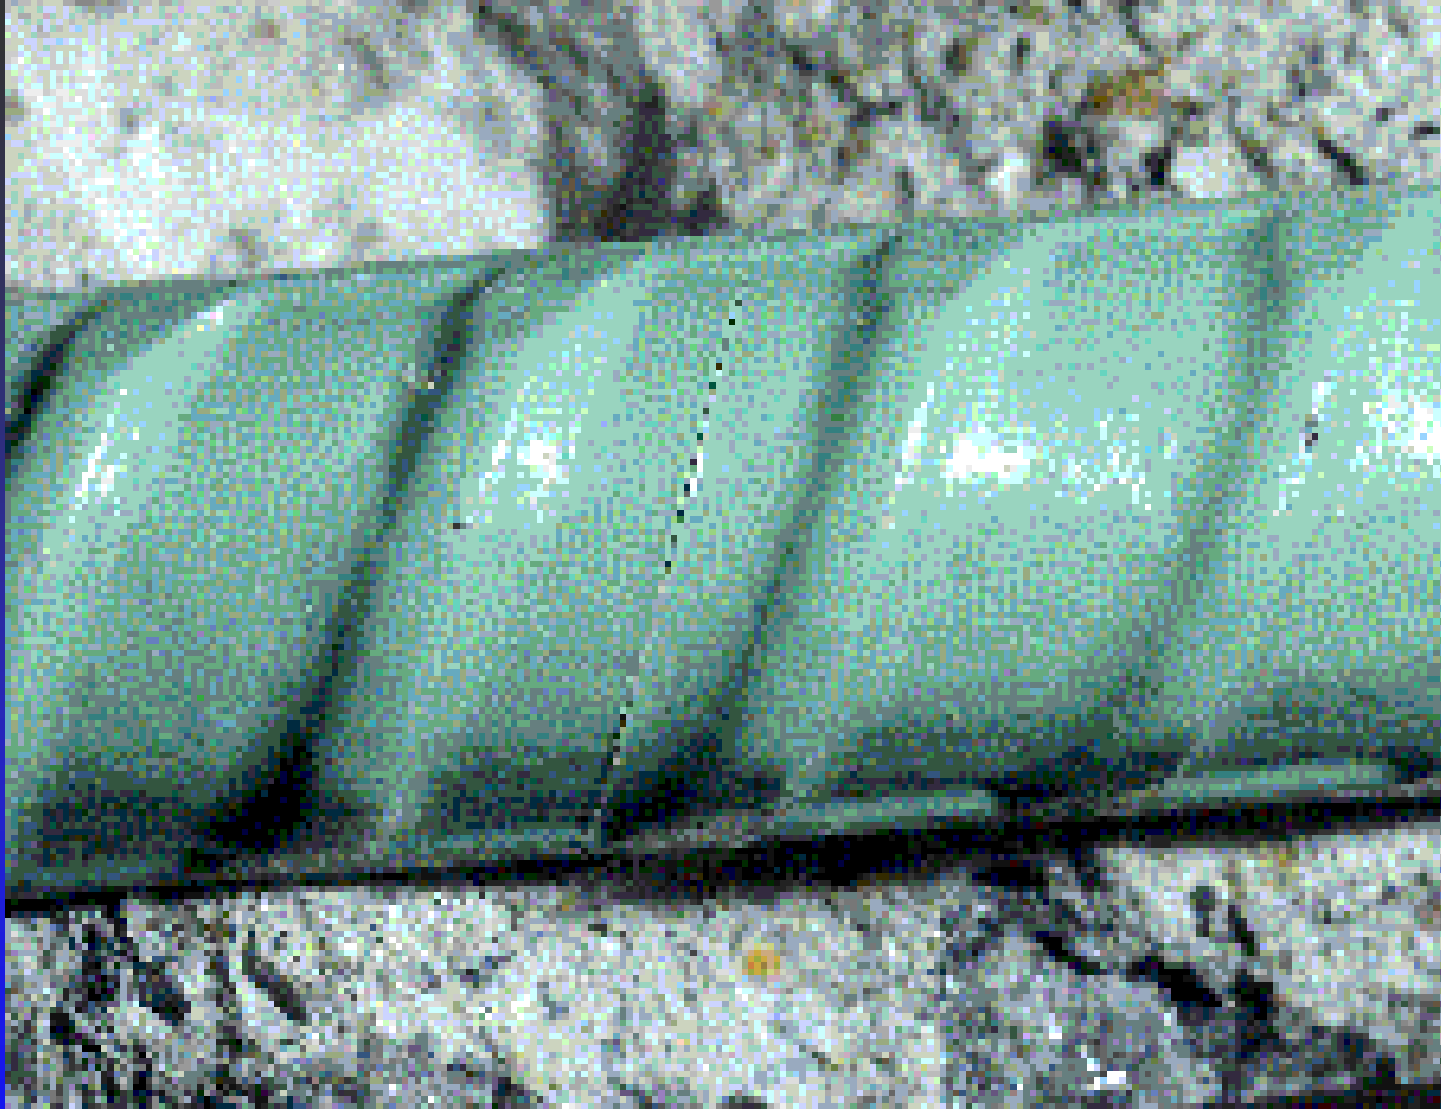
A Second Zn-Epoxy Coated Bar (1A) with a Cut Through Both Coatings, From the Same Concrete Block. (Notice there is no sign of corrosion that is associated with the cut.)

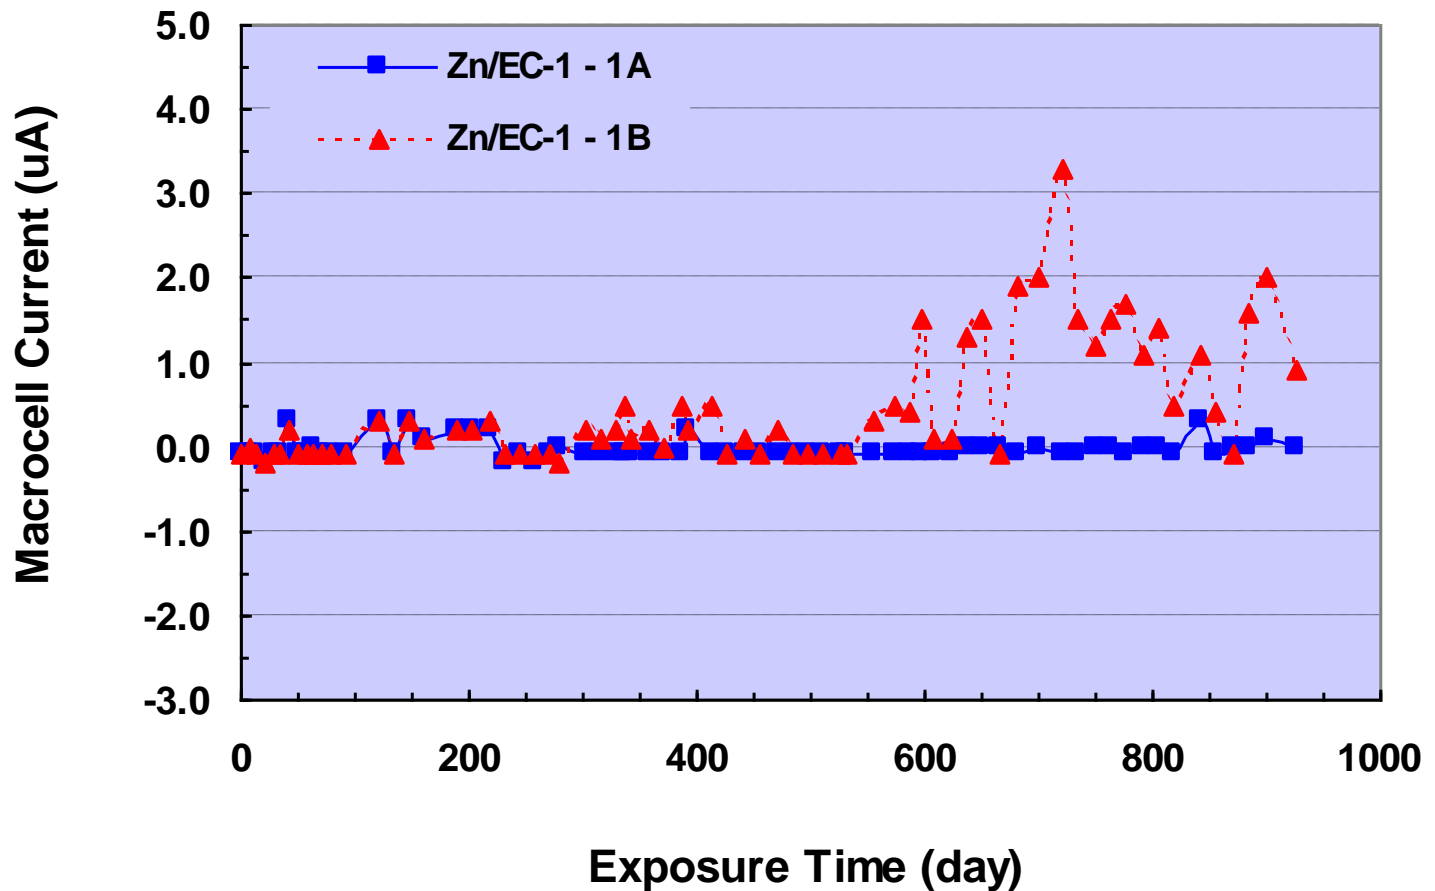
The differences in the macrocell currents of Zn-Epoxy Coated Bars 1A and 1B, both with a cut through the coatings, explained the difference in the conditions of these two bars, as revealed in the autopsy.

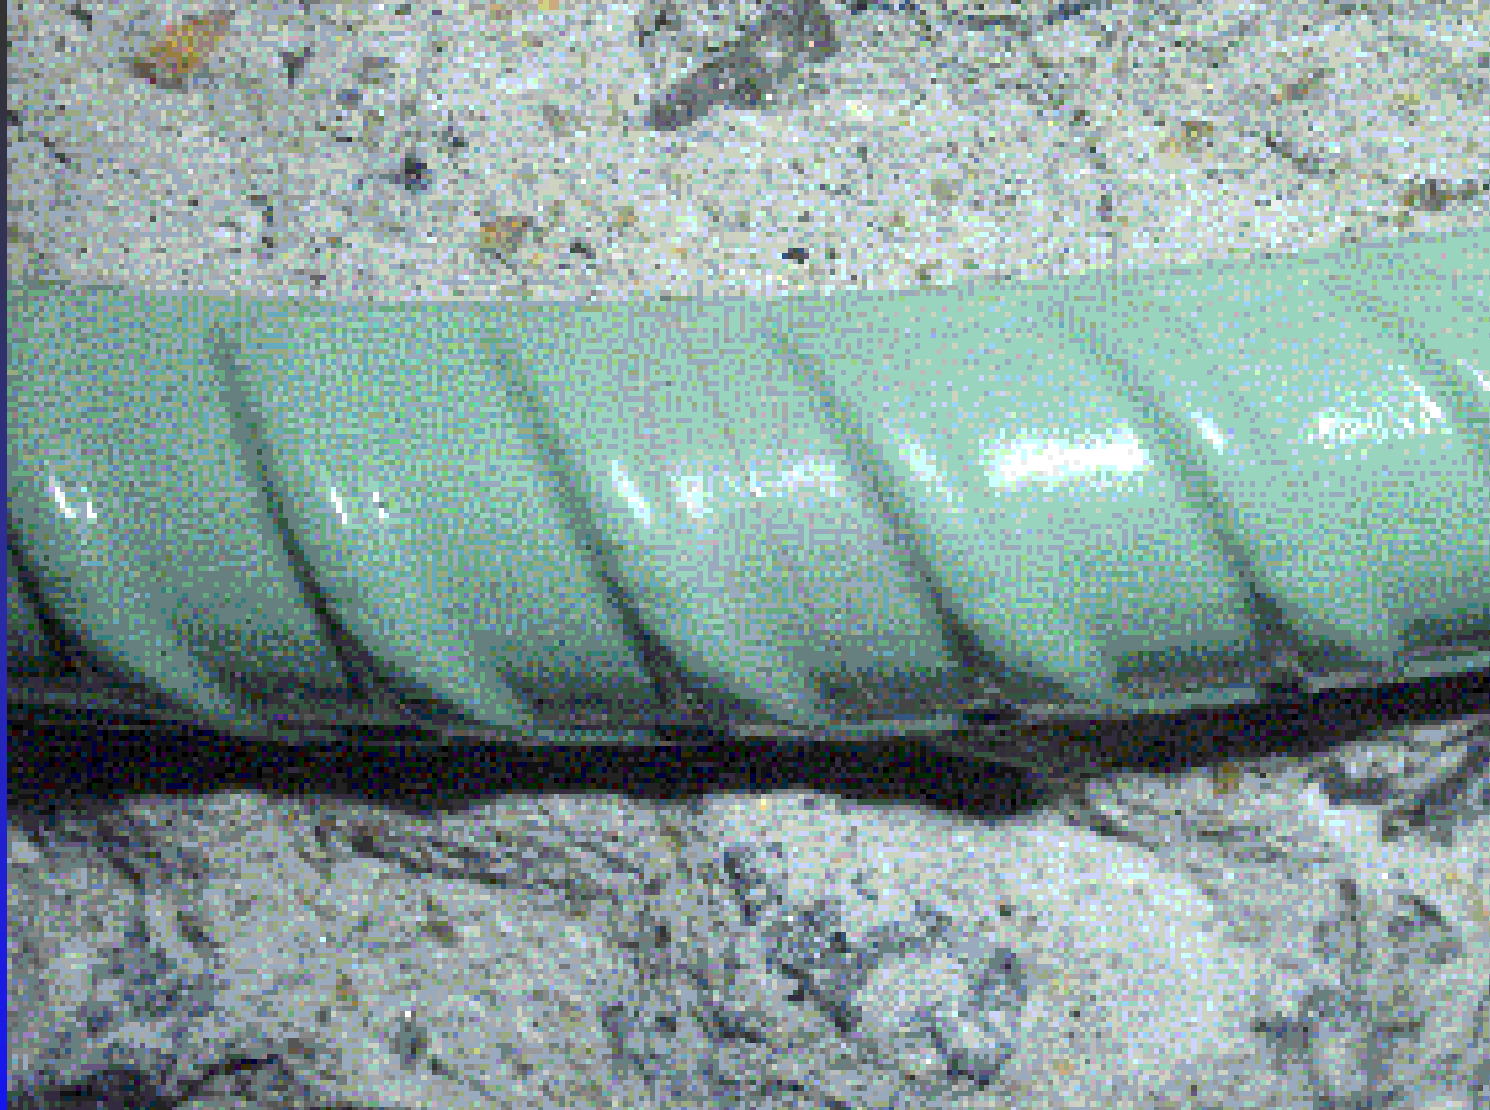
One of the Two Autopsied Zn-Epoxy Coated Bars With a Cut Through The Epoxy Coating Only. (Notice there is no evidence of corrosion associated with the cut. The second bar was similar in condition.)

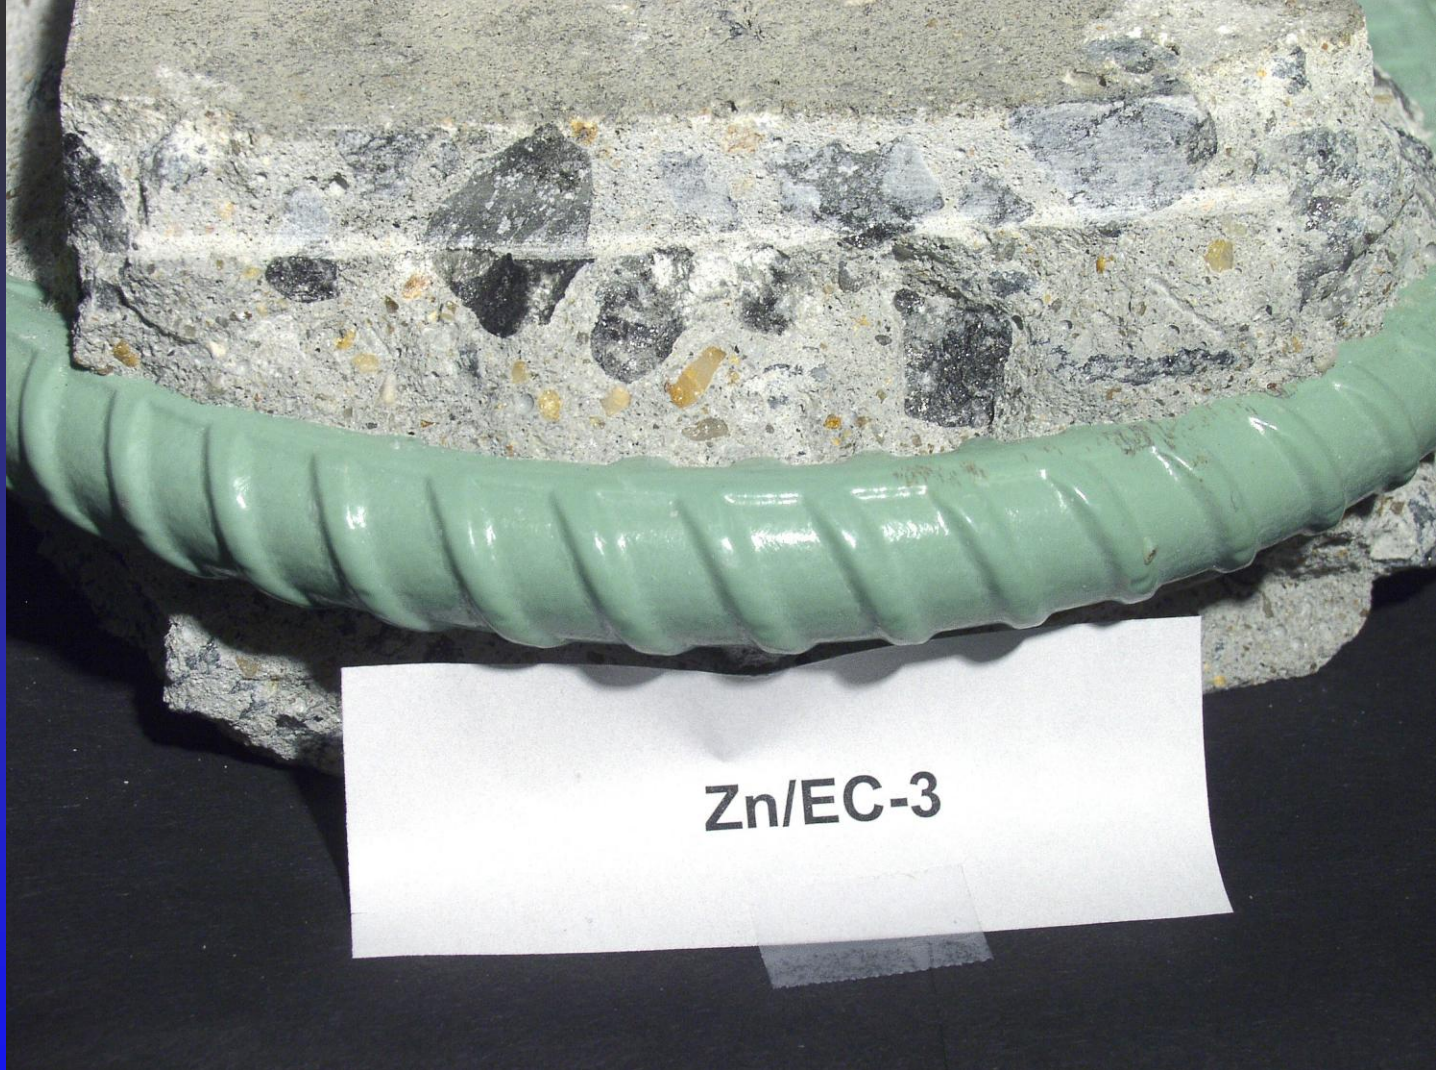
One of the Two Autopsied Zn-Epoxy Coated Bars With No Cut Through Any of the Coatings, After 900 Days of Exposure. (Noticed the presence of isolated minor corrosion – probably on pre-existing holidays.)
