REHABILITATION AND CONSTRUCTION OPTIONS FOR CONCRETE BRIDGES — ENSURING LONG SERVICE LIFE

Gerardo G. Clemeña, Ph.D., MSc.
Virginia Transportation Research Council*
Charlottesville, Virginia

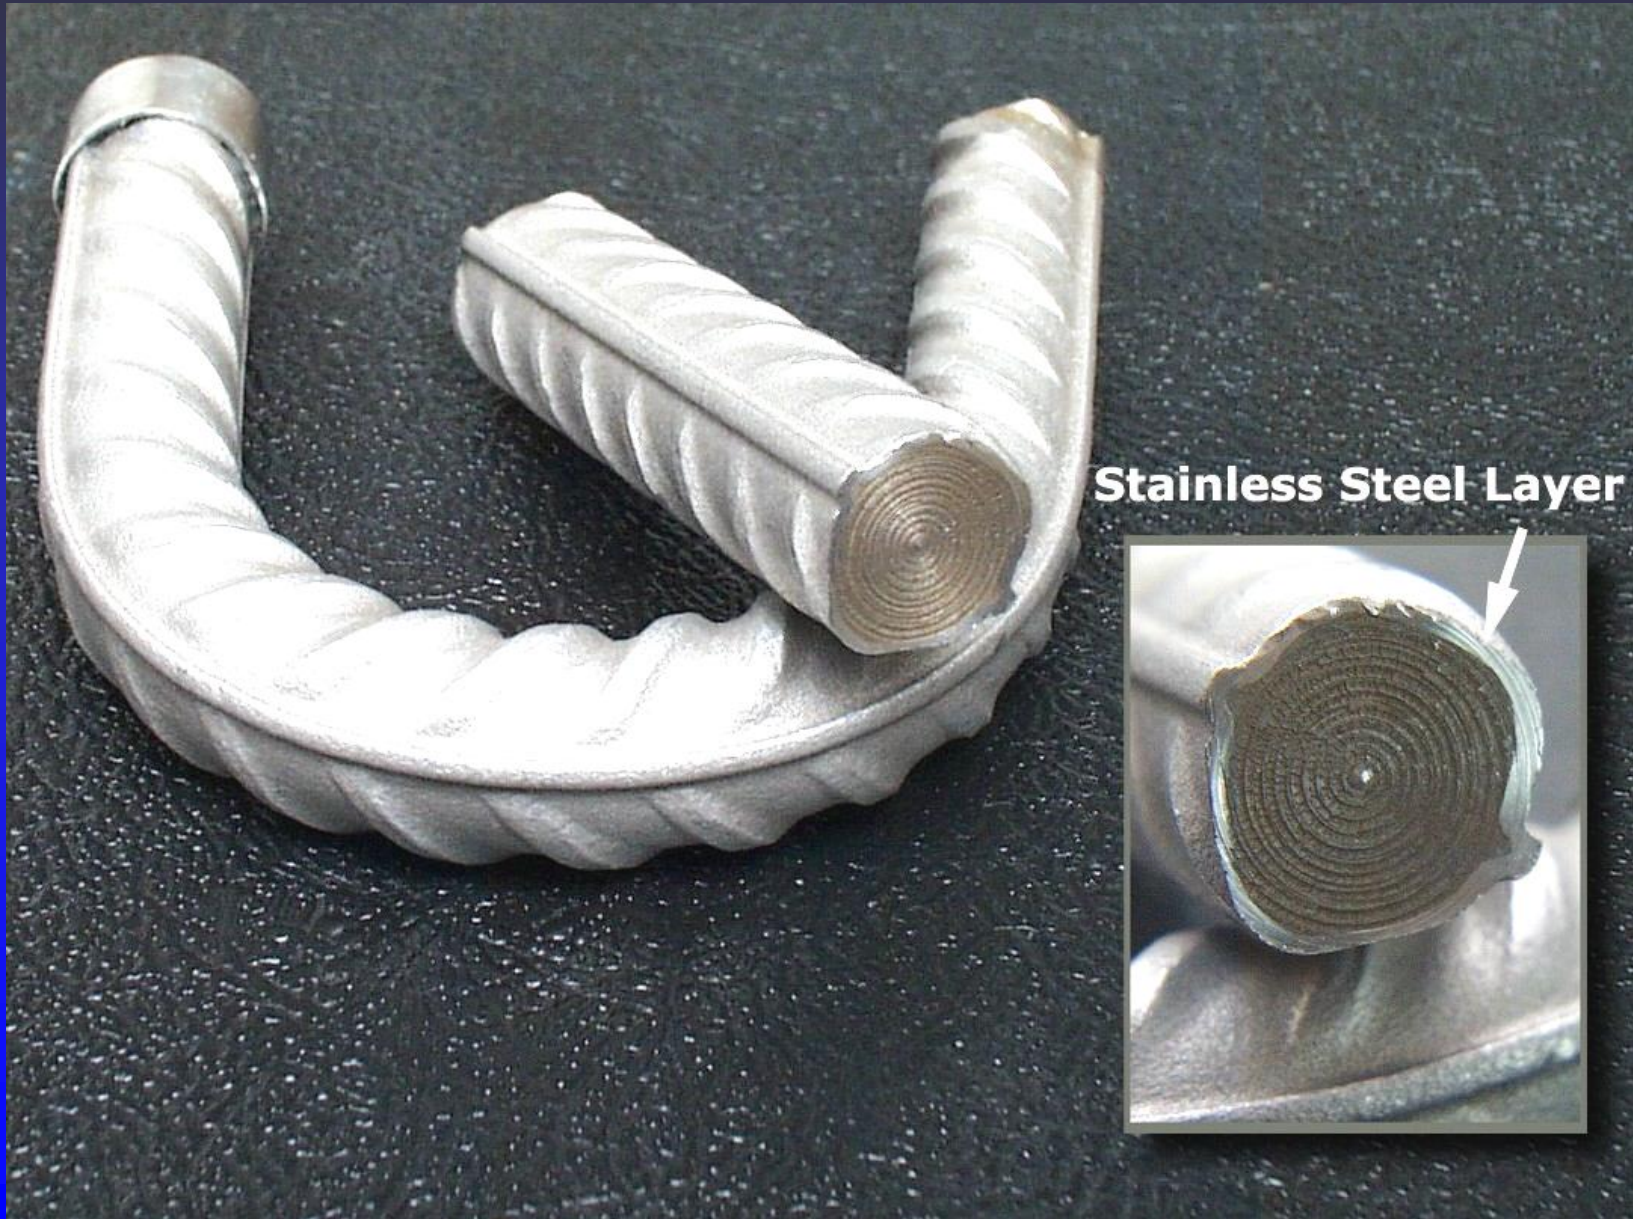
SS-CLAD BAR SAMPLES

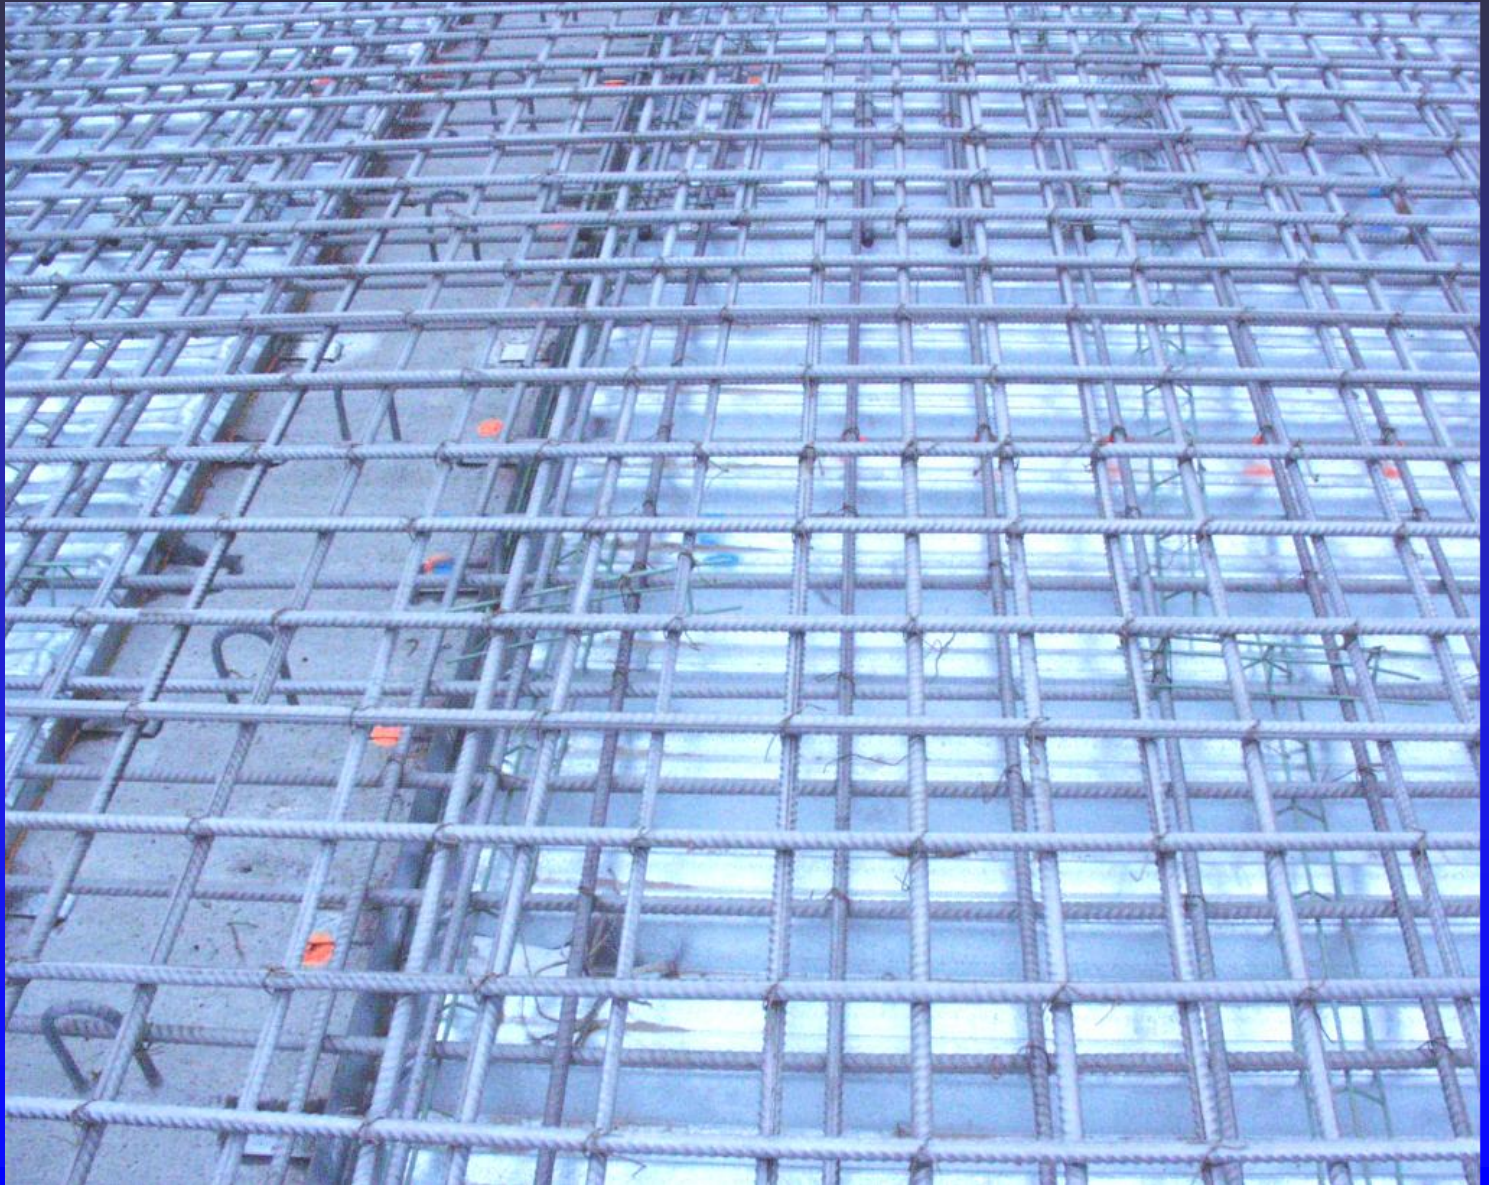
USE OF CLAD BARS IN A NEW BRIDGE
