Comparing the Chloride Resistances of Reinforcing Bars

Evaluating new, economical metallic reinforcement for its ability to withstand high salt concentrations

BY GERARDO G. CLEMEÑA AND YASH PAUL VIRMANI

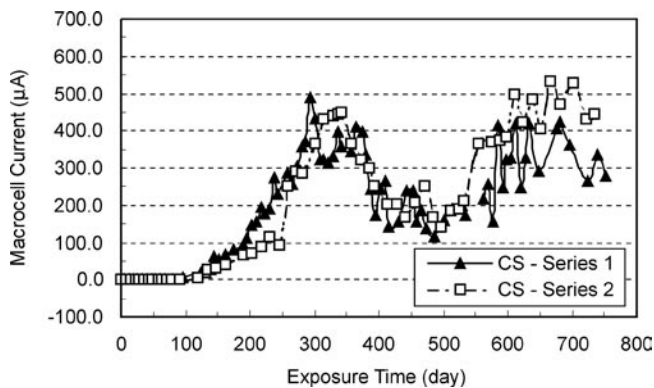
Fig. 2: Macrocell currents of the two sets of concrete blocks with bent CS bars at the top and straight CS bars at the bottom of each block

As basis for comparison, Fig. 2 shows the weekly macrocell currents of the two subsets of concrete blocks—one was part of the Series 1 and the other of the Series 2 blocks—that were reinforced with bent CS bars at the top and straight CS bars at the bottom (Bent CS/CS (1) and (2)) as these blocks were being subjected to outdoor weekly cycles of salt ponding and drying. As Fig. 2 shows, the top bent CS bars in both series of concrete blocks were initially passive, with mean macrocell

differences of only 9 and 4% for the mean and the maximum macrocell currents, respectively, between these two series of concrete blocks, the results presented in Fig. 2 are in good agreement.

Examination of all electrochemical data collected would indicate that both the macrocell current and the potential, in relation to exposure time, indicate when corrosion has begun on a particular type of bar. As clearly demonstrated in Fig. 2, the onset of corrosion in the

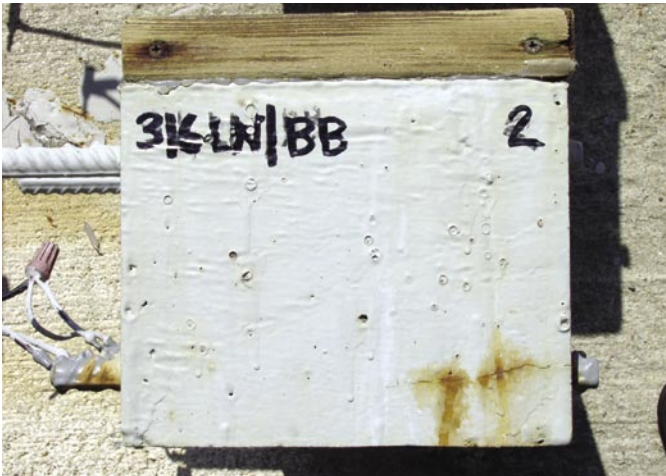
Fig. 4: Side view of a concrete block with 316LN bars at the top and CS bars at the bottom

For those blocks with 316LN bars in the top and bottom (316LN/316LN), weekly macrocell currents after 1299 days (or 186 weekly cycles) of salt exposure were insignificant, averaging 0.0 μA at a standard deviation of $\pm 0.2 \mu\text{A}$, which indicates that the bars were passive (Table 3). In addition, Fig. 3 shows that after about 400 days, the concrete blocks with 316LN bars at the top and CS bars at the bottom (316LN/CS and Bent 316LN/CS) began to exhibit negative macrocell currents. This indicated that sufficient chloride ions had reached the CS bars so that they became more anodic than the top 316LN bars and were corroding. As indicated in Table 3, the macrocell currents for these two subsets of blocks reached -9.0 and $-9.2 \mu\text{A}$ before we stopped taking measurements (at approximately 752 days) due to cracking of some of the blocks near the bottom CS bars (see Fig. 4).

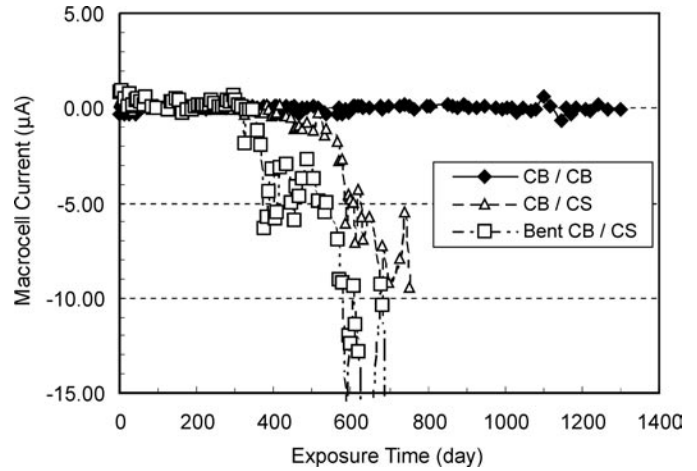
Fig. 6: Macrocell current of the concrete blocks with 316L-clad bars in various combinations

Graphs for the R304 and 316L-clad bars (Fig. 5 and 6, respectively) show similar results to that of Fig. 3 for the 316LN bars. All of these graphs share two common characteristics. First, the concrete blocks containing either 316LN, R304, or 316L-clad bars in both mats, even after 1299 days of the salt exposure regime, lack any significant macrocell current. This implies that the R304 bars, which are basically a solid 304 stainless steel, and the 316L-clad bars had, so far, exhibited the same good resistance to attack by chloride ions in concrete as the solid 316LN bars had. Second, negative macrocell currents (after 350 to 450 days) appeared in the blocks where CS bars were used in the bottom mat. Noteworthy is the smaller negative macrocell currents in the blocks with CS bars and R304 bars, compared to those with the 316LN and the 316L-clad bars, as shown in Fig. 3, 5, and 6. Perhaps this is a reflection that R304 is relatively less noble than 316L and 316LN.

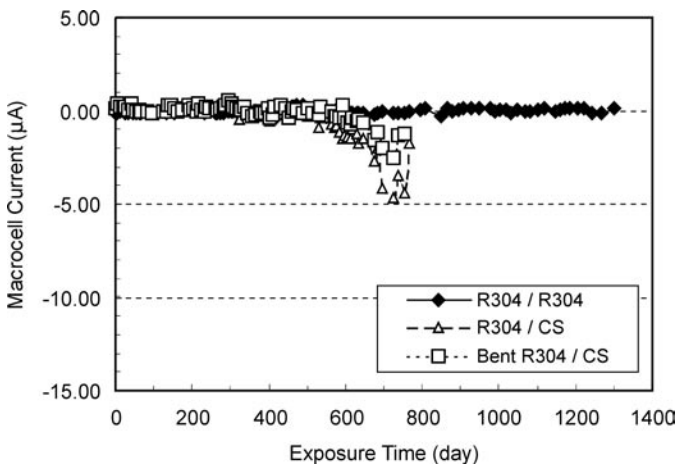
Fig. 5: Macrocell current of the concrete blocks with R304 bars in various combinations

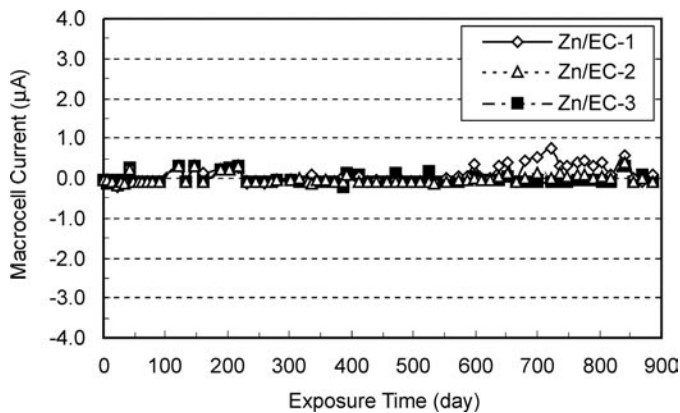
Fig. 7: Macrocell current of the concrete blocks with Zn/EC bars in three different coating conditions

In contrast, there were no significant macrocell currents in the blocks with the Zn/EC bars until after 76 to 79 weekly cycles of salt exposure when the Zn/EC-1 bars began to indicate some activity (Fig. 7). There was no apparent activity, even after 899 days of exposure, on the Zn/EC-2 bars or the Zn/EC-3 bars.

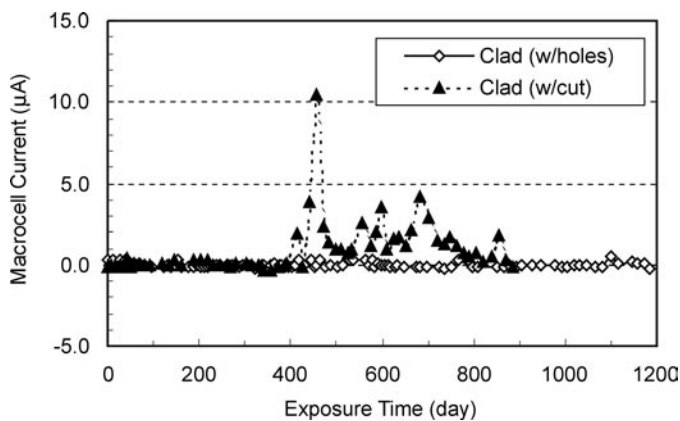
Fig. 8: Macrocell currents of the concrete blocks with the 316L-clad bars with either holes or a cut introduced through the cladding

The 316L-clad bars with three holes drilled through the cladding had no significant macrocell current, even after 1186 days of exposure (Fig. 8). In contrast, the 316L-clad bars with a cut intentionally introduced through the cladding began to show measurable positive macrocell current at 392 days, however, the maximum macrocell current exhibited was only 10.5 μA on Day 456, which is comparatively less than the currents observed on the CS, the unpickled 2101 LDX, and the unpickled microcomposite steel bars. Regardless, this likely indicates that the exposed CS core had begun to corrode.

In contrast, the absence of macrocell current for the entire 1299 days of testing of the 316L-clad bars with holes drilled through the cladding (Fig. 8) suggested no corrosion yet on these bars. Similar autopsy of a concrete block with two of these bars confirmed no sign of corrosion around each of the holes (Fig. 14). These results certainly point toward a possible influence of cladding defect size on loss of protection for the CS core. The cuts introduced on some of the 316L-clad bars in this investigation were probably unrealistic. Although it is expected that the stainless steel cladding would be very resistant to damage by impact, abrasion, or penetration, it is conceivable that cladding “breaks” can occur if sections of bars with insufficient cladding are bent.

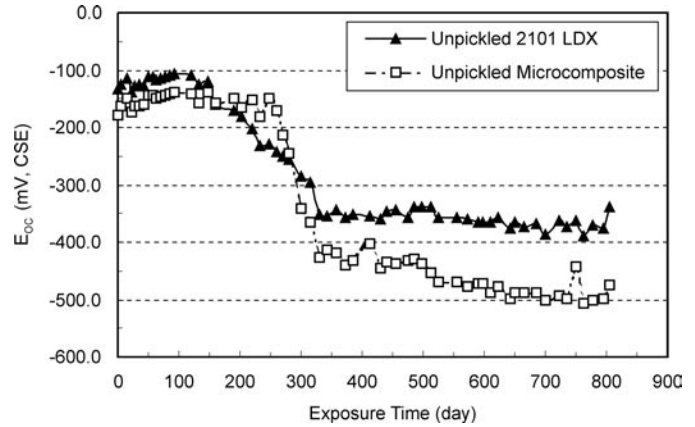
Fig. 11: Open-circuit potentials of the unpickled 2101 LDX and microcomposite bars

Meanwhile, the potentials of the unpickled 2101 LDX and microcomposite bars behaved almost like that of the CS bars—abruptly shifting electronegatively after some initial period of stability—but longer than that for the CS bars: 147 and 247 days for the unpickled 2101 LDX and microcomposite steel, respectively (Fig. 11). Again, these two turning points in their potentials were in good agreement with the observed times at which these two bars started to exhibit significant increases in their macrocell currents—147 and 245 days for the unpickled 2101 LDX and microcomposite steel, respectively.

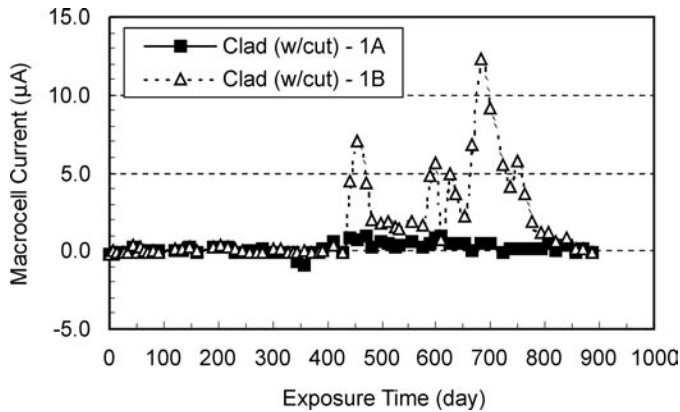
Fig. 13: The macrocell currents flowing between 316L-clad bars with cuts 1A and 1B and their respective accompanying bottom clad bars

For visual confirmation, block CB (w/cut) –1 was autopsied to expose the two top 316L-clad bars. This revealed that bar 1A had no sign of corrosion at the cut, while bar 1B had two round corrosion areas—one at each end of the cut. Further examination of bar 1B revealed no further damage to the bar, and that the corrosion in both

areas may have subsided. The macrocell currents of these individual bars strongly reflect the apparent absence of corrosion on bar 1A, and the initiation and then probable subsidence of corrosion on bar 1B (Fig. 13). As shown, there was no significant macrocell current for bar 1A, even though it had a cut similar to that in bar 1B, which exhibited macrocell current from approximately day 400. The relatively smaller magnitude of the macrocell current in bar 1B, when compared to those of the CS, 2101 LDX, and microcomposite bars, and its continuous decreasing trend in the last 100 days, may be an indication that the corrosion did not continue to propagate, or at least not at a fast rate. Future plans include slicing bar 1B at the vicinity of the cut to allow for close examination of the cladding/core interface at the two corrosion areas.

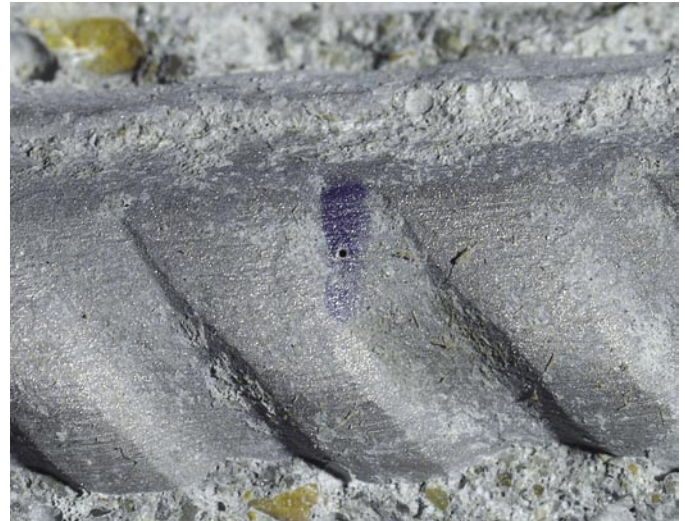
Fig. 14: One of the holes (marked area in the center) drilled through the cladding of a 316L-clad bar. Notice the absence of any sign of corrosion around the hole, even though it was apparently not filled with cement paste

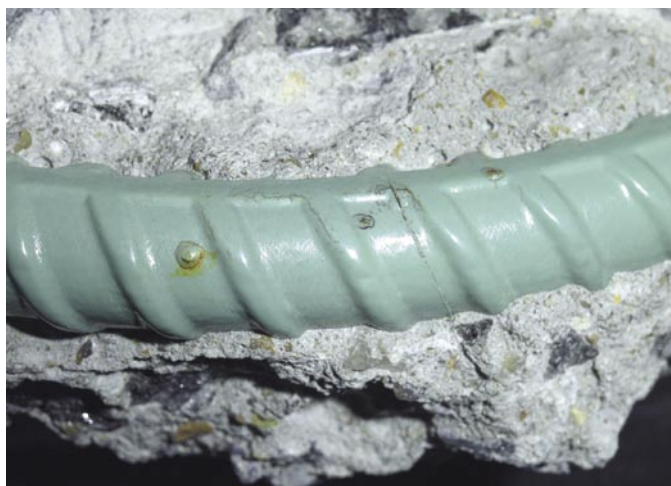
Fig. 15: The Zn/EC-1-1B bar recovered from a concrete block. Notice the four corrosion areas that ranged from 2 to 5 mm (0.08 to 0.20 in.) across and at 0 to 22 mm (0 to 0.9 in.) from the cut in the composite coating system

Similar autopsy of three different concrete blocks, one each for Zn/EC-1, -2, and -3 bars, confirmed that: 1) there was no corrosion yet on any one of the two Zn/EC-2 or -3 bars exposed; and 2) not surprisingly, one of the Zn/EC-1 bars, the 1A, had no sign of corrosion yet around the cut, while the other bar in the same block, the 1B bar, had four small corrosion areas—all within 22 mm (0.9 in) of the cut through both the Zn and the epoxy coating (Fig. 15). As in the case of the two exposed 316L-clad bars with the cut, this is supported by the changes in the macrocell

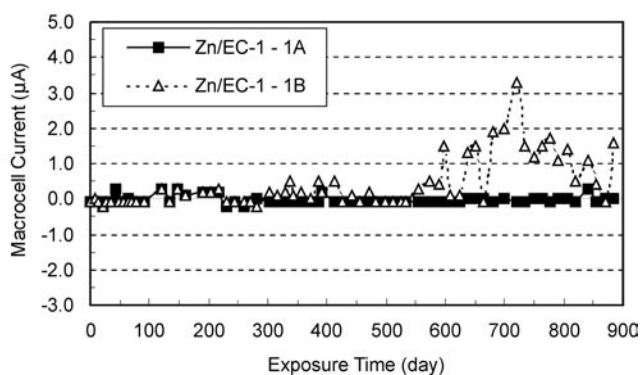
Fig. 16: The macrocell currents flowing between Zn/EC-1-1A and -1B bars and their respective accompanying bottom Zn/EC bars

currents—as a function of salt exposure time—for these two individual bars (Fig. 16).
